Brampton Road

Inspection Ref: 2174040

Operational Inspection - 18-September-2023 - 10:57 Inspector Terry Hill

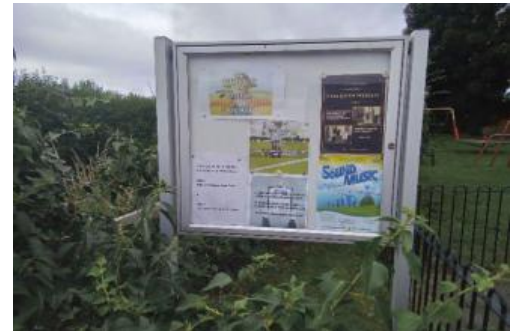
Item: Notice Board
Manufacturer: Owner/Operator
Surface Type: Grass
Item Quantity: 1
Equipment Compliance: N/A
Surface Area Compliance: N/A

This item is satisfactory - no work required -

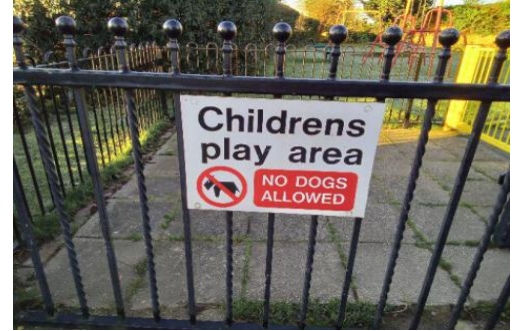
Item: Sign
Manufacturer: Unknown
Surface Type: Grass
Item Quantity: 1
Equipment Compliance: N/A
Surface Area Compliance: N/A

Item satisfactory - Item satisfactory

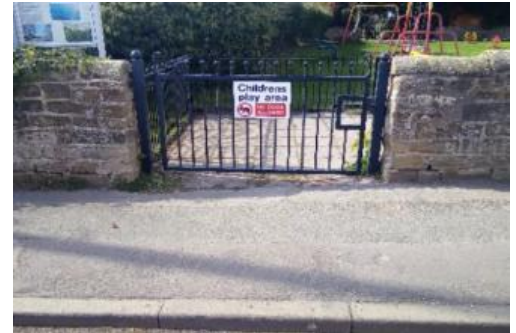
Item: Gate
Manufacturer: Owner/Operator
Surface Type: N/A
Item Quantity: 1
Equipment Compliance: N/A
Surface Area Compliance: N/A

This item is satisfactory - no work required -

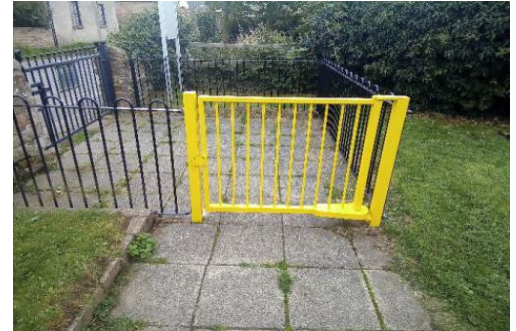
Item: Gate - Pedestrian
Manufacturer: A & E Group Ltd
Surface Type: Concrete
Item Quantity: 1
Equipment Compliance: N/A
Surface Area Compliance: N/A

Item satisfactory - No work required

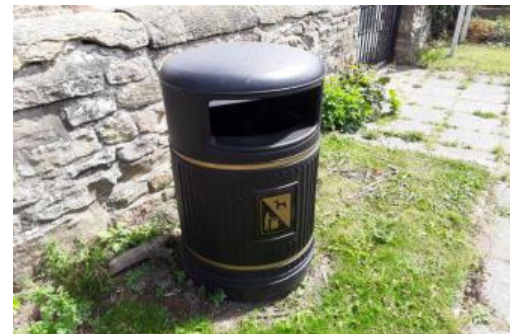
Item: Litter Bin
Manufacturer: Owner/Operator
Surface Type: Grass
Item Quantity: 1
Equipment Compliance: N/A
Surface Area Compliance: N/A

This item is satisfactory - no work required -

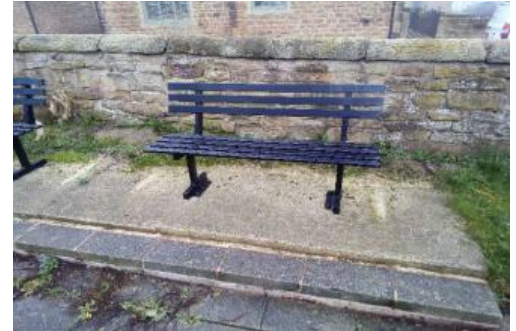
Item: Bench
Manufacturer: Owner/Operator
Surface Type: Concrete
Item Quantity: 2
Equipment Compliance: N/A
Surface Area Compliance: N/A

This item is satisfactory - no work required -

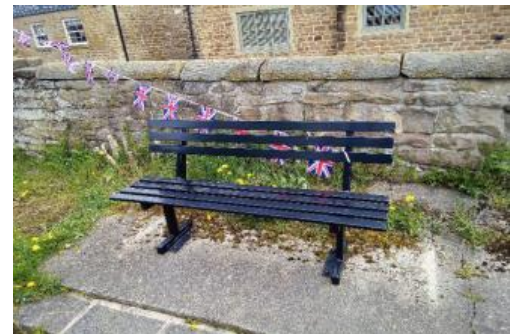
Item: Bench
Manufacturer: Unknown
Surface Type:
Item Quantity: 1
Equipment Compliance: N/A
Surface Area Compliance: N/A

This item is satisfactory - no work required -

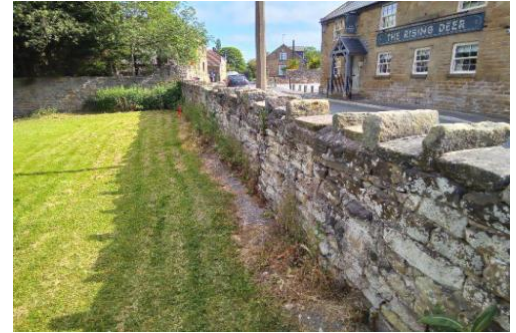
Item: Wall
Manufacturer: Owner/Operator
Surface Type: N/A
Item Quantity: 1
Equipment Compliance: N/A
Surface Area Compliance: N/A

Item decaying - Monitor

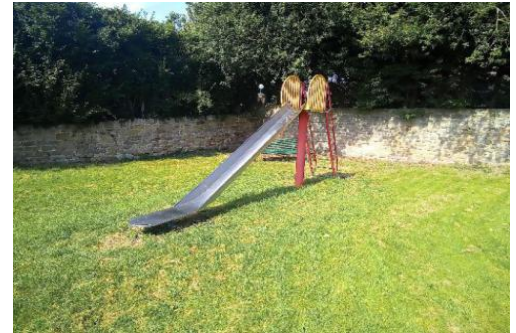
Item: Free Standing Slide
Manufacturer: Not Identified
Surface Type: Grass
Item Part Number:
Item Quantity: 1
Equipment Compliance: No
Surface Area Compliance: No
Total Findings: 2

Dents in slide chute - Monitor

Safety surface compacted - Repair required

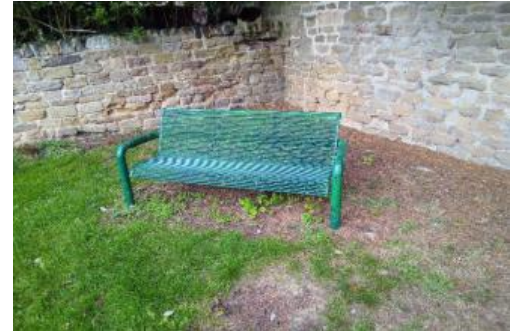
Item: Bench
Manufacturer: Owner/Operator
Surface Type: Grass
Item Quantity: 2
Equipment Compliance: N/A
Surface Area Compliance: N/A

This item is satisfactory - no work required -

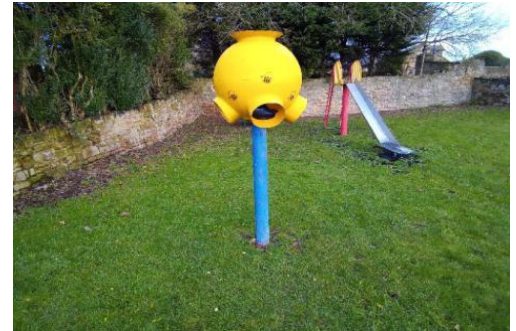
Item: Ball Shoot
Manufacturer: Wicksteed Playgrounds
Surface Type: Grass
Item Quantity: 1
Equipment Compliance: Yes
Surface Area Compliance: N/A

Leg rusting - Monitor

Top decaying - Monitor

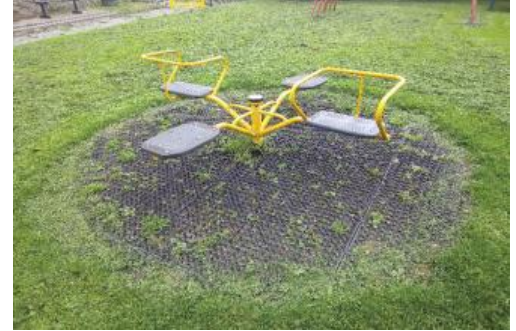
Item: Rotating Chairs
Manufacturer: Wicksteed Playgrounds
Surface Type: Grass Matrix Tiles
Item Quantity: 1
Equipment Compliance: No
Surface Area Compliance: Yes

This item is satisfactory - no work required -

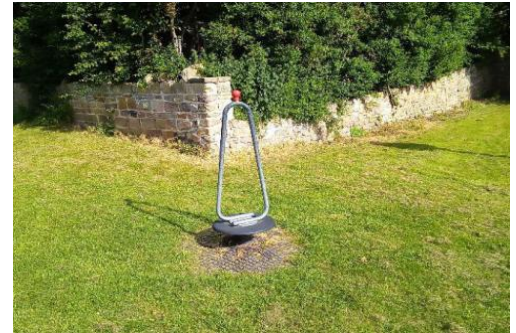
Item: Spinning Pole
Manufacturer: Sutcliffe Play Limited
Surface Type: Grass Matrix Tiles
Item Quantity: 1
Equipment Compliance: Yes
Surface Area Compliance: Yes

Safety surface compacted - Repair required

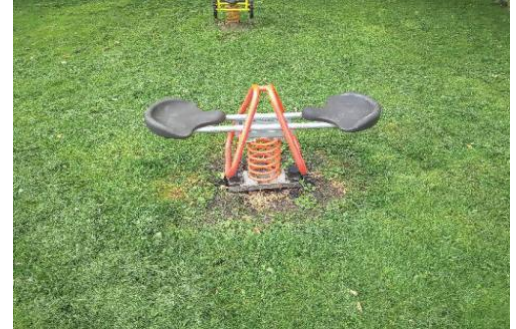
Item: See Saw
Manufacturer: Sutcliffe Play Limited
Surface Type: Grass Matrix Tiles
Item Quantity: 1
Equipment Compliance: Yes
Surface Area Compliance: Yes

Safety surface compacted - Repair required

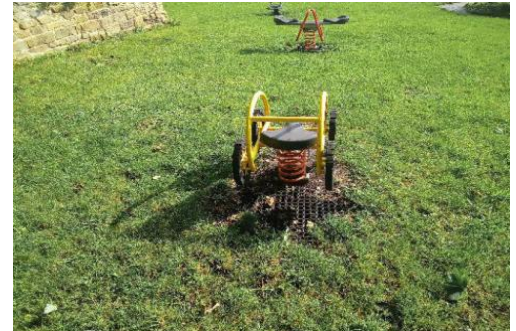
Item: Spring Car
Manufacturer: Sutcliffe Play Limited
Surface Type: Grass Matrix Tiles
Item Quantity: 1
Equipment Compliance: Yes
Surface Area Compliance: Yes

Safety surface compacted - Repair required

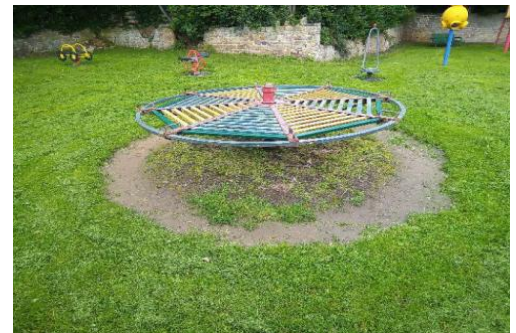
Item: Roundabout
Manufacturer: Hirst & Sons Ltd
Surface Type: Grass
Item Quantity: 1
Equipment Compliance: No
Surface Area Compliance: Yes

Metal rusting - Monitor

No safety surface present - Monitor

Weeds present - Removal required

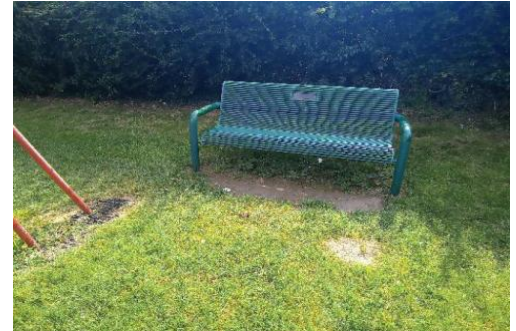
Item: Bench
Manufacturer: Unknown
Surface Type: Concrete
Item Quantity: 1
Equipment Compliance: N/A
Surface Area Compliance: N/A

Small Hole in metal - Monitor

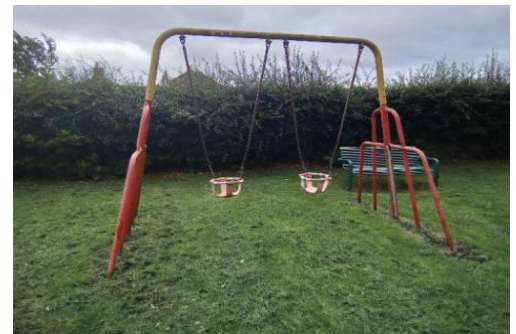
Item: 1 Bay 2 Seat (Cradle)
Manufacturer: Not Identified
Surface Type: Grass
Item Quantity: 1
Equipment Compliance: No
Surface Area Compliance: No

Both Seats cracked underneath - New seats required

Swing Frame rusting - Monitor

Safety surface compacted - Repair required

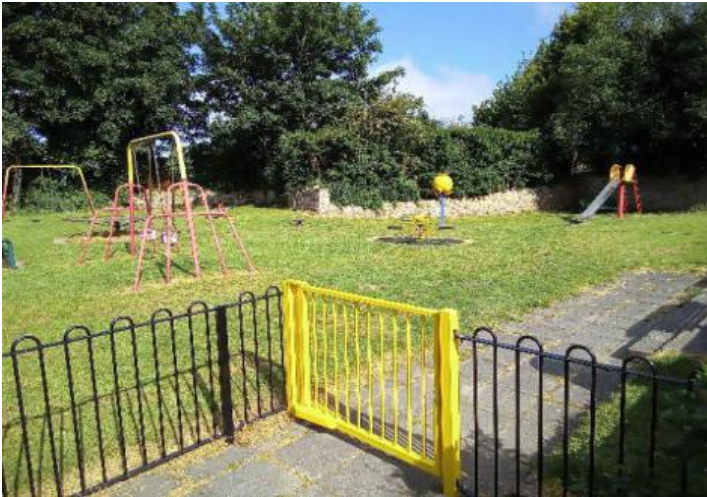
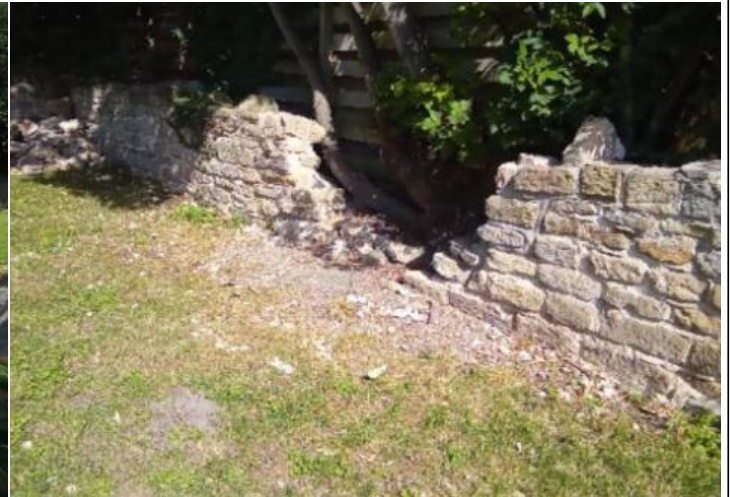
Risk Level: L - Low Risk
Surface: N/A

Finding: Brickwork removed

Action: Repair required

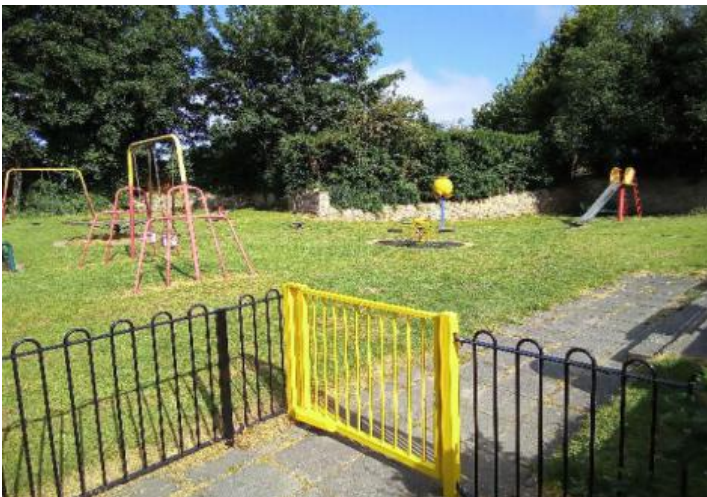
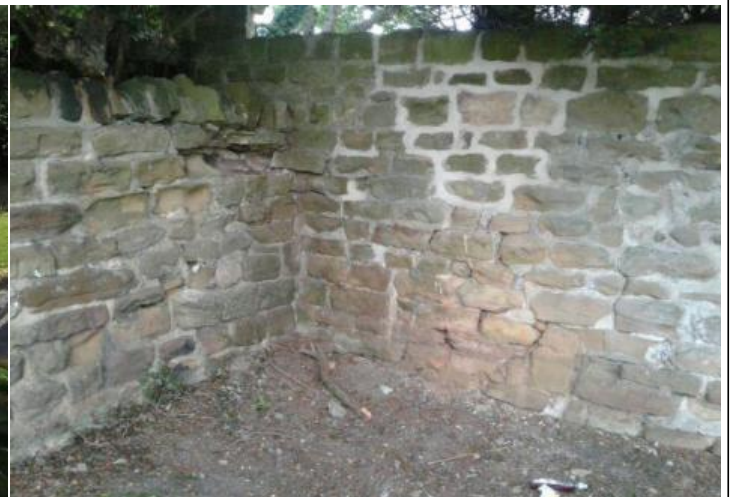
Risk Level: L - Low Risk
Surface: N/A

Finding: Brickwork , missing, decaying

Action: Repair required

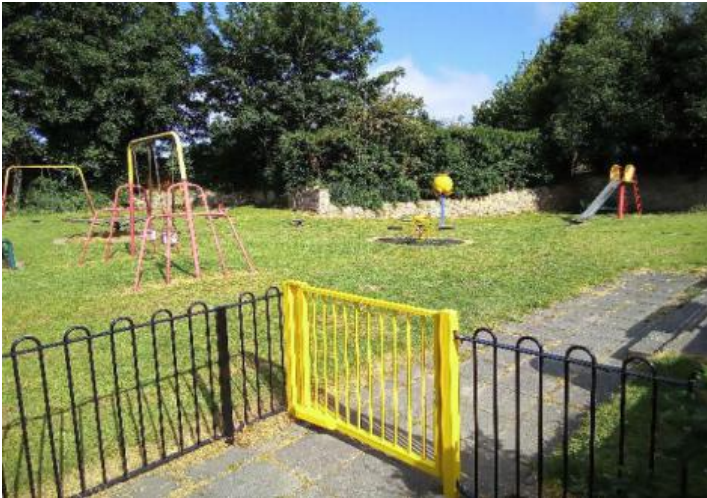
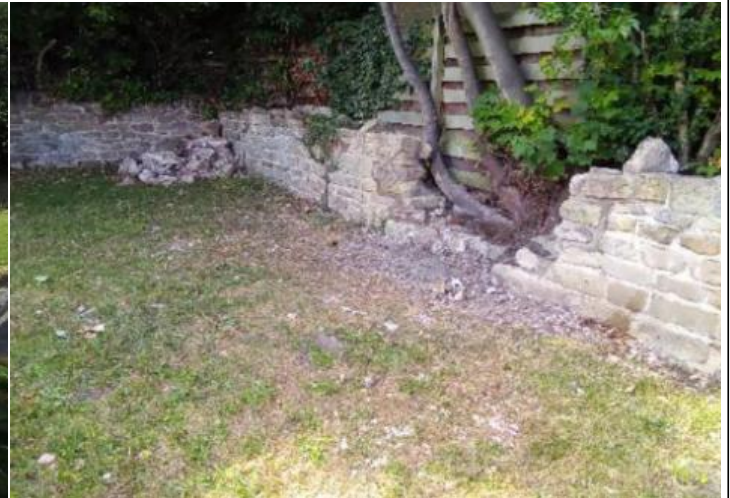
Risk Level: L - Low Risk
Surface: N/A

Finding: Brickwork removed

Action: Repair required

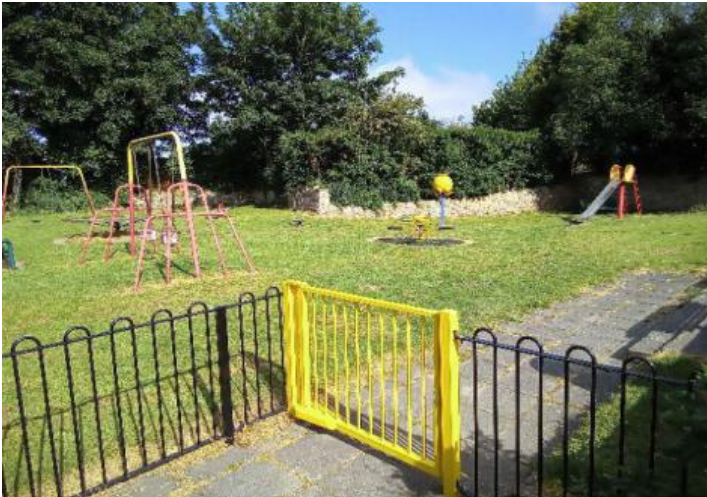
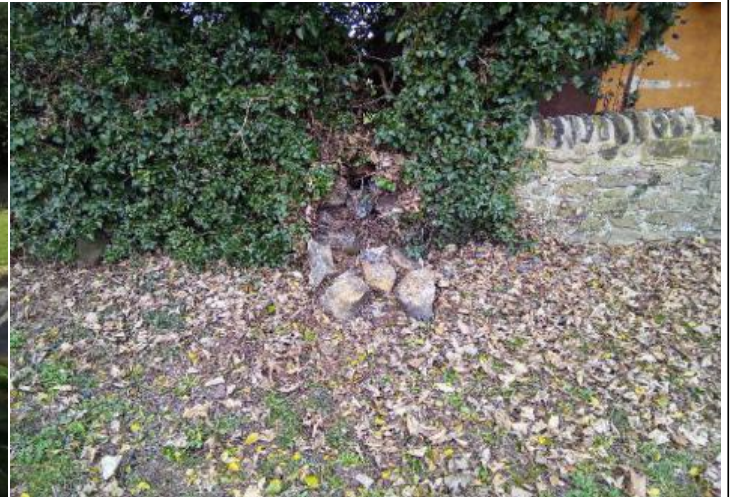
Risk Level: L - Low Risk
Surface: N/A

Finding: Damage to brick wall

Action: Repair required

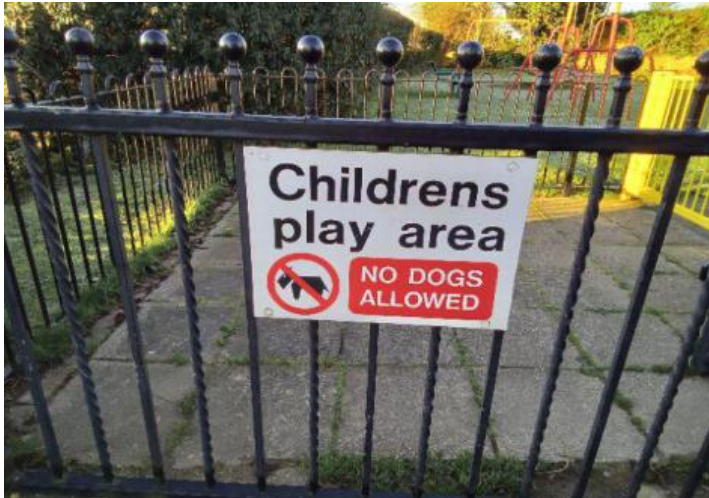
Finding: Item satisfactory

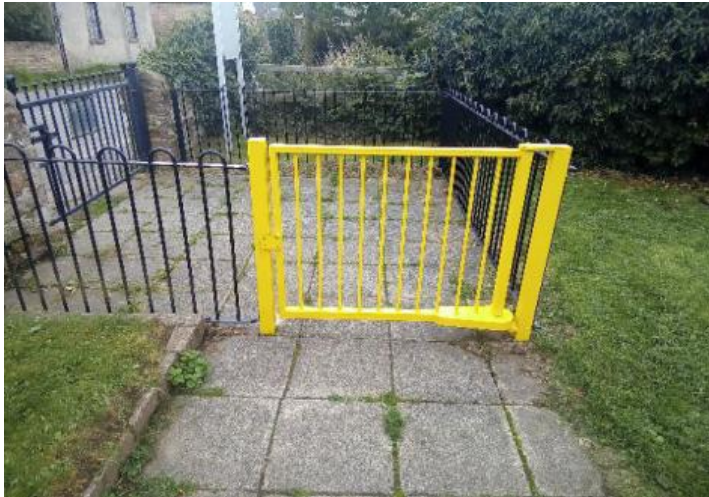
Finding: Item satisfactory

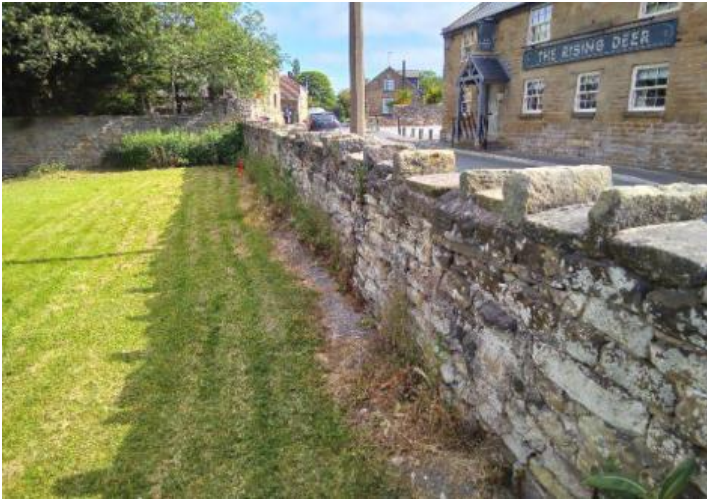
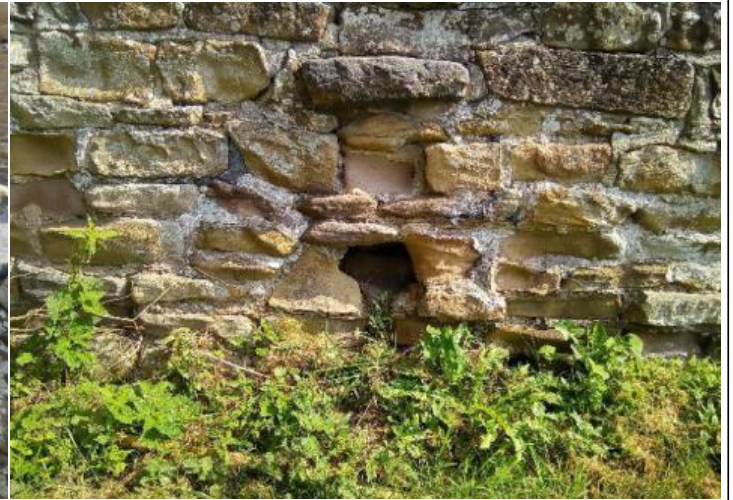
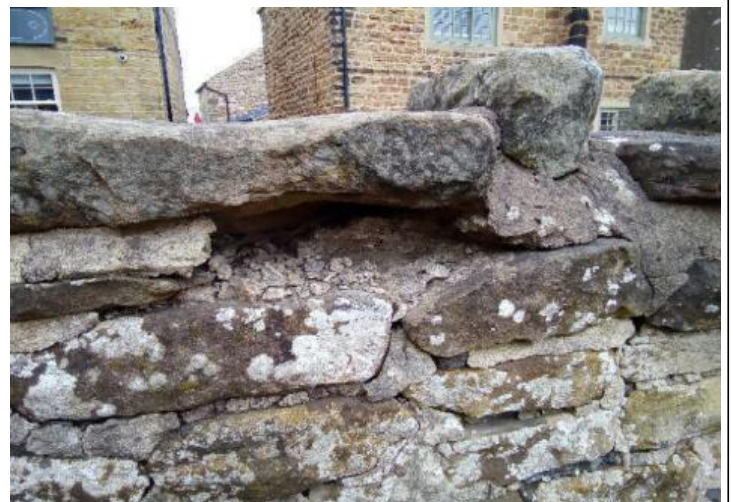
Risk Level: V - Very Low Risk
Surface: N/A

Finding: Item decaying

Action: Monitor

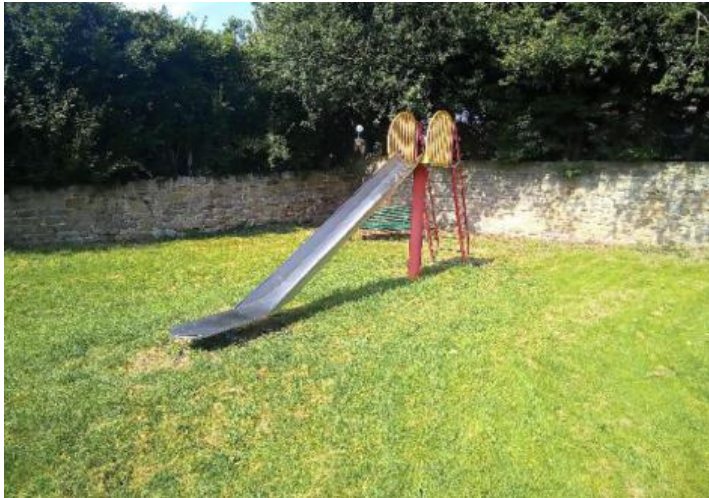
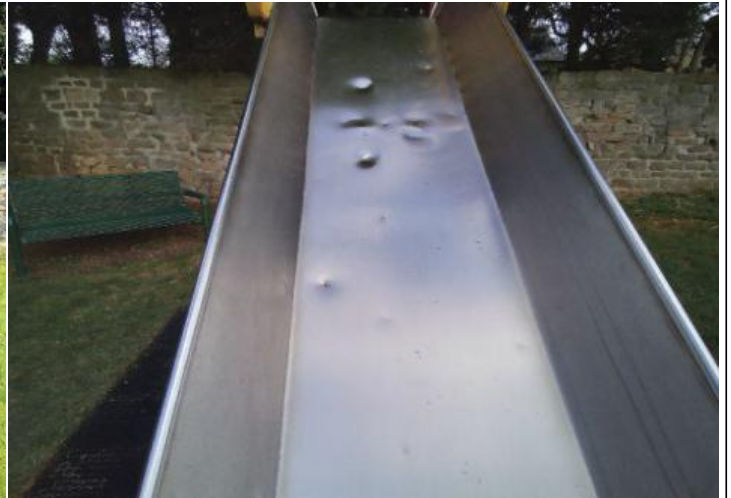
Risk Level: V - Very Low Risk
Surface: Grass

Finding: Dents in slide chute

Action: Monitor

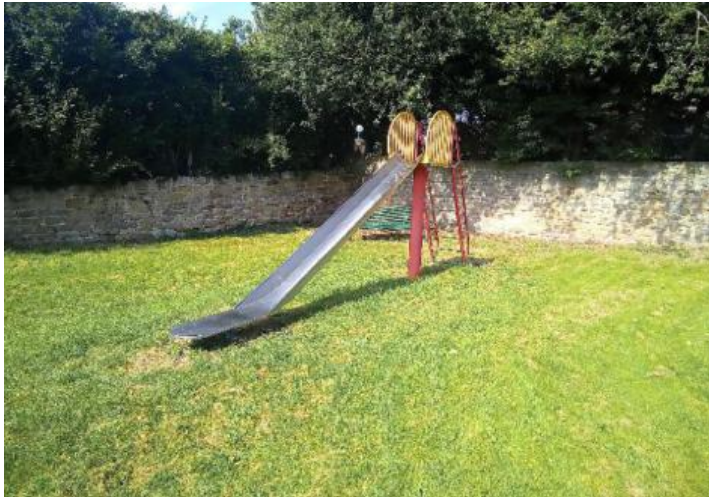
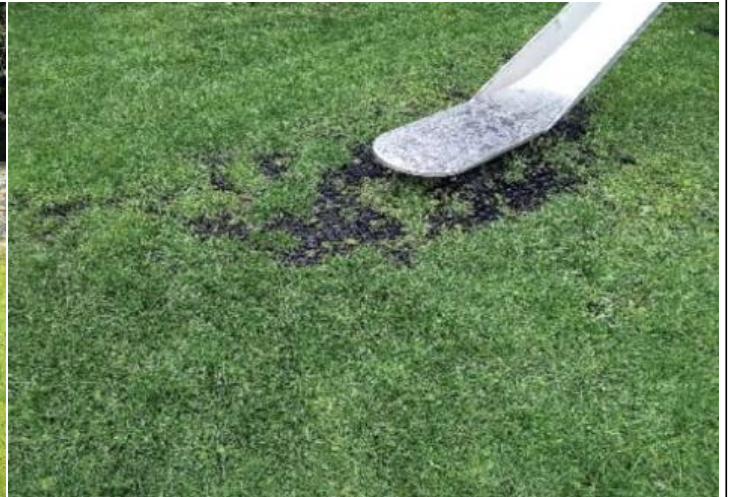
Risk Level: L - Low Risk
Surface: Grass

Finding: Safety surface compacted

Action: Repair required

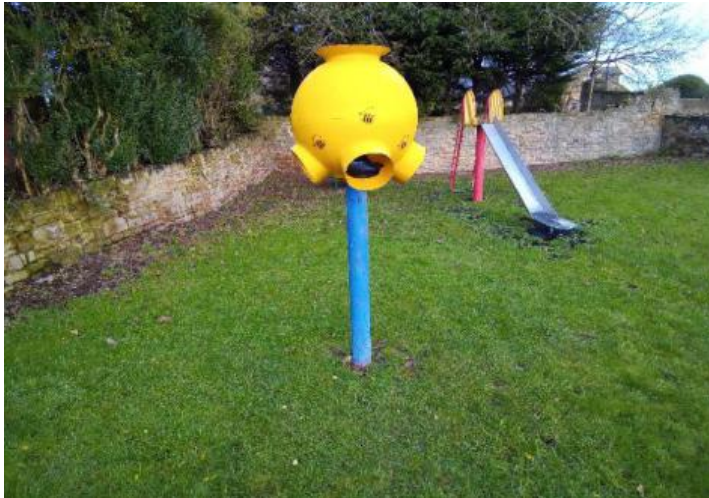
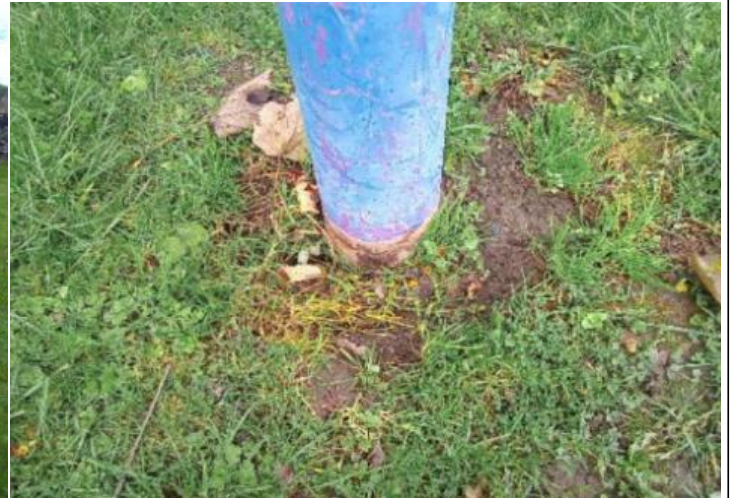
Risk Level: V - Very Low Risk
Surface: Grass

Finding: Leg rusting

Action: Monitor

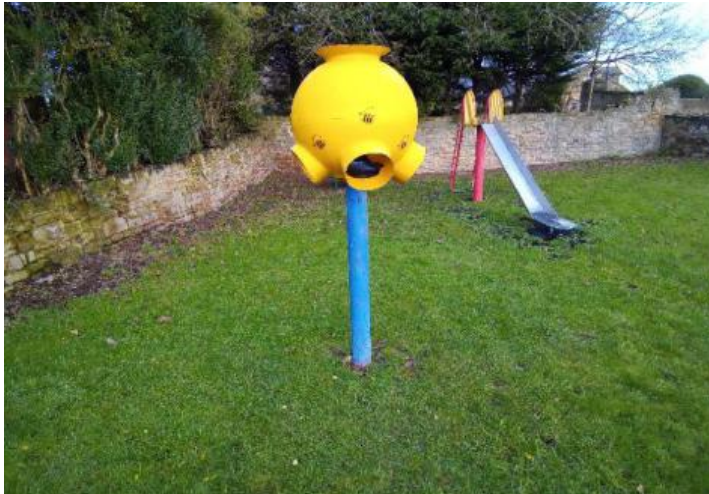
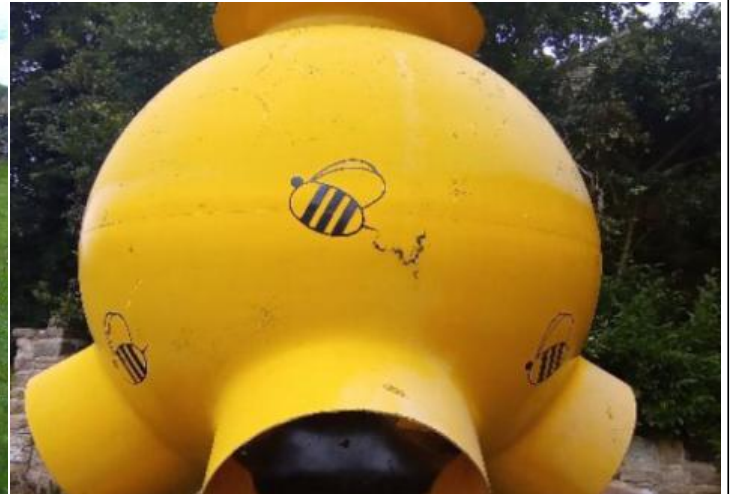
Finding: Top decaying

Action: Monitor

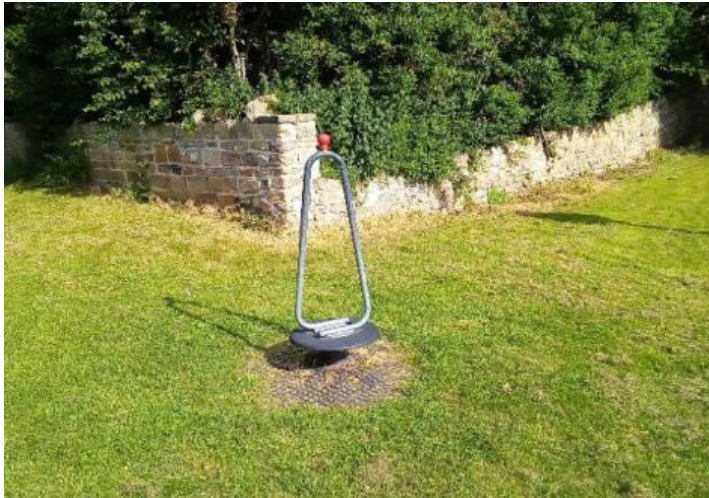
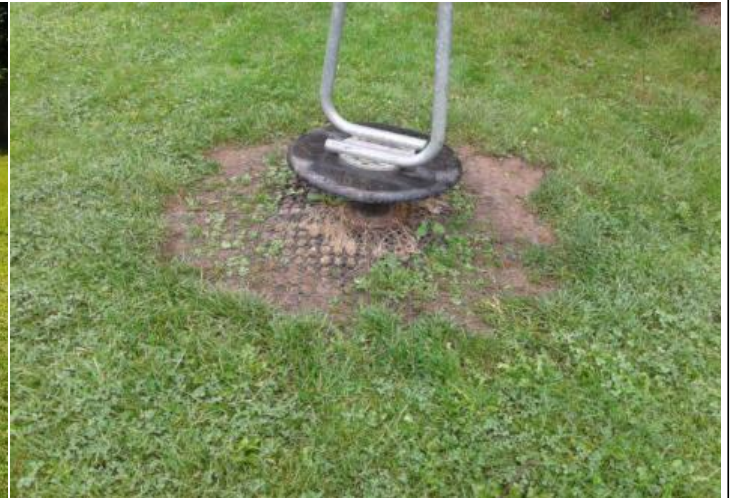
Risk Level: L - Low Risk
Surface: Grass Matrix Tiles

Finding: Safety surface compacted

Action: Repair required

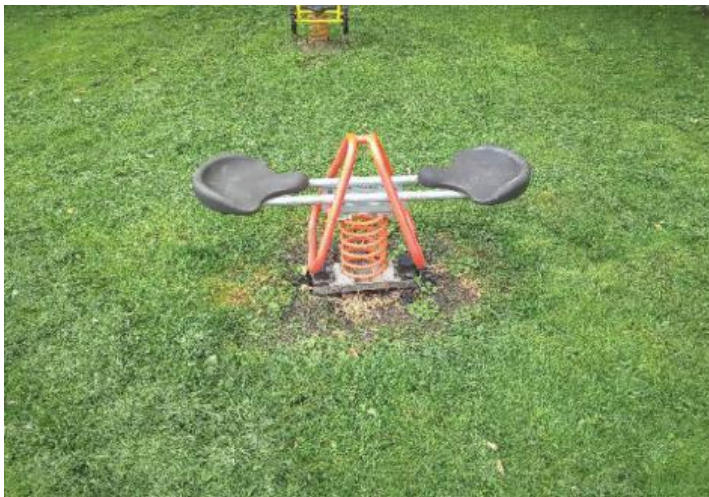
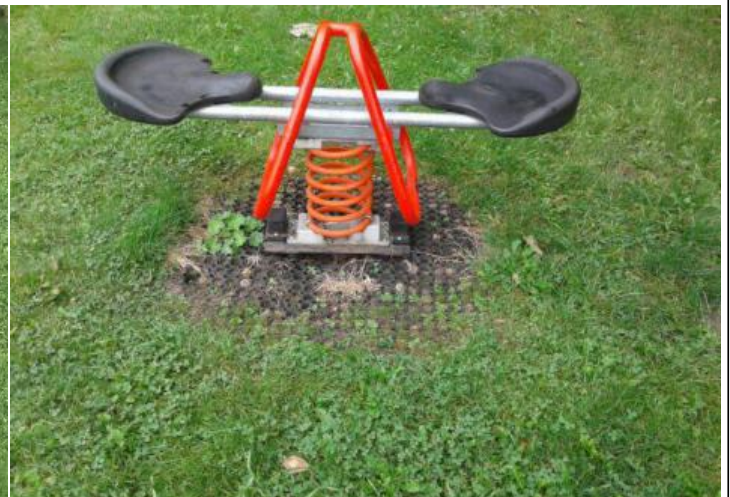
Risk Level: L - Low Risk
Surface: Grass Matrix Tiles

Finding: Safety surface compacted

Action: Repair required

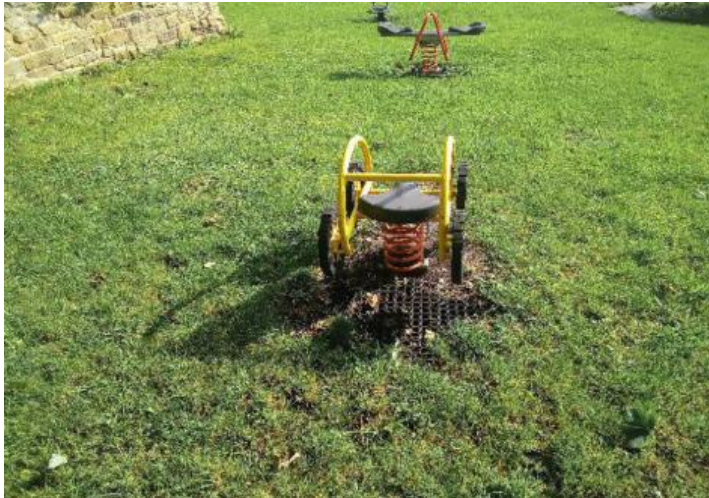
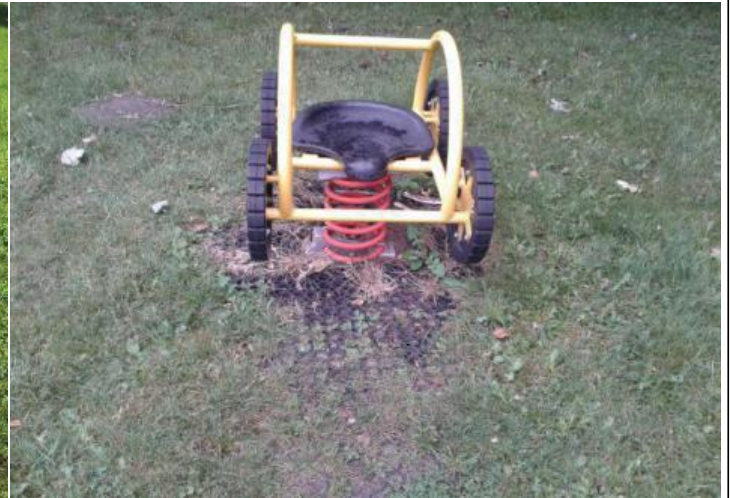
Risk Level: L - Low Risk
Surface: Grass Matrix Tiles

Finding: Safety surface compacted

Action: Repair required

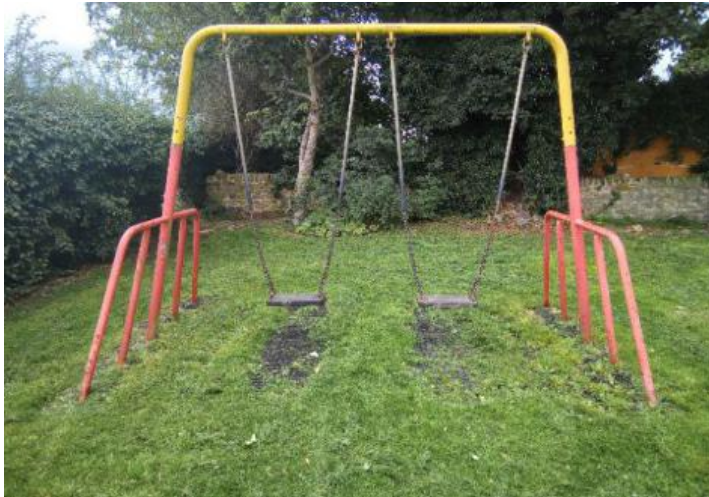
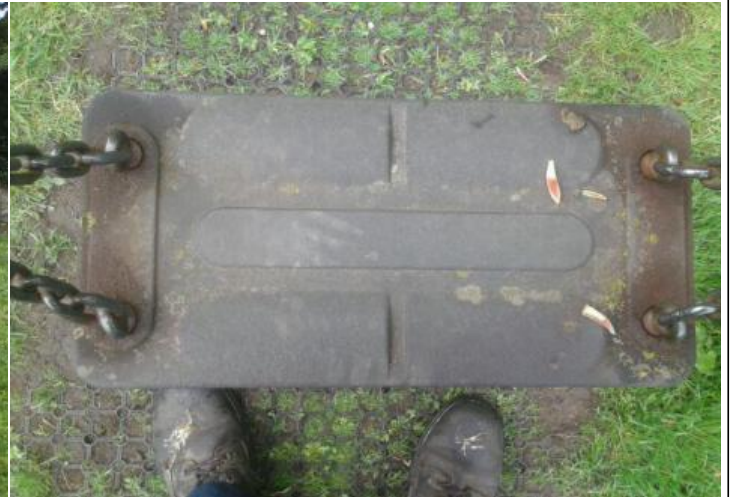
Risk Level: V - Very Low Risk
Surface: Grass Matrix Tiles

Finding: Seats decaying

Action: Monitor

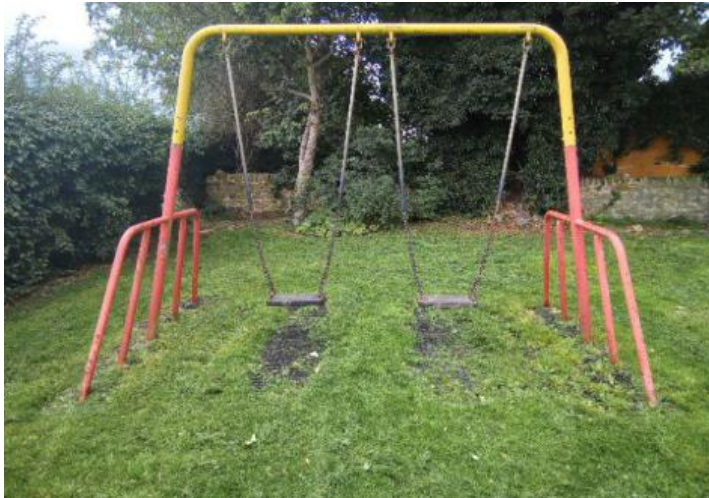
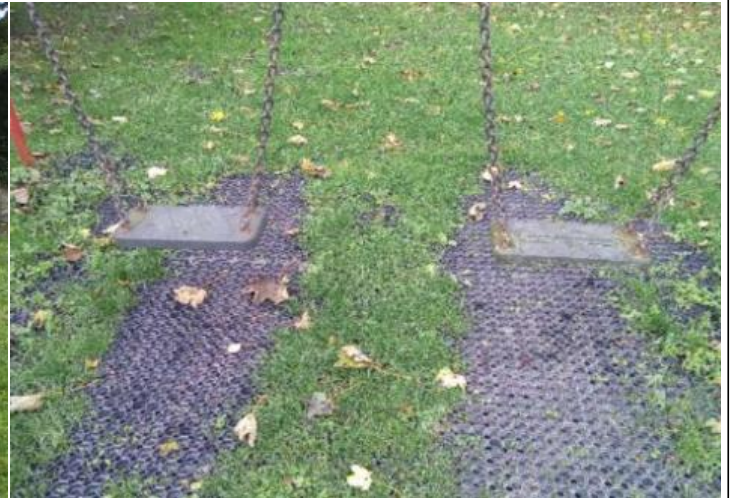
Risk Level: V - Very Low Risk
Surface: Grass Matrix Tiles

Finding: Seats low

Action: Hiring required

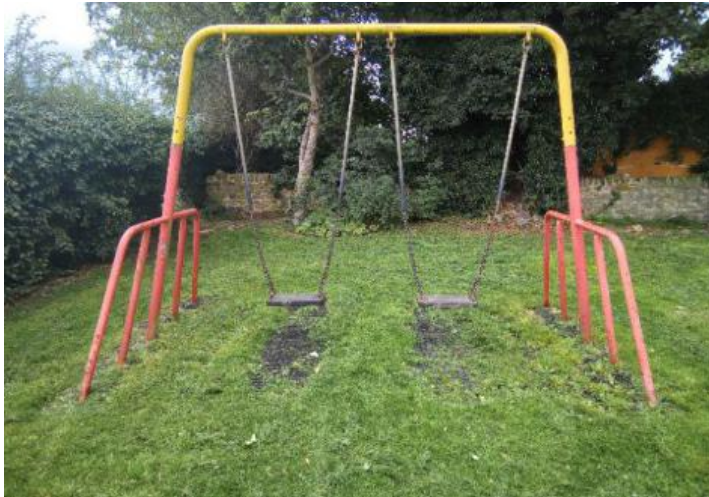
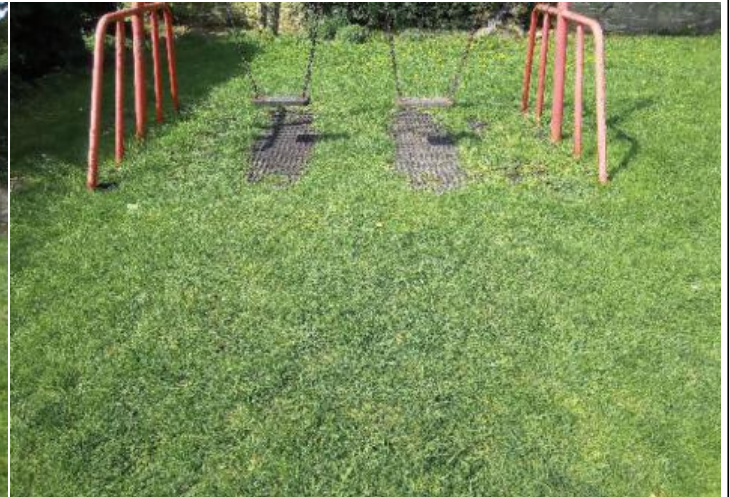
Risk Level: L - Low Risk
Surface: Grass Matrix Tiles

Finding: Safety surface compacted

Action: Repair required

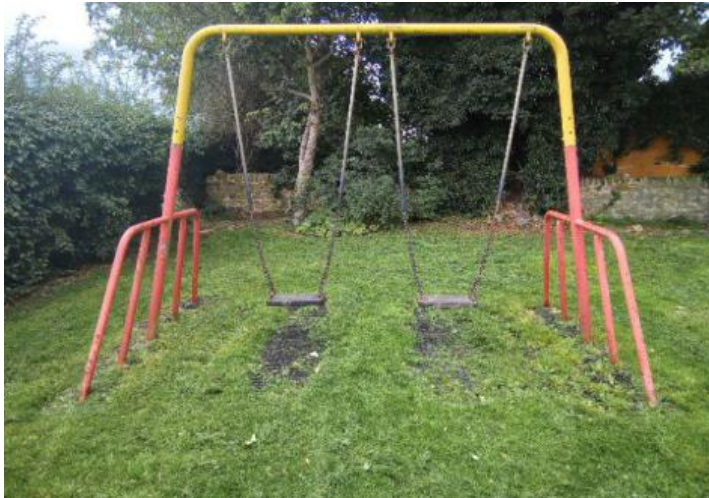
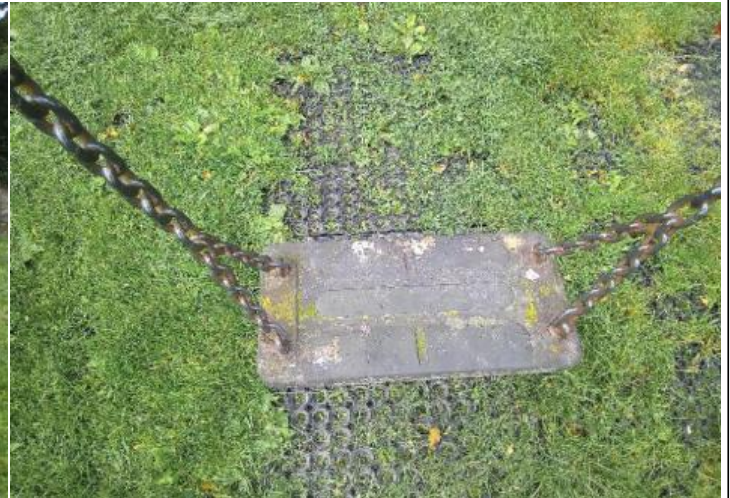
Risk Level: L - Low Risk
Surface: Grass Matrix Tiles

Finding: Seats soiled

Action: Cleaning required

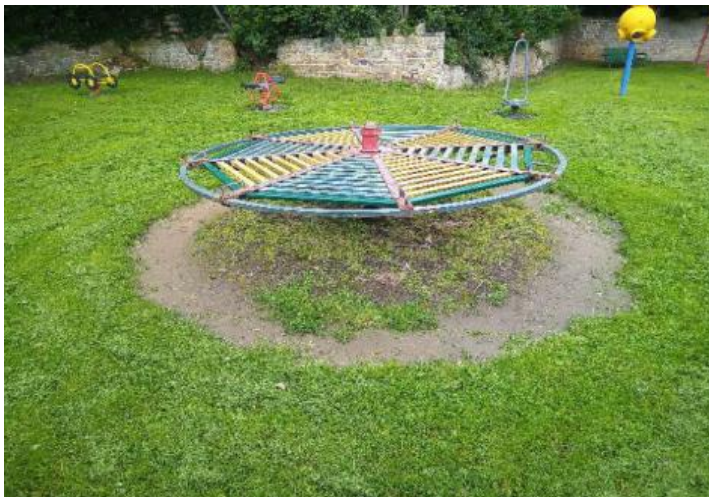
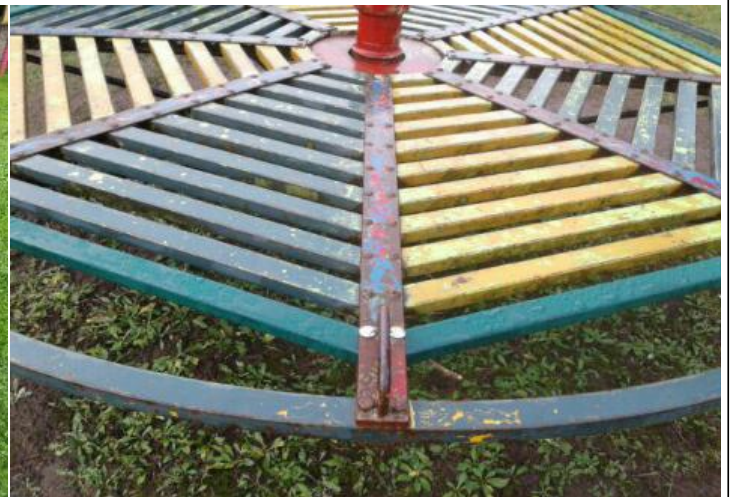
Risk Level: V - Very Low Risk
Surface: Grass

Finding: Metal rusting

Action: Monitor

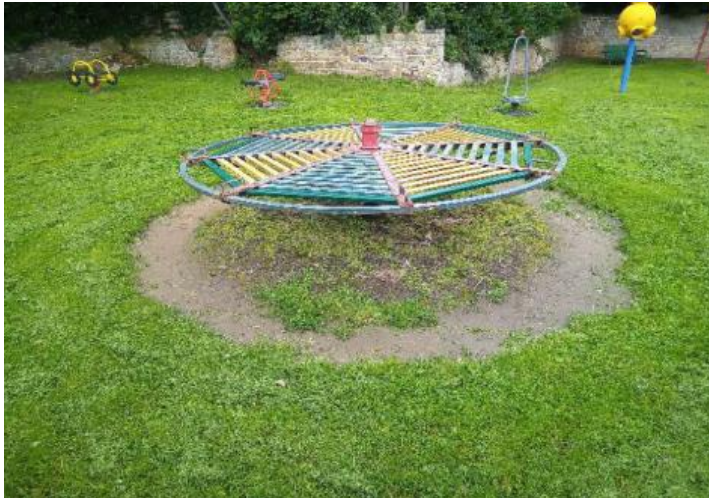
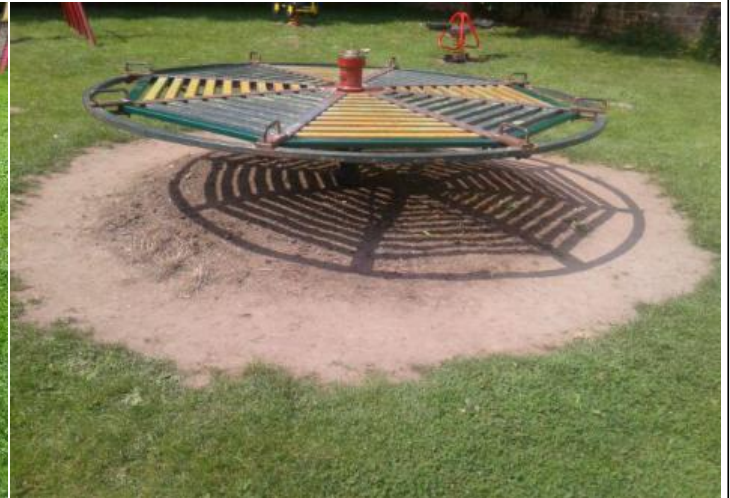
Risk Level: L - Low Risk
Surface: Grass

Finding: No safety surface present

Action: Monitor

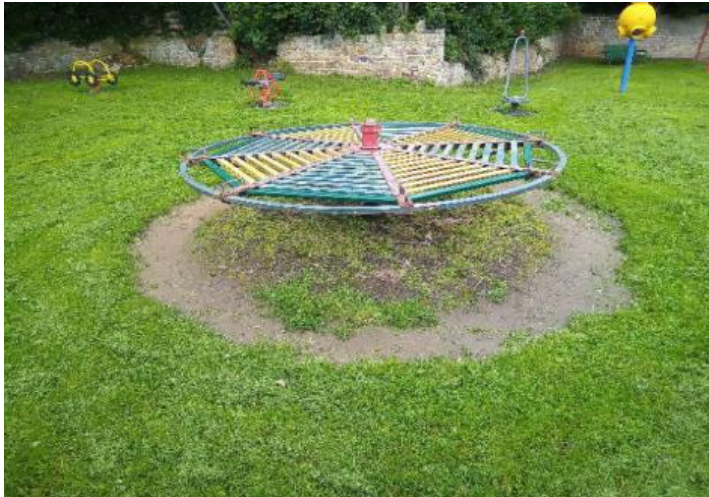
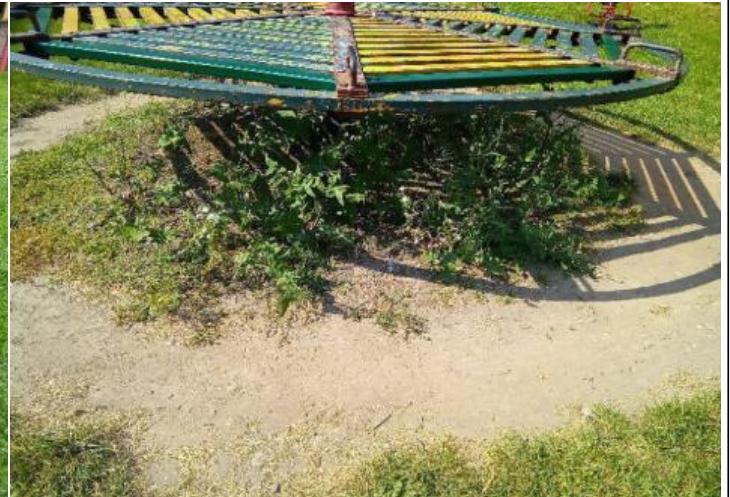
Finding: Weeds present

Action: Removal required

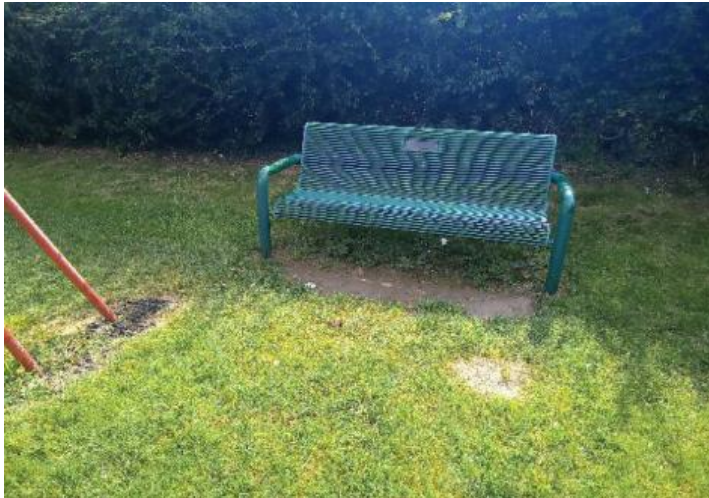
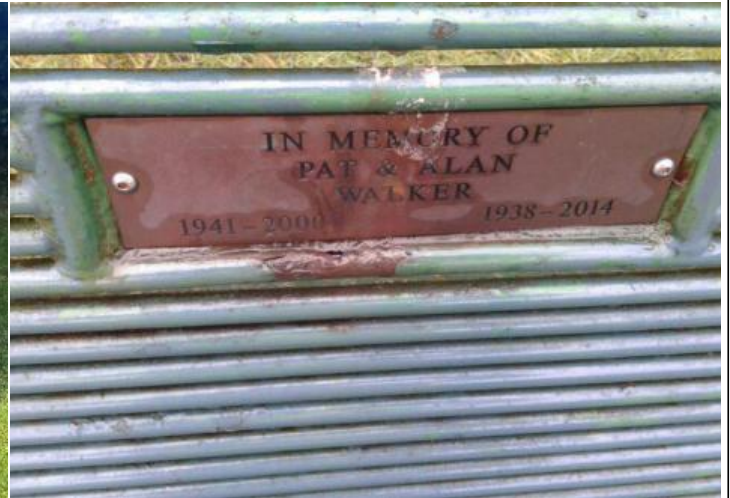
Risk Level: V - Very Low Risk
Surface: Concrete

Finding: Small Hole in metal

Action: Monitor

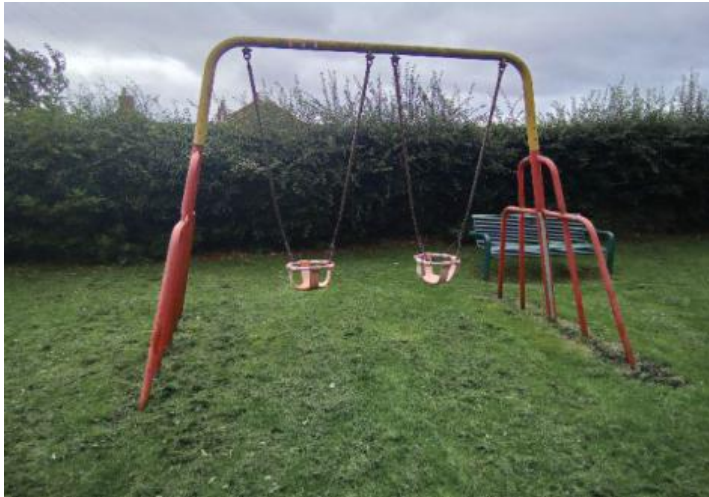
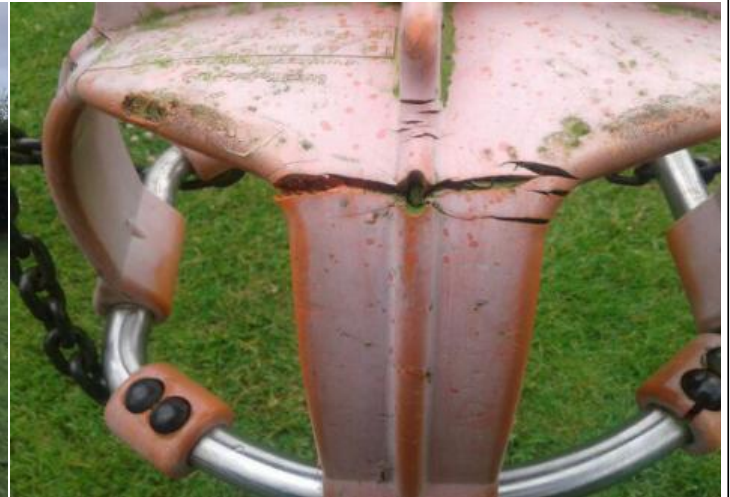
Risk Level: L - Low Risk
Surface: Grass

Finding: Both Seats cracked underneath

Action: New seats required

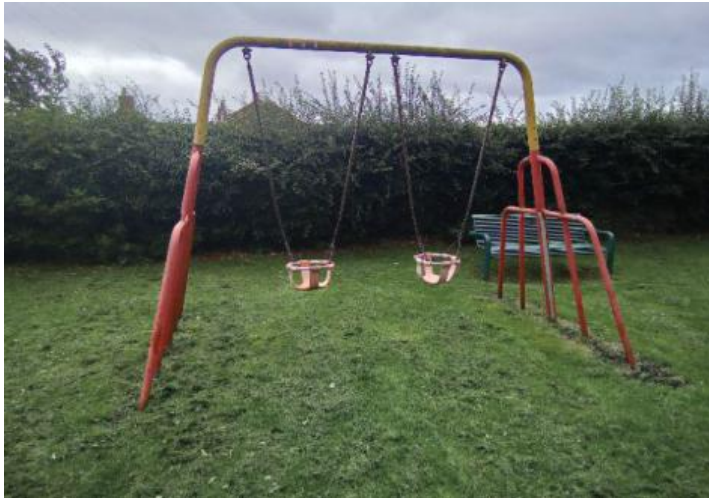
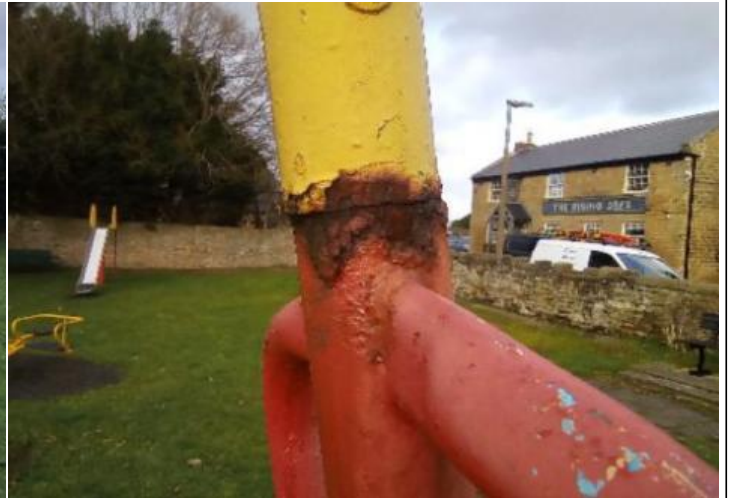
Risk Level: V - Very Low Risk
Surface: Grass

Finding: Swing Frame rusting

Action: Monitor

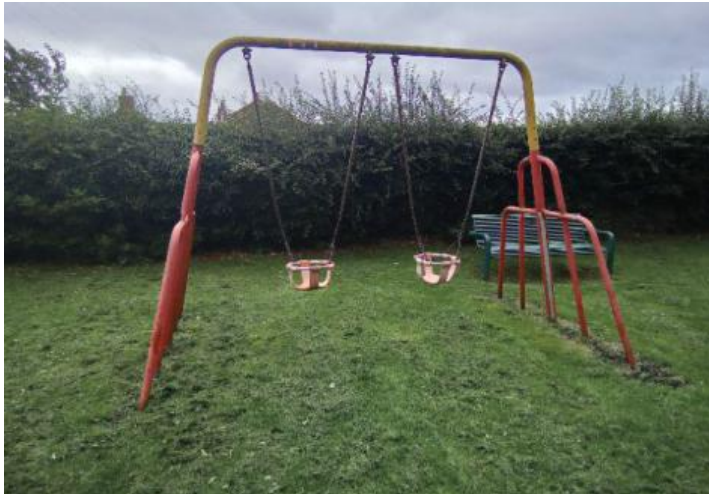
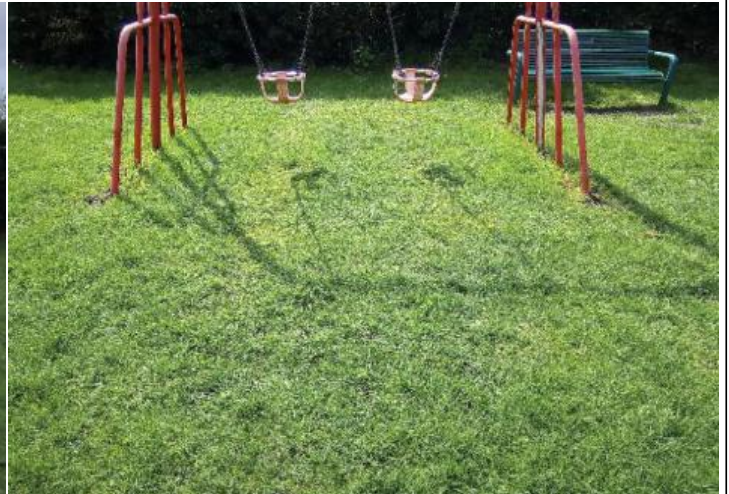
Risk Level: L - Low Risk
Surface: Grass

Finding: Safety surface compacted

Action: Repair required
