Annual Inspection

Rotherham Metropolitan Borough Council

Brampton Road

Inspection Ref: 2203189

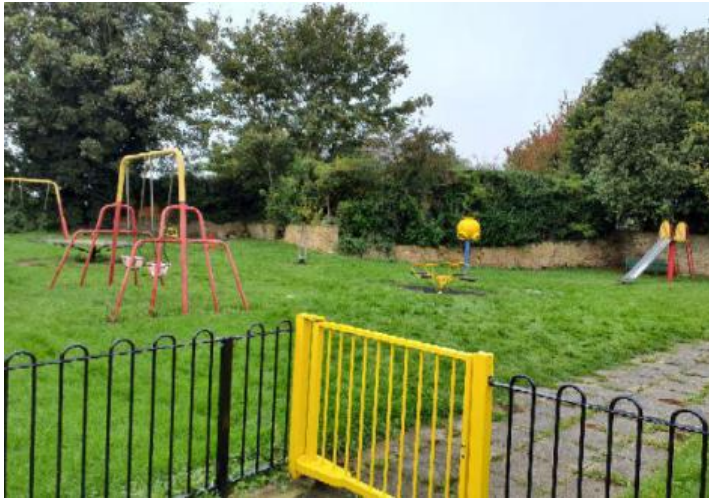
Finding: It is recommended that signage, with information including the site address, contact information for maintenance issues and emergency contact details are provided for the facility

Action: Provide in accordance with the recommendations

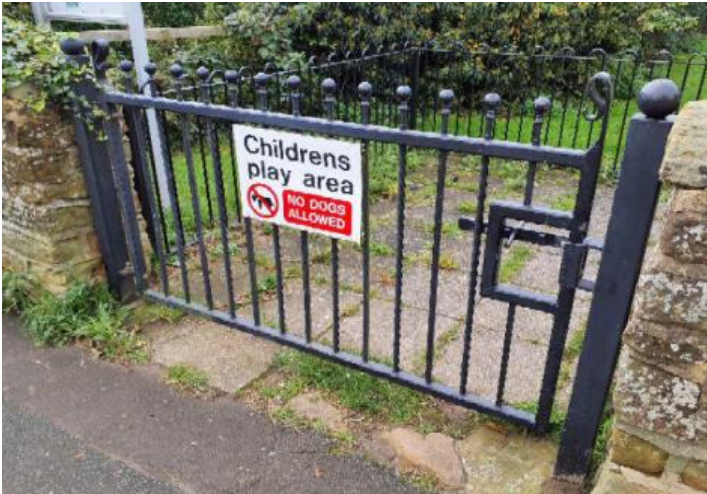
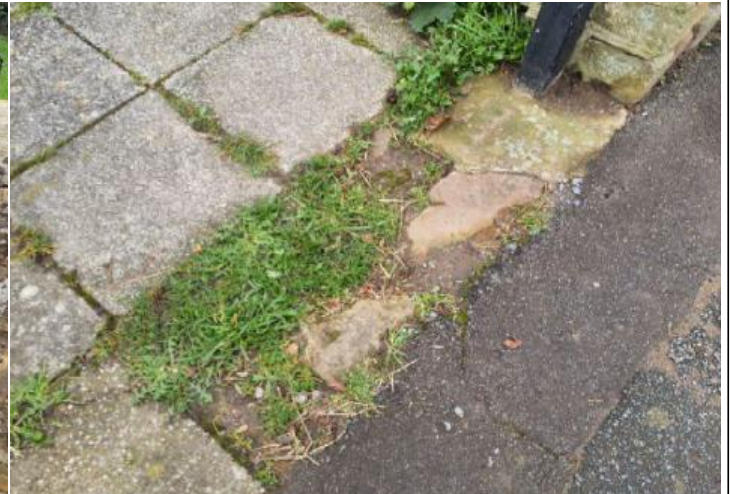
Finding: There are trip hazards present

Action: Reinstate surrounding surfaces to level to remove the trip points

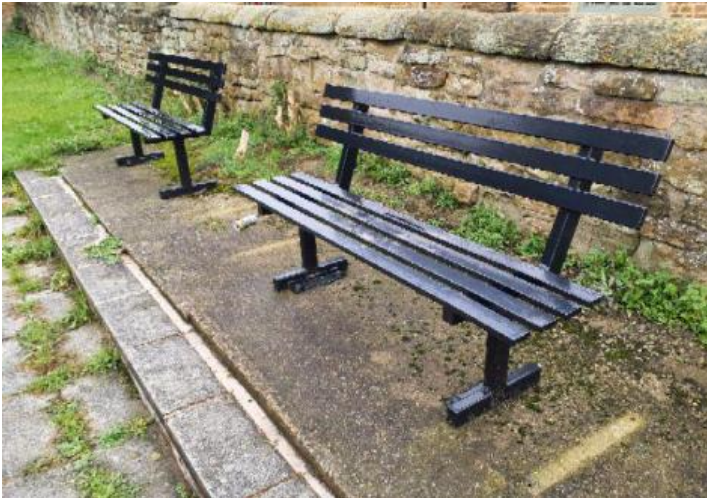
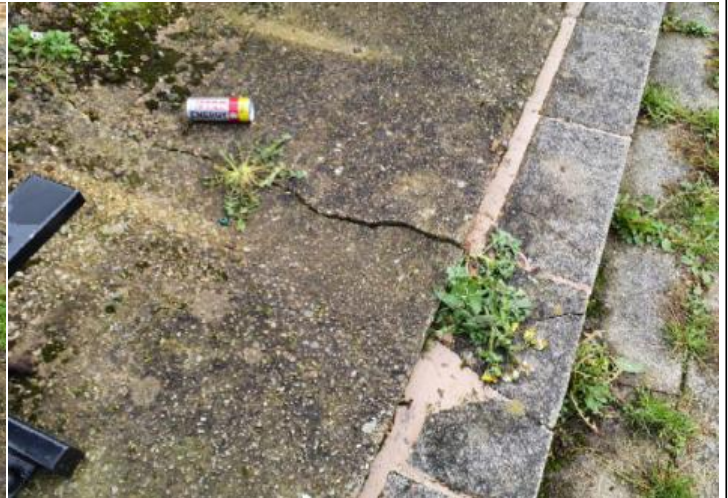
Finding: There are trip hazards present

Action: Reinstate surrounding surfaces to level to remove the trip points

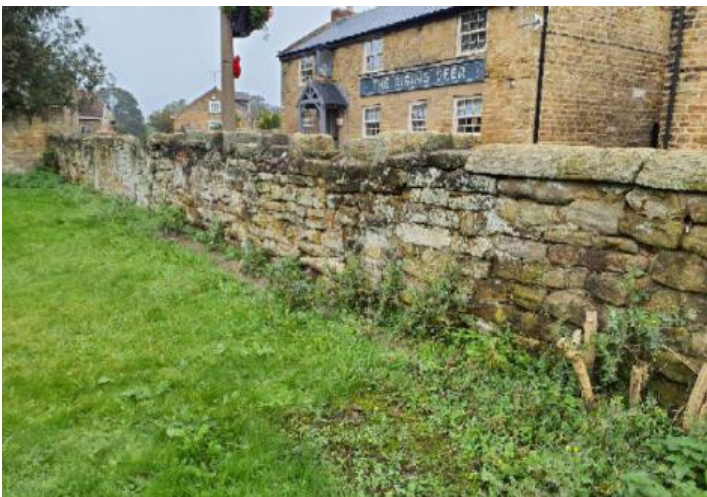
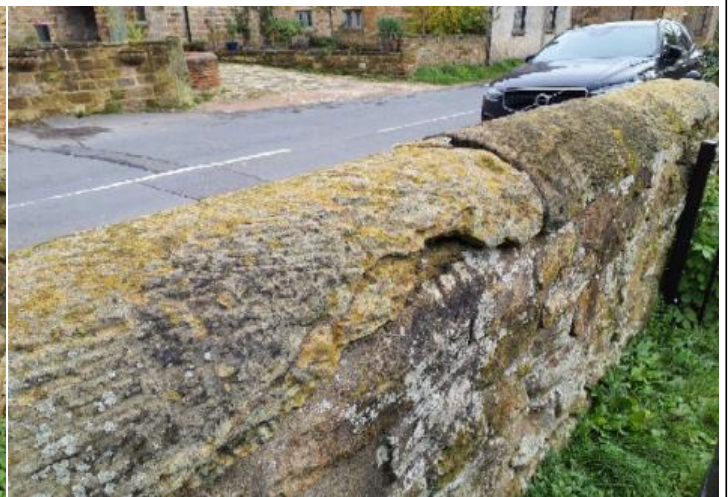
Finding: The masonry is loose, degrading or damaged

Action: Replace or repair as required

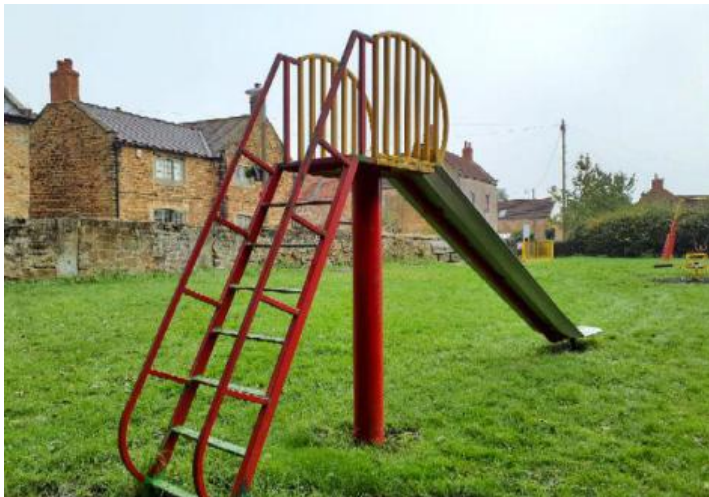
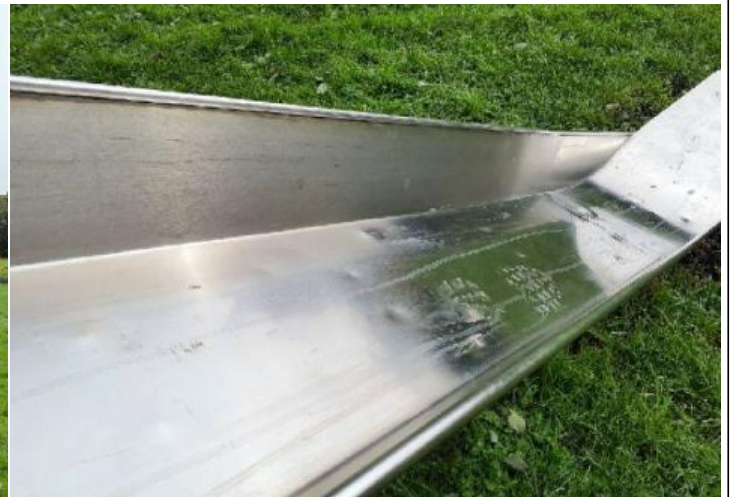
Finding: There are a number of dents in the slide surface

Action: Monitor for any further deterioration and repair as required

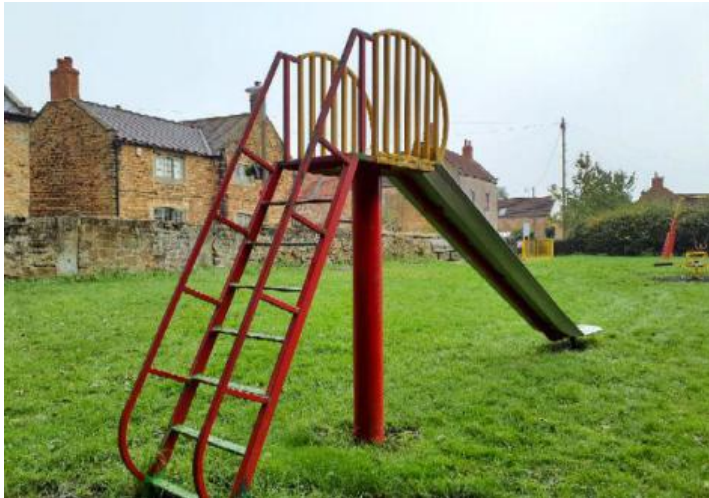
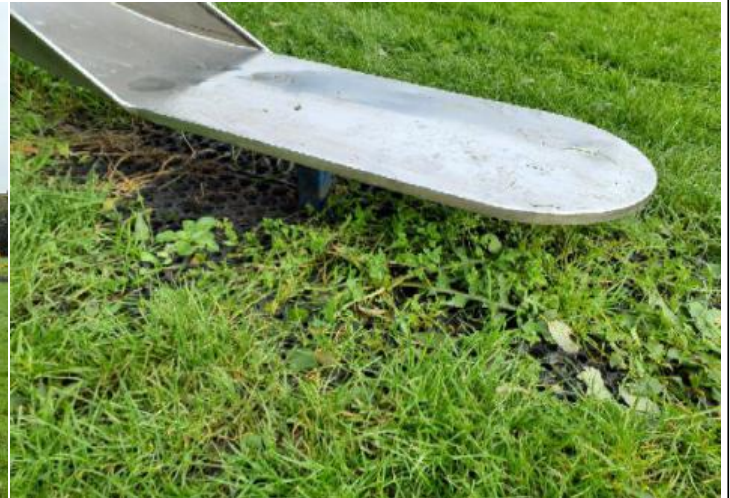
Finding: The item is slightly loose in its foundations

Action: Monitor for any further deterioration and repair as required

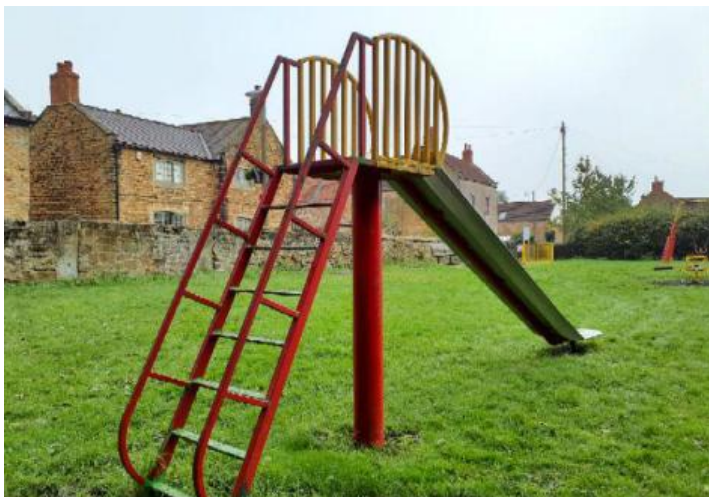
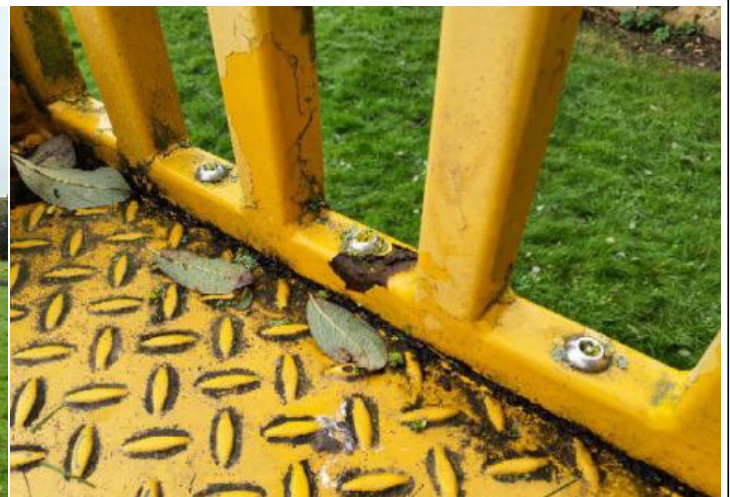
Finding: The paintwork on this item has been damaged or worn exposing the metal underneath which is rusting / corroding

Action: Treat affected areas and repaint

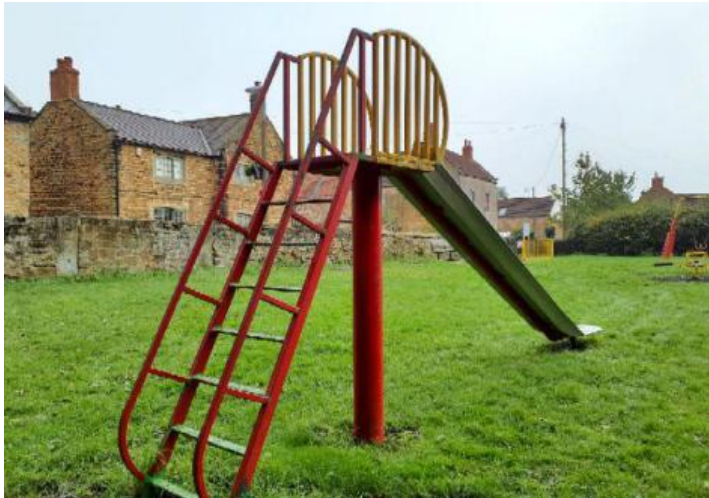
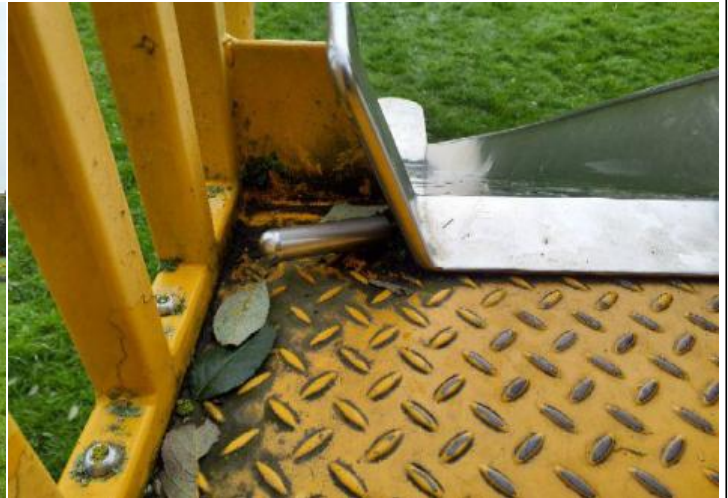
Finding: There is/are finger entrapment/s in the framework and the item fails to meet the requirements of BS EN 1176 Part 1 4.2.7.6 Entrapment of fingers

Action: Monitor - No remedial work recommended

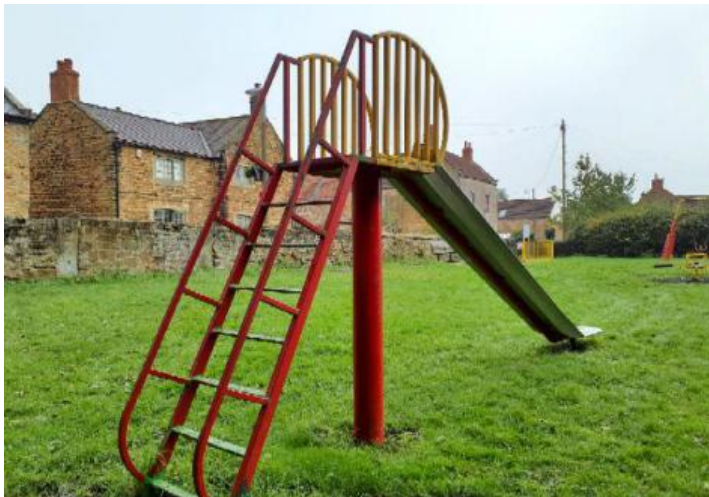
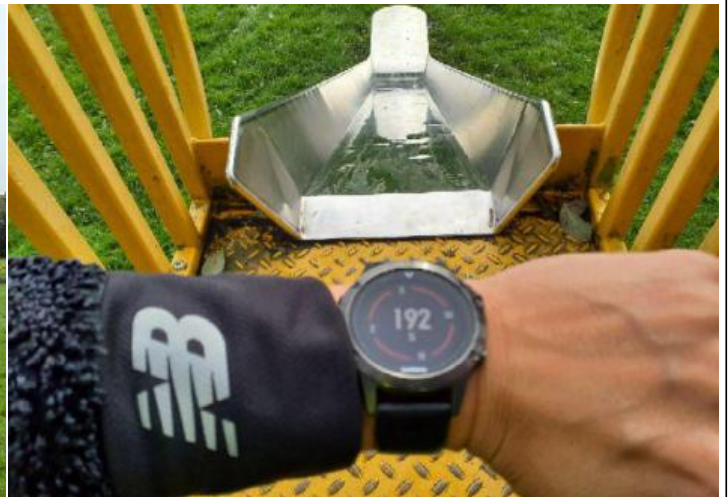
Finding: The slide is predominately south facing and will catch the majority of the sun's heat during the day. Slide surfaces can become very warm during periods of sustained sunny weather

Action: Monitor - No remedial work recommended

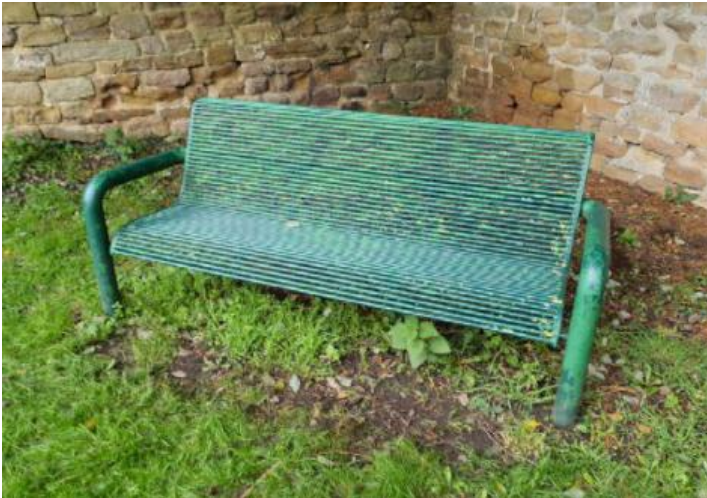
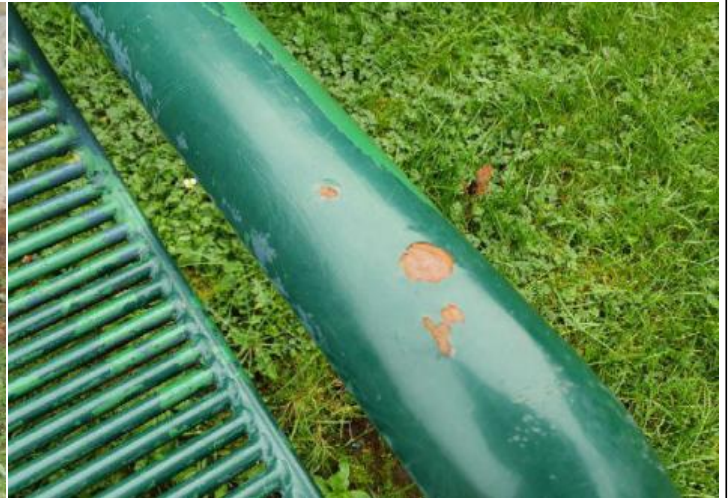
Finding: The paintwork on this item has been damaged or worn exposing the metal underneath which is rusting / corroding

Action: Treat affected areas and repaint

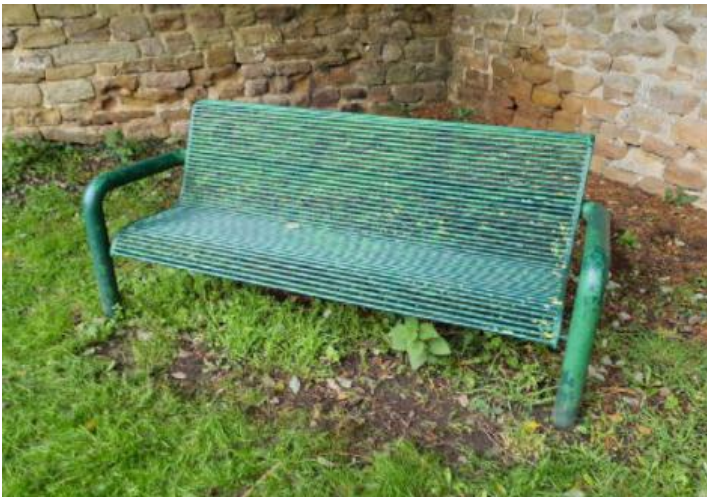
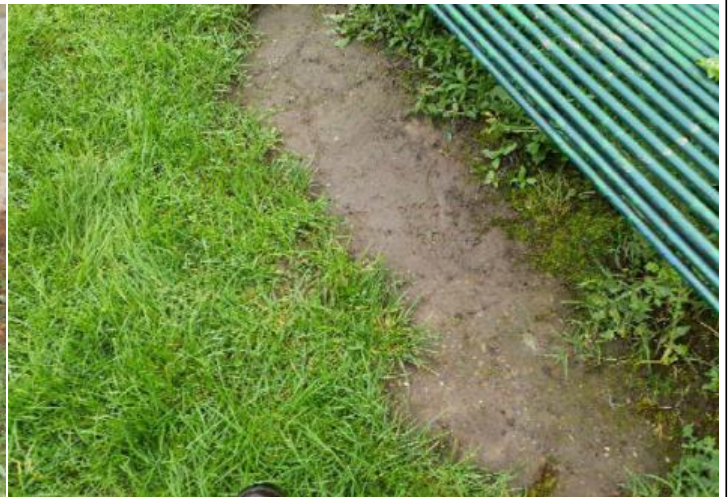
Finding: The surface has eroded in some areas and may be slippery in wet conditions

Action: Reinststate the surface

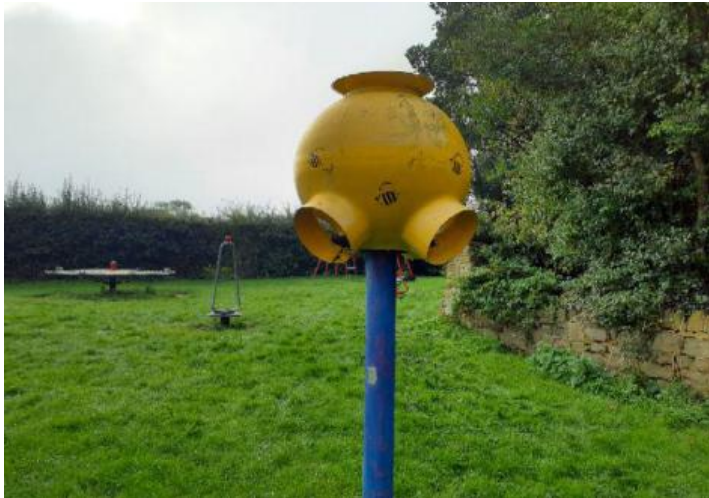
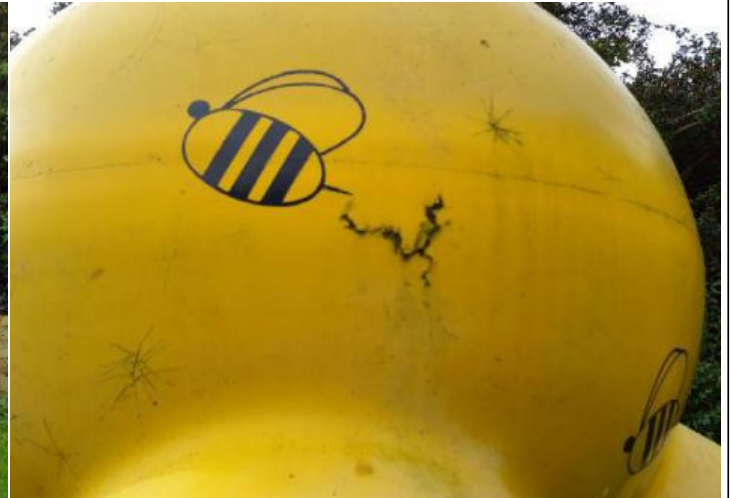
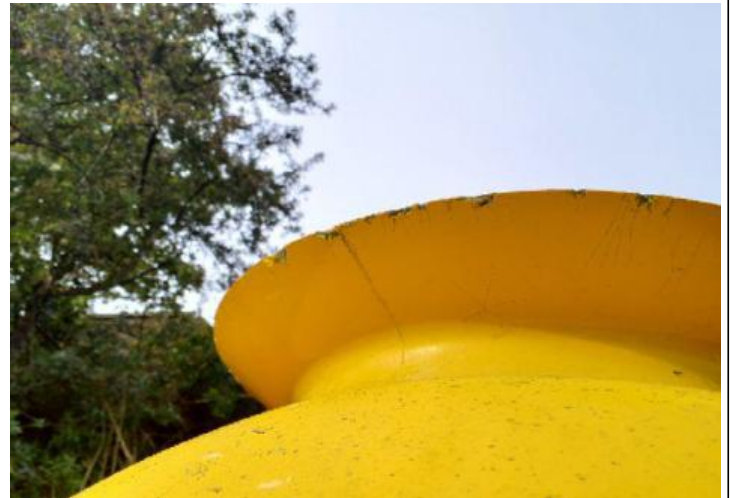
Finding: The item has been damaged

Action: Monitor for any further deterioration and replace as required

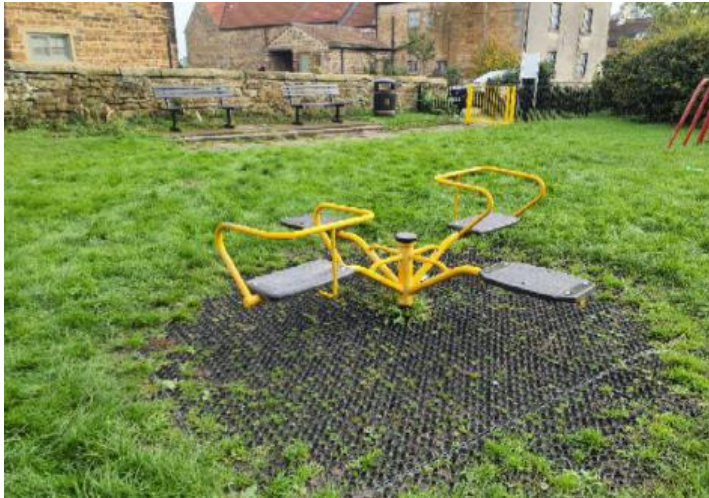
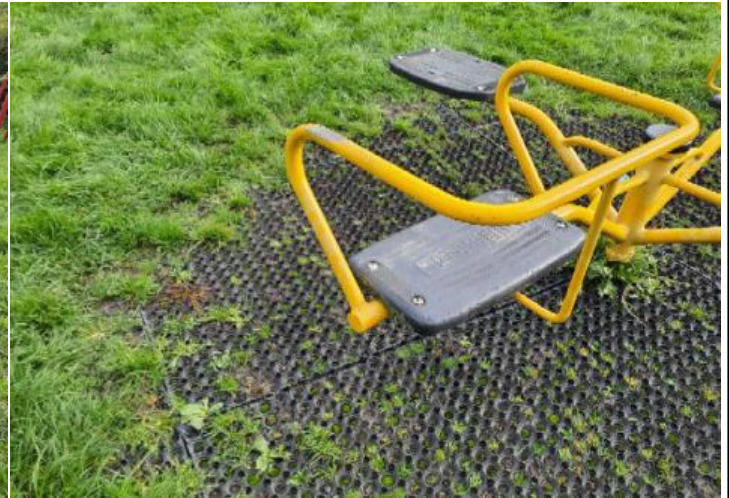
Finding: Parts of the steel structure protrude beyond the protected elements of the seat and fail to meet the requirements of BS EN 1176 Part 5

Action: Monitor - no remedial action recommended

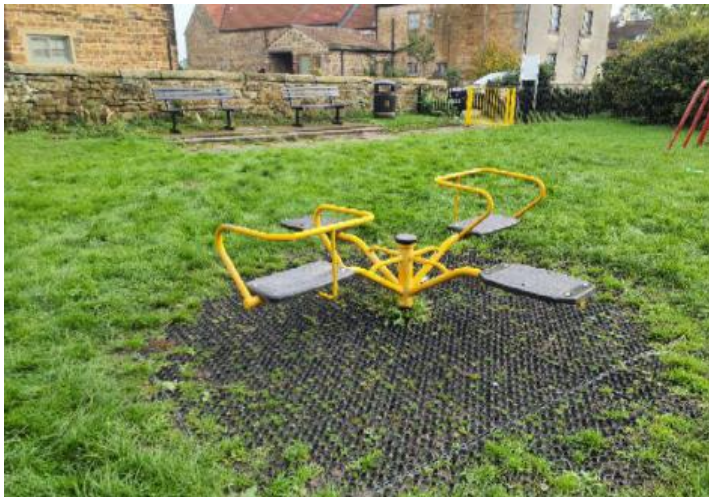
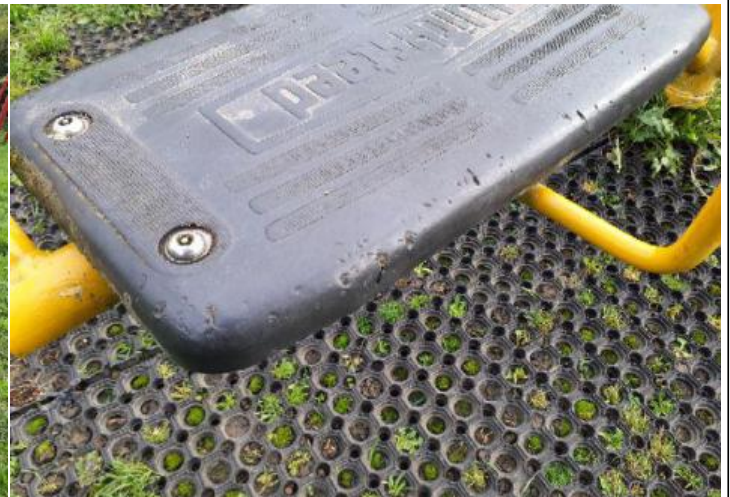
Finding: The seat has been damaged

Action: Monitor for any further deterioration and replace as required

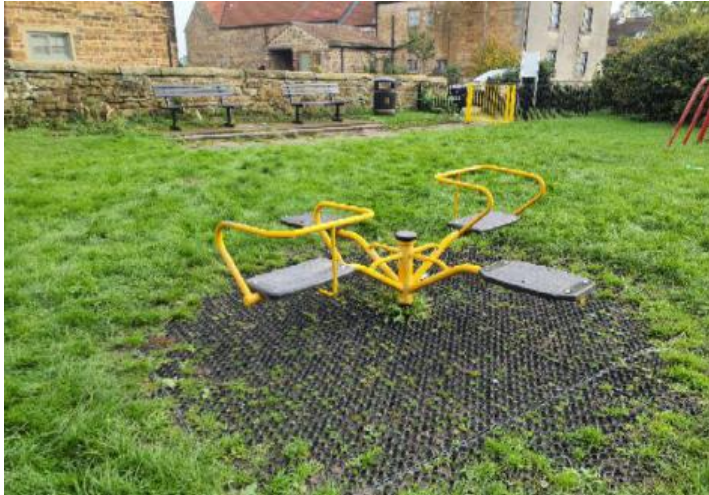
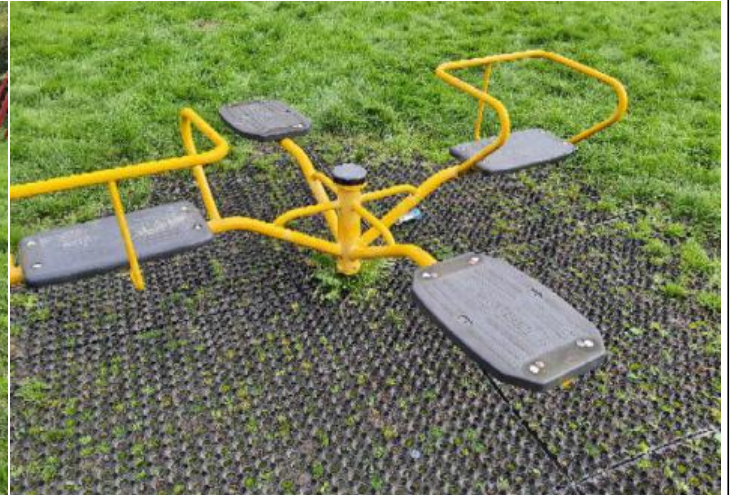
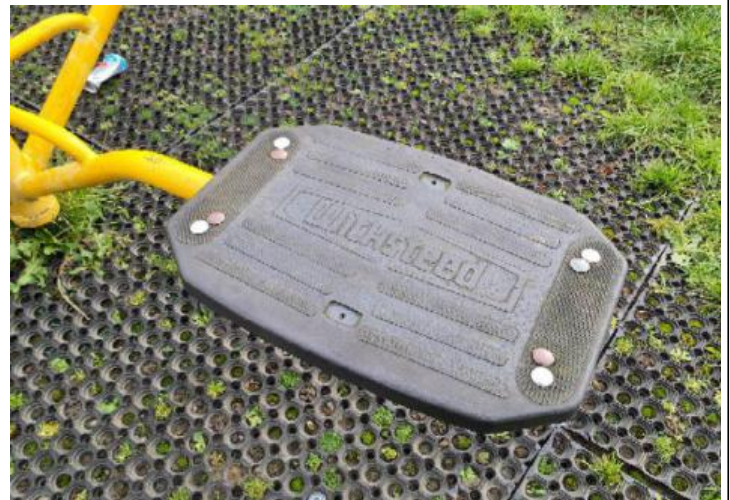
Finding: The seats have been damaged or modified resulting in missing cradle seat enclosures which are required for the safe use of the item

Action: Replace the seats with the full cradle design

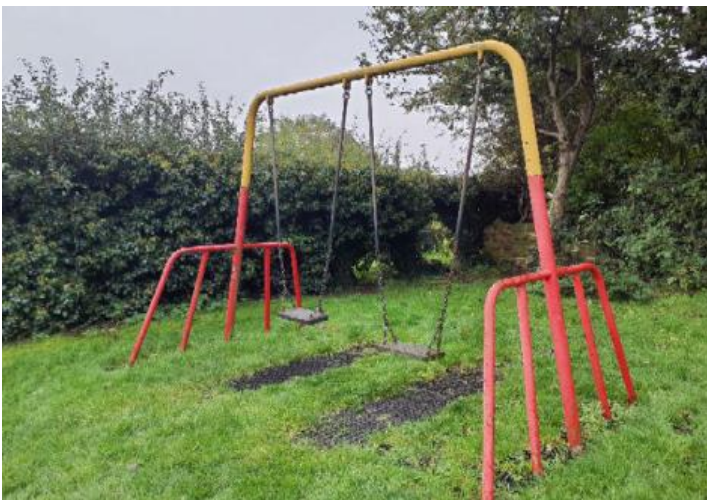
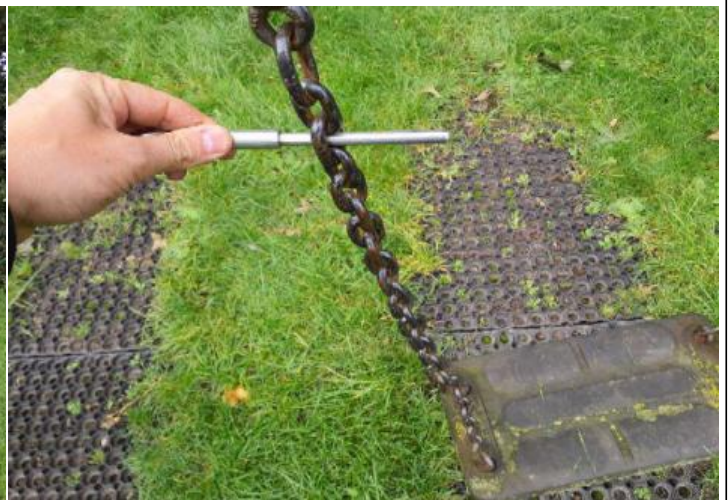
Finding: The chain openings are in excess of the 8.6mm as recommended by BS EN 1176

Action: Monitor - No remedial work recommended

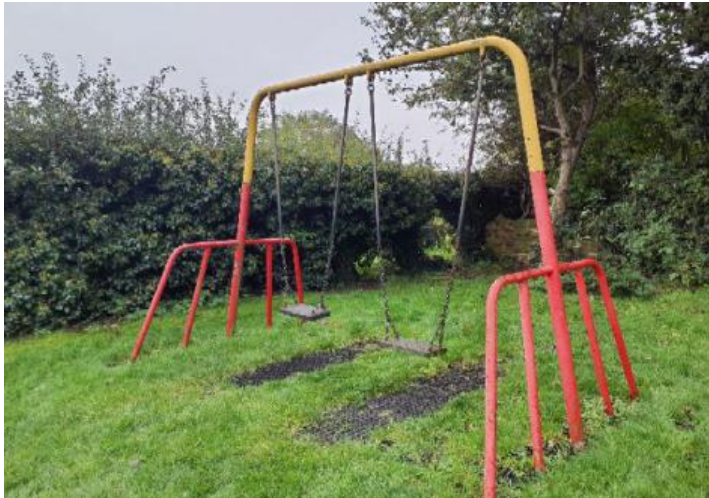
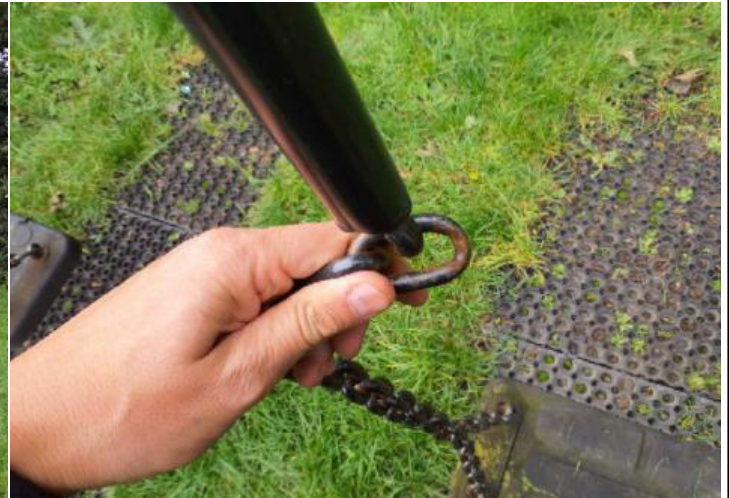
Finding: There is some notable evidence of chain wear	Action: Monitor for any further deterioration and replace when 40% worn
--	--

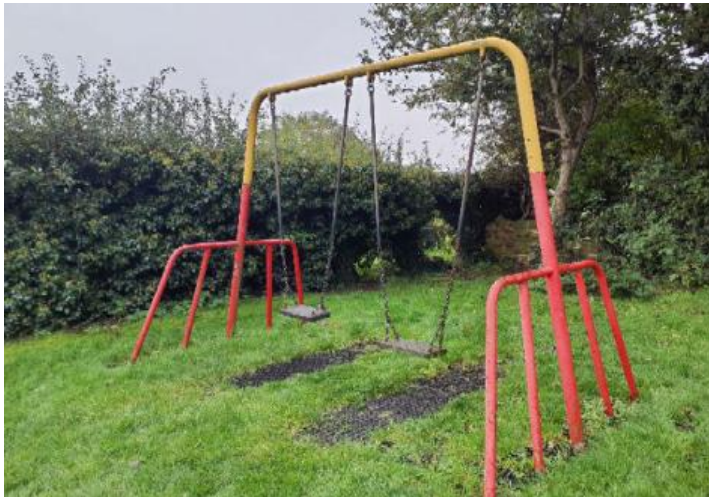
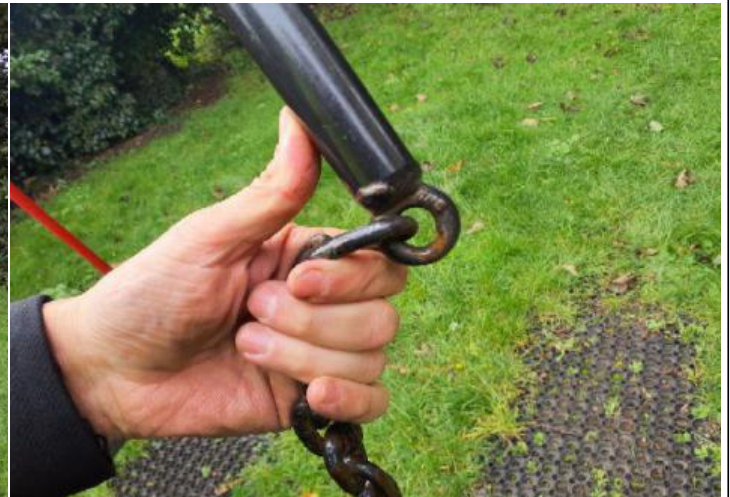
Finding: There is some notable evidence of wear to the anti wrap bars	Action: Monitor for any further deterioration and replace when 40% worn
--	--

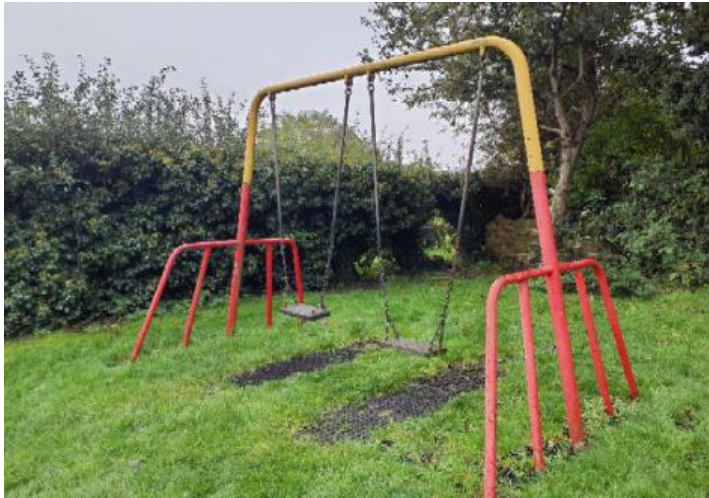
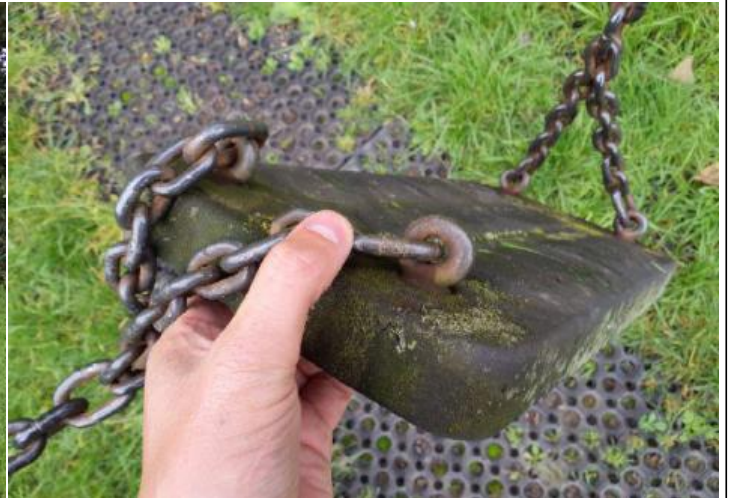
Finding: The swing seat connectors have some wear present

Action: Monitor for further deterioration and replace when 40% worn

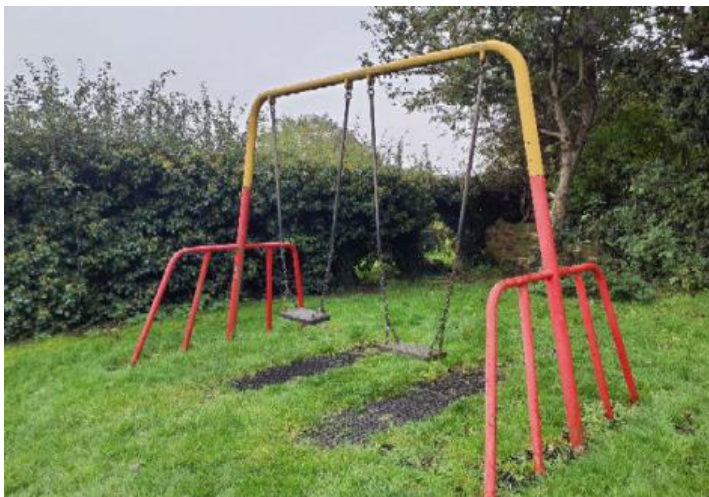
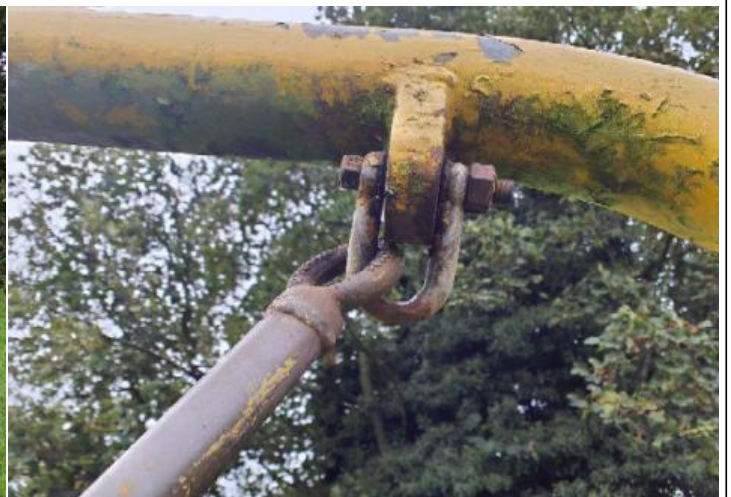
Finding: There is some wear to the shackles.

Action: Monitor for any further deterioration and replace when 40% worn

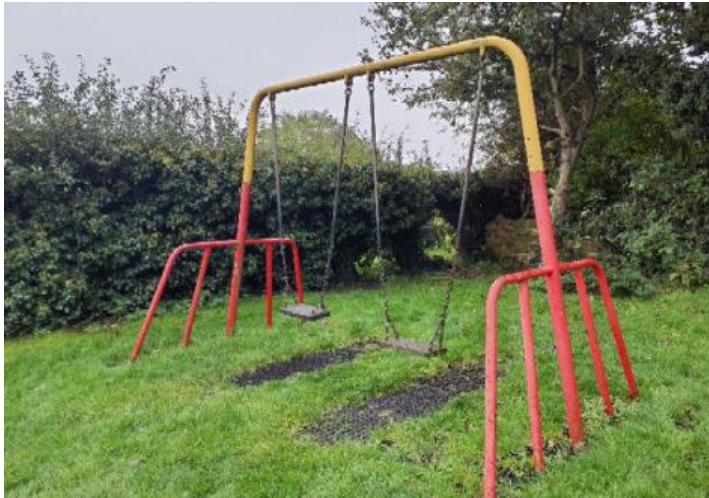
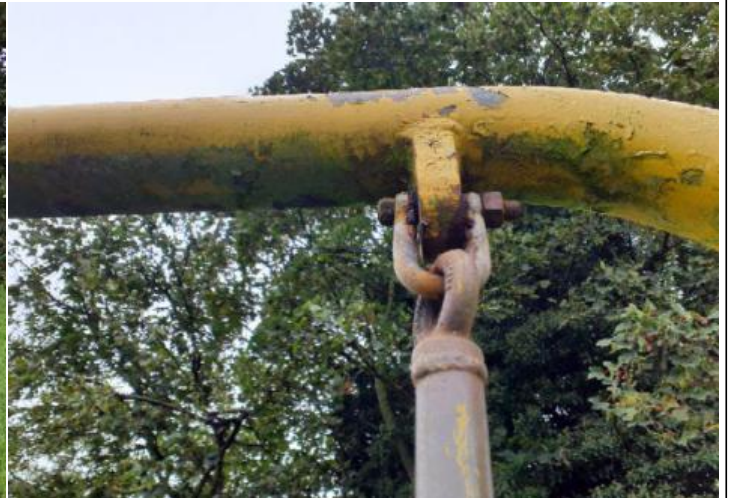
Finding: The bushes are worn or missing

Action: Replace worn or missing bushes

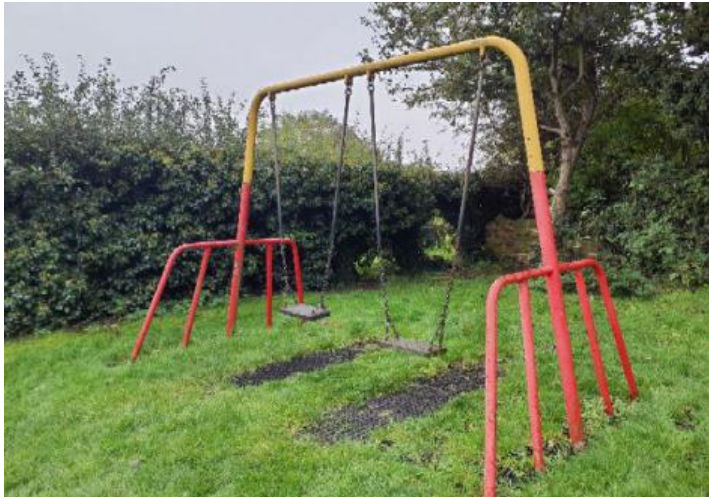
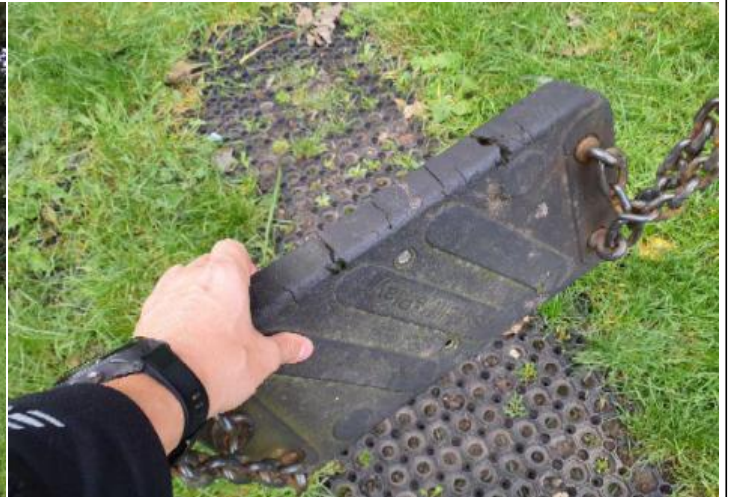
Finding: The seat has minor damage or wear

Action: Monitor for any further deterioration and replace as required

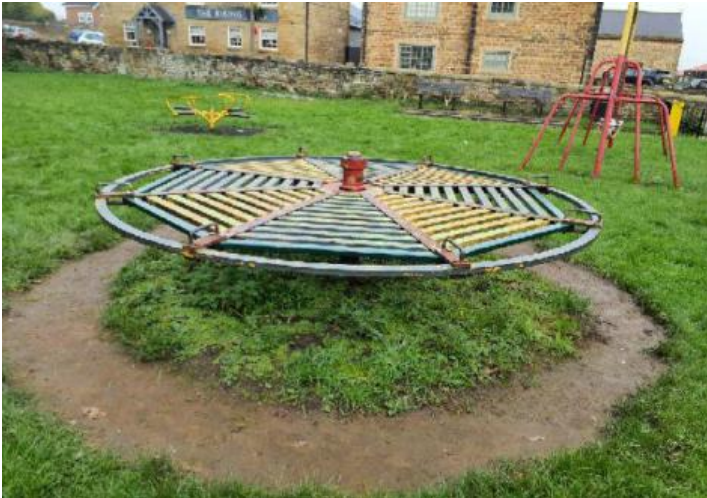
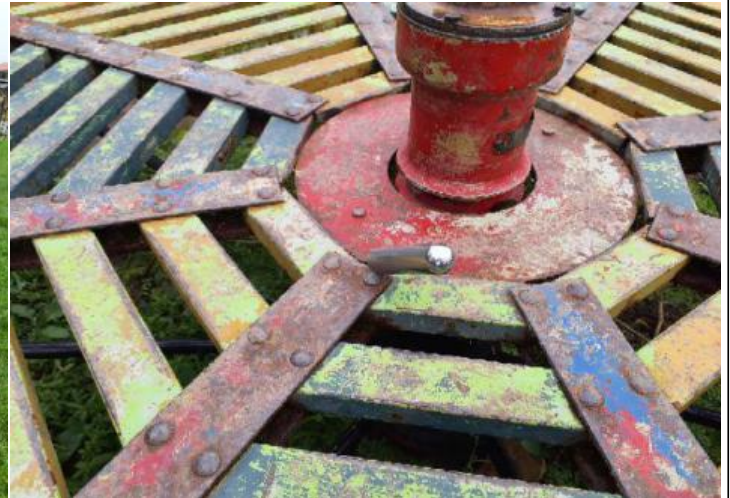
Finding: There is/are finger entrapment/s in the framework and the item fails to meet the requirements of BS EN 1176 Part 1 4.2.7.6 Entrapment of fingers

Action: Monitor - No remedial work recommended

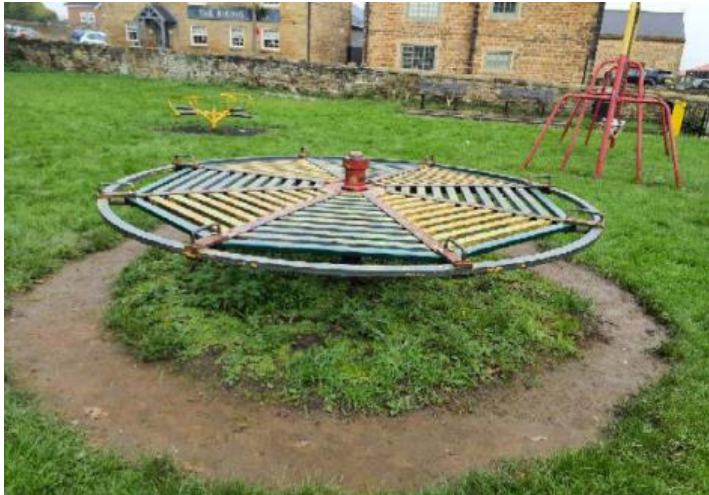
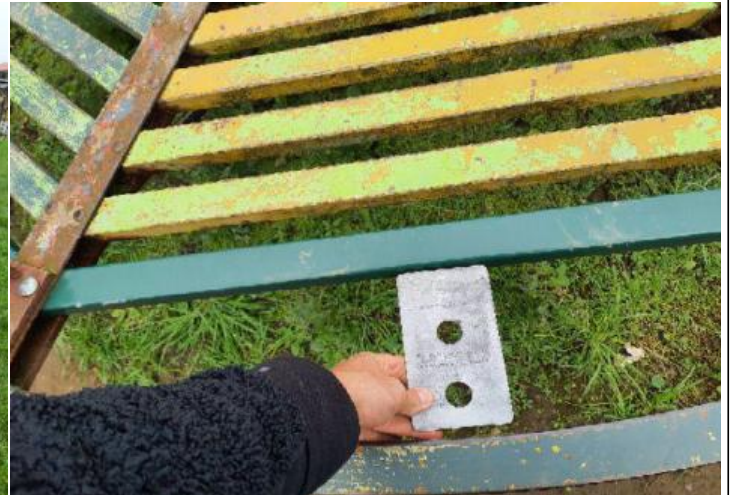
Finding: The item fails to meet the requirements of BS EN 1176 Part 1 4.2.7.2 for head and neck entrapment in the framework

Action: Monitor - No remedial work recommended

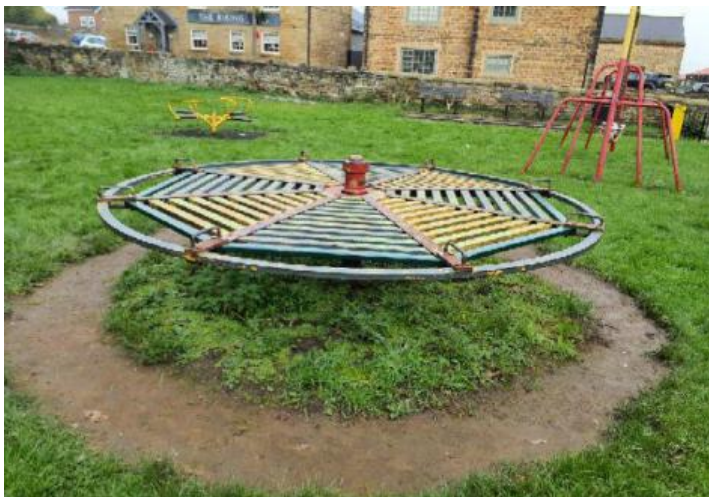
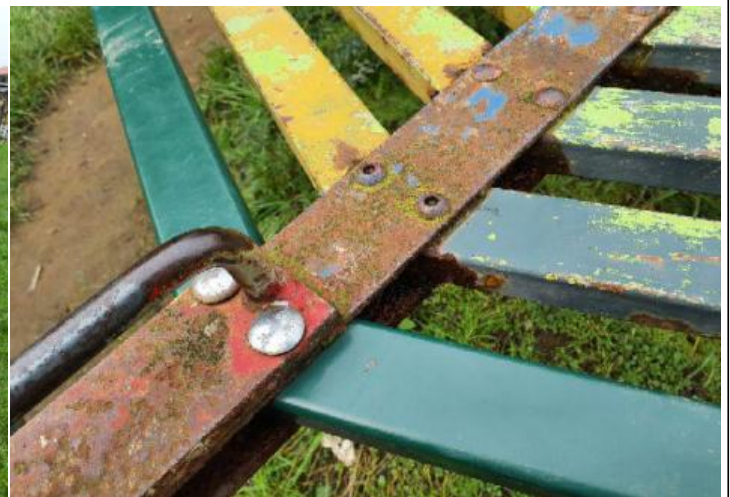
Finding: The paintwork on this item has been damaged or worn exposing the metal underneath which is rusting / corroding

Action: Treat affected areas and repaint

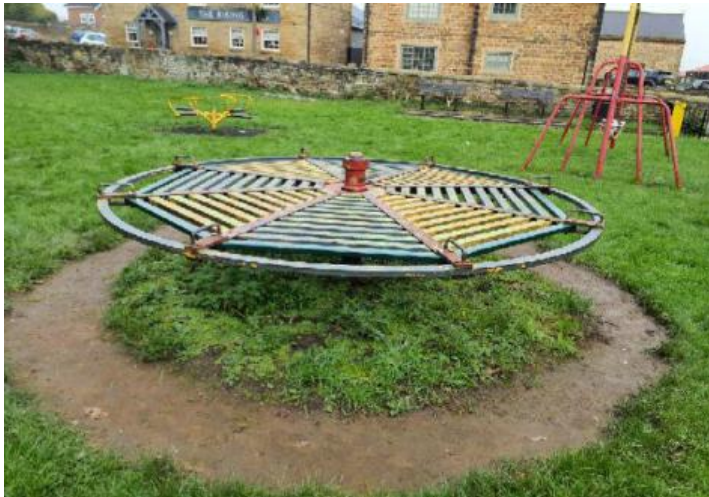
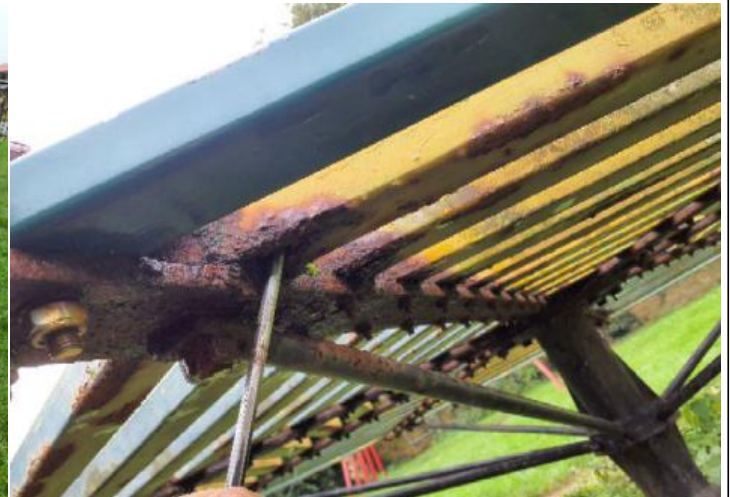
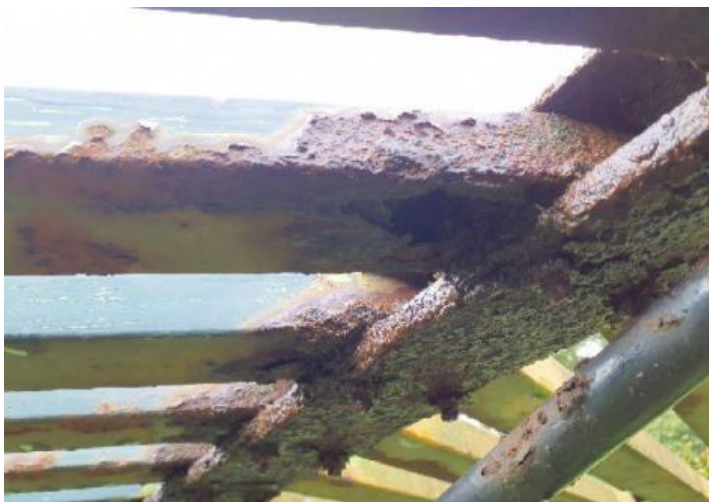
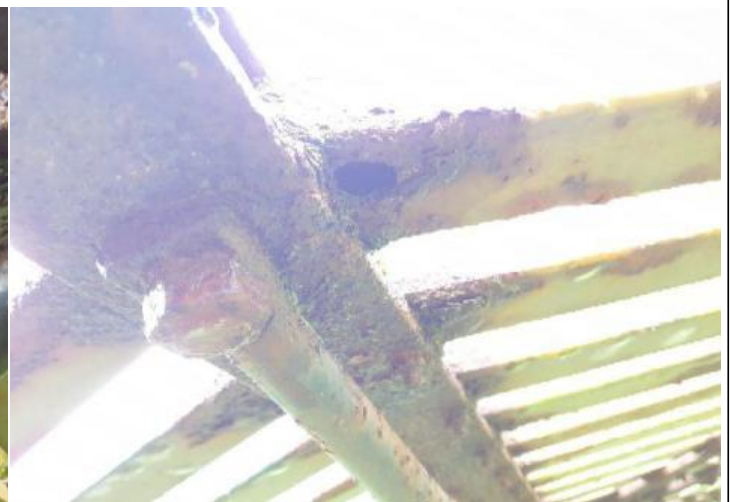
Finding: Parts of the steel on this item have corroded excessively and the metal has perforated in places

Action: Ensure all affected areas are treated and repaired

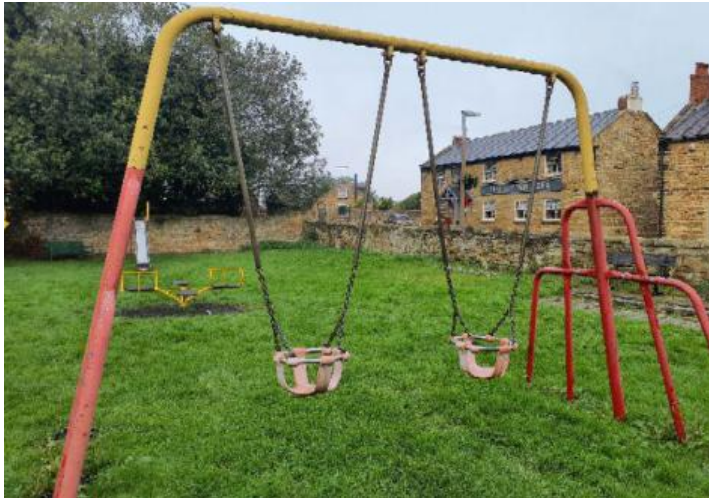
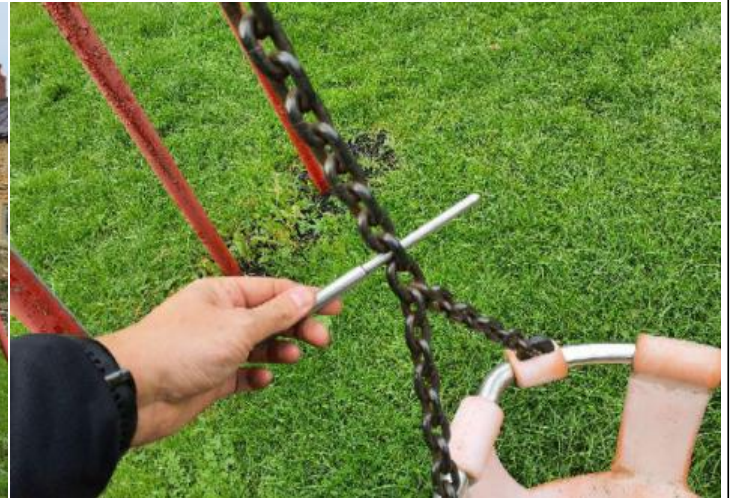
Finding: There is some notable evidence of chain wear

Action: Monitor for any further deterioration and replace when 40% worn

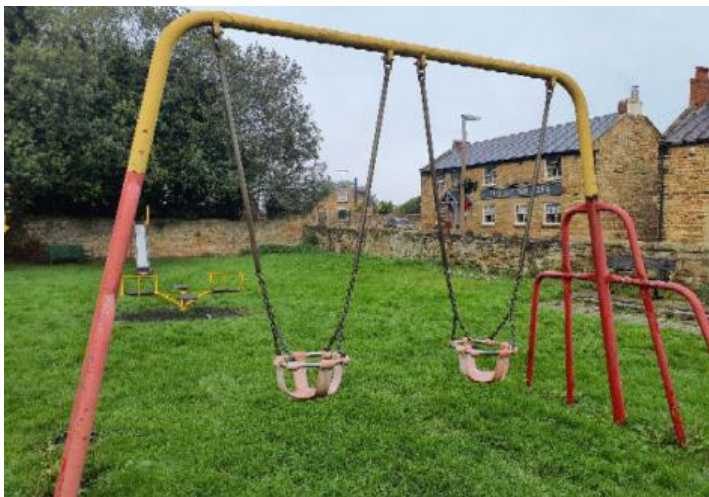
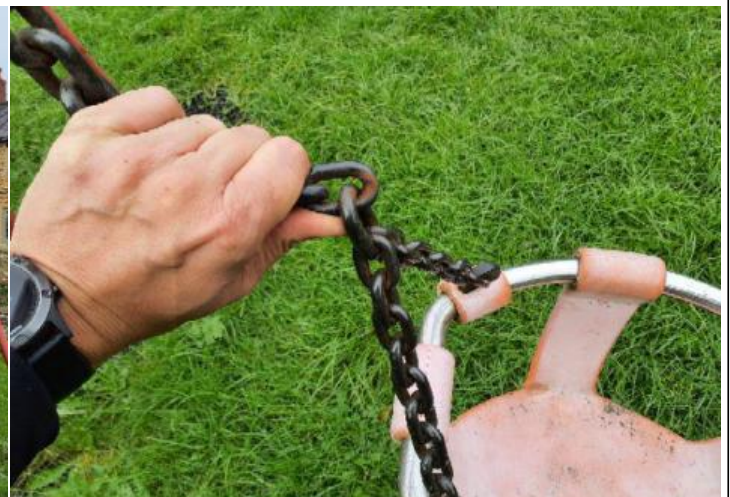
Finding: There is some notable evidence of chain wear

Action: Monitor for any further deterioration and replace when 40% worn

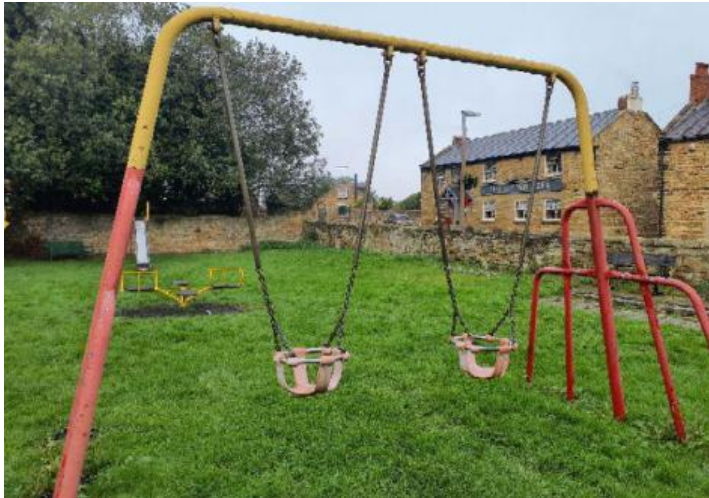
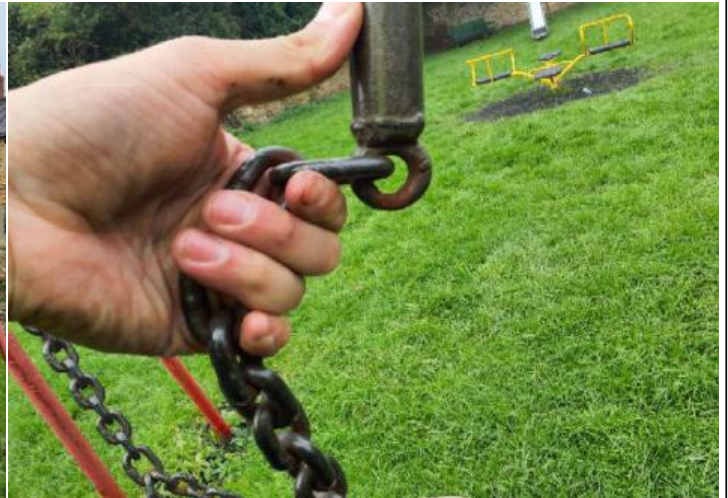
Finding: There is some notable evidence of wear to the anti wrap bars
Action: Monitor for any further deterioration and replace when 40% worn
