Annual Inspection

Rotherham Metropolitan Borough Council

Brampton Road

Inspection Ref: 2203189

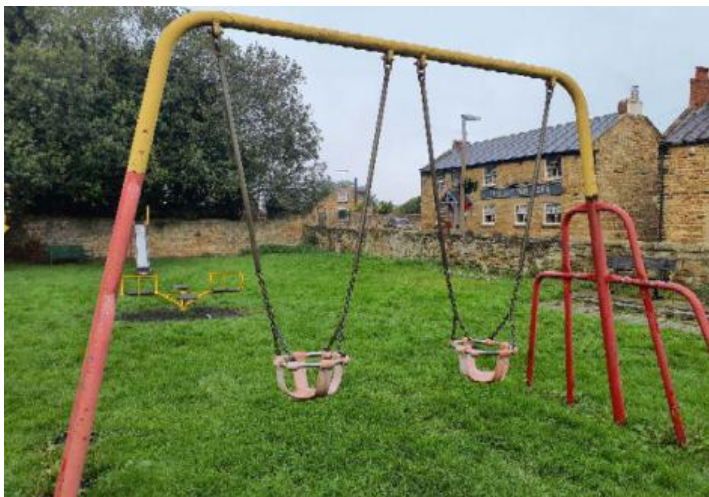
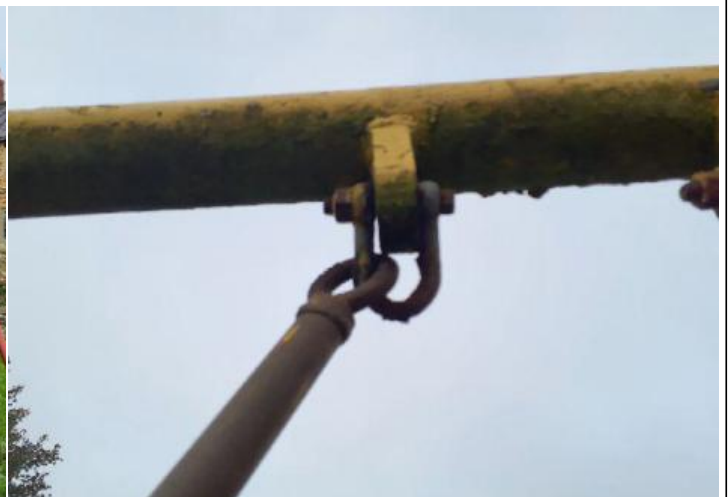
Finding: There is some wear to the shackles.
Action: Monitor for any further deterioration and replace when 40% worn

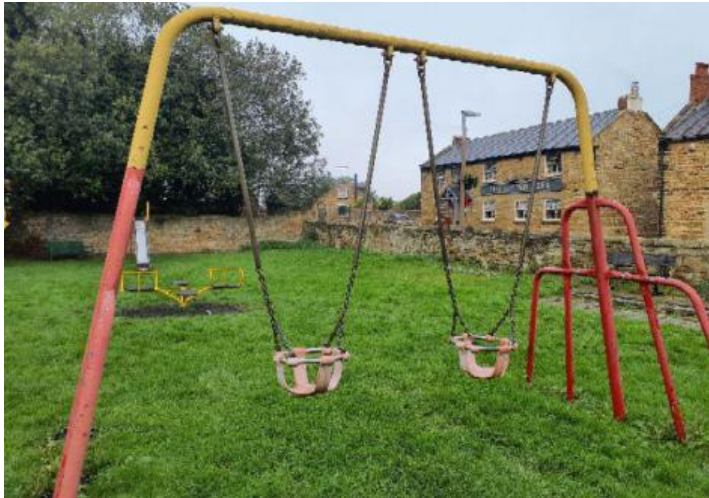
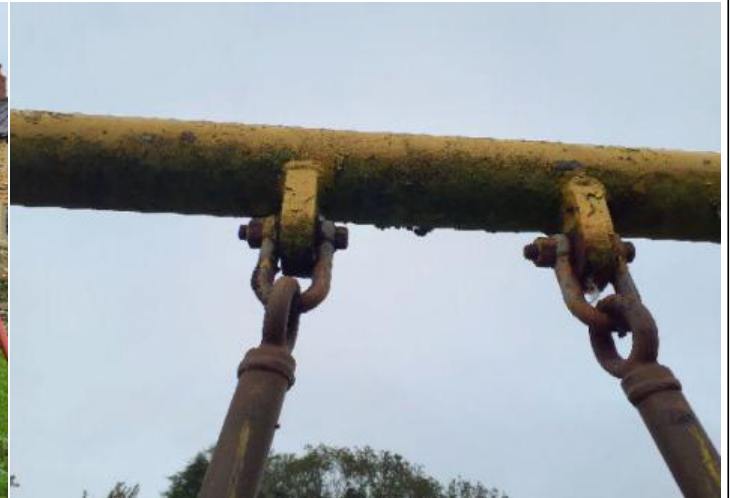
Finding: The bushes are showing signs of wear

Action: Monitor for any further deterioration and replace as required

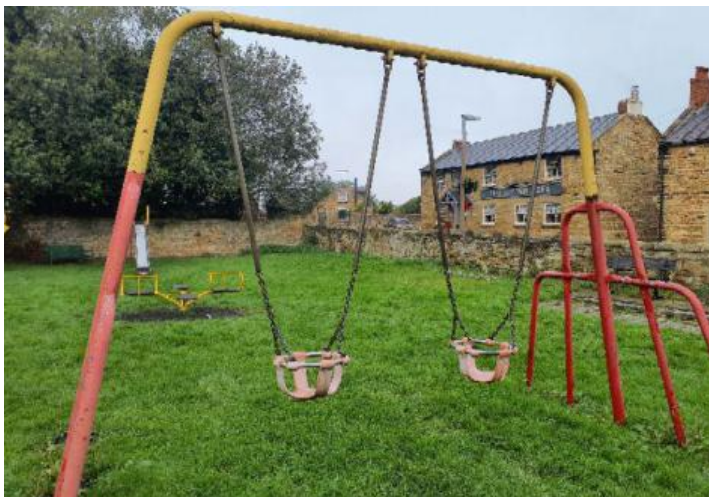
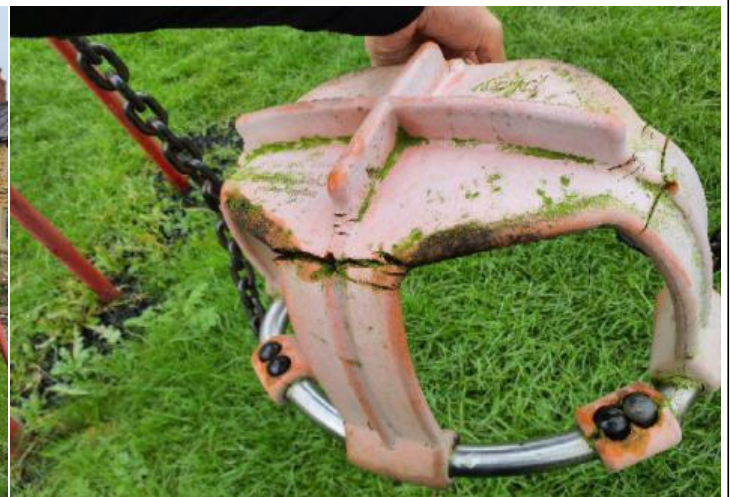
Finding: The seat has minor damage or wear

Action: Monitor for any further deterioration and replace as required

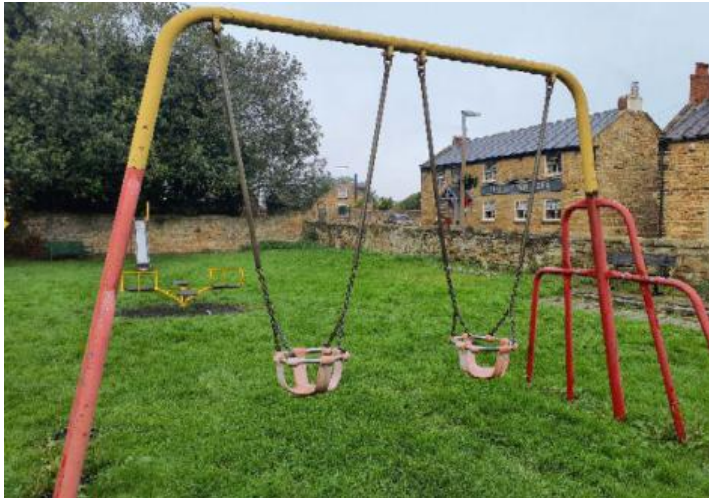
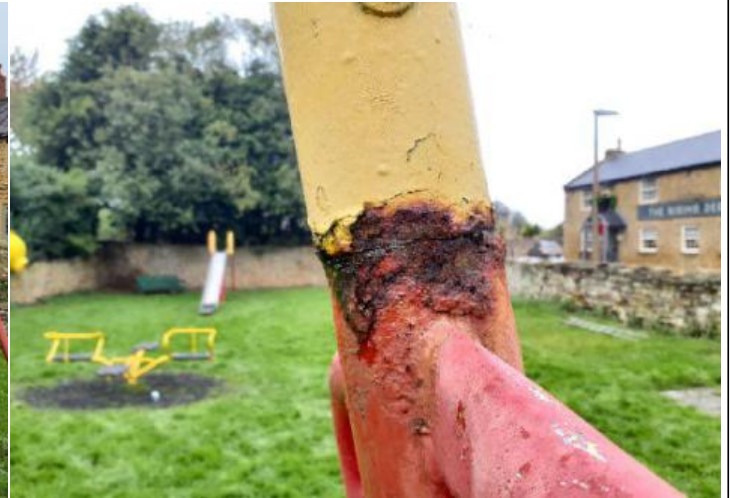
Finding: The paintwork on this item has been damaged or worn exposing the metal underneath which is rusting / corroding

Action: Treat affected areas and repaint
