## Gordon Bennett

Inspection Ref: 2174034

Operational Inspection - 18-September-2023 - 08:22 Inspector Terry Hill

Risk Assessment: 8 Low Risk

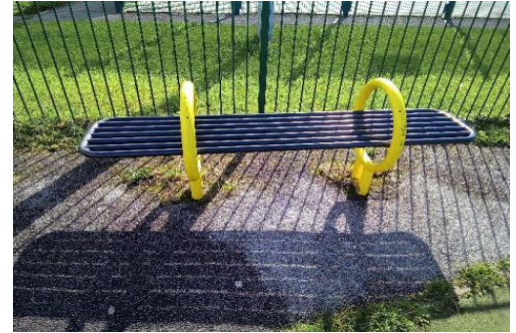
**Item:** Bench  
**Manufacturer:** Sutcliffe Play Limited  
**Surface Type:** Tarmac  
**Item Quantity:** 2  
**Equipment Compliance:** N/A  
**Surface Area Compliance:** N/A

Graffiti present - Removal required

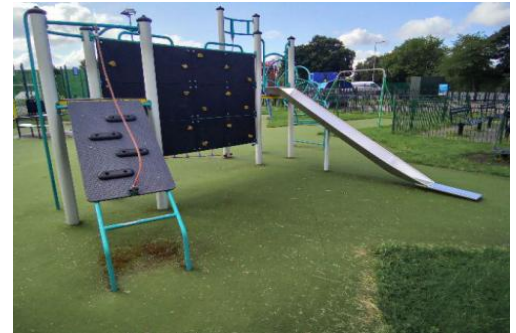
**Item:** Multi Play (Senior)  
**Manufacturer:** Sutcliffe Play Limited  
**Surface Type:** Carpet System  
**Item Quantity:** 1  
**Equipment Compliance:** No  
**Surface Area Compliance:** Yes

Rope damaged - Monitor

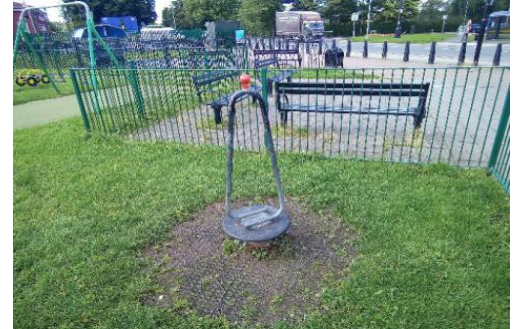
**Item:** Spinning Pole  
**Manufacturer:** Sutcliffe Play Limited  
**Surface Type:** Grass Matrix Tiles  
**Item Quantity:** 1  
**Equipment Compliance:** Yes  
**Surface Area Compliance:** Yes

Safety surface compacted - Repair required

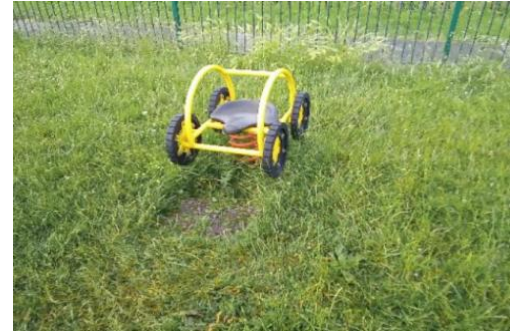
**Item:** Spring Car  
**Manufacturer:** Sutcliffe Play Limited  
**Surface Type:** Grass Matrix Tiles  
**Item Quantity:** 1  
**Equipment Compliance:** Yes  
**Surface Area Compliance:** Yes

Safety surface compacted - Repair required

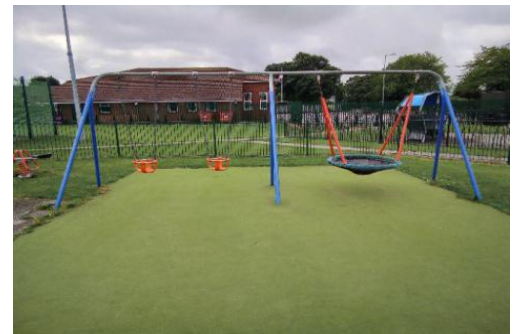
**Item:** 2 Bay 2 Cradle 1 Basket  
**Manufacturer:** Sutcliffe Play Limited  
**Surface Type:** Carpet System  
**Item Quantity:** 1  
**Equipment Compliance:** Yes  
**Surface Area Compliance:** Yes

Chains wearing - Monitor

Surface damage - Monitor

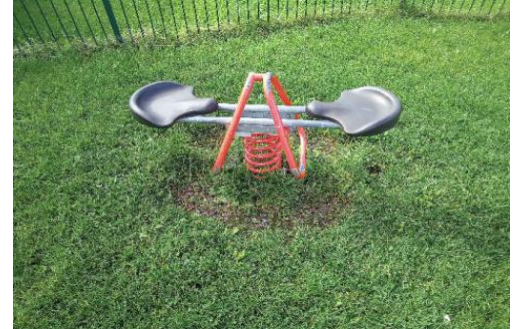
**Item:** Spring See-Saw  
**Manufacturer:** Sutcliffe Play Limited  
**Surface Type:** Grass Matrix Tiles  
**Item Quantity:** 1  
**Equipment Compliance:** Yes  
**Surface Area Compliance:** Yes

Safety surface compacted - Repair required

Rubber bumper damaged - Repair required

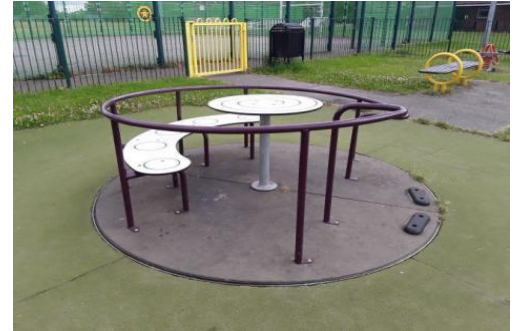
**Item:** Inclusive Roundabout  
**Manufacturer:** Sutcliffe Play Limited  
**Surface Type:** Carpet System  
**Item Quantity:** 1  
**Equipment Compliance:** No  
**Surface Area Compliance:** No

Platform catching - Inspection required

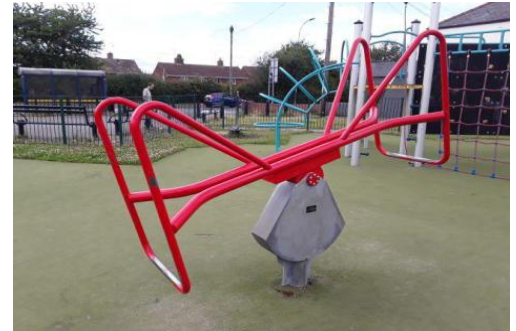
**Item:** Stand up SeeSaw  
**Manufacturer:** Sutcliffe Play Limited  
**Surface Type:** Carpet System  
**Item Quantity:** 1  
**Equipment Compliance:** Yes  
**Surface Area Compliance:** Yes

Paint peeling - Monitor

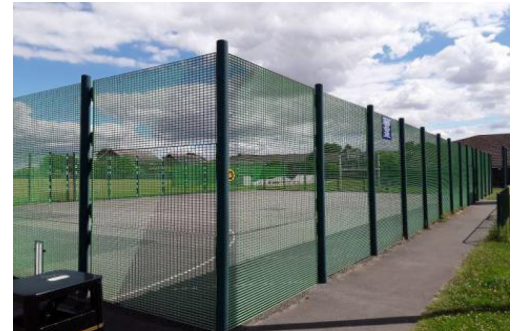
**Item:** Multi Use Games Area (MUGA)  
**Manufacturer:** Parkdale Play & Leisure Ltd  
**Surface Type:** Bitmac  
**Item Quantity:** 1  
**Equipment Compliance:** No  
**Surface Area Compliance:** N/A

Welds broken cricket stumps - Repair required

Panel damaged - Monitor

2 nuts missing on back of backboard - Repair required

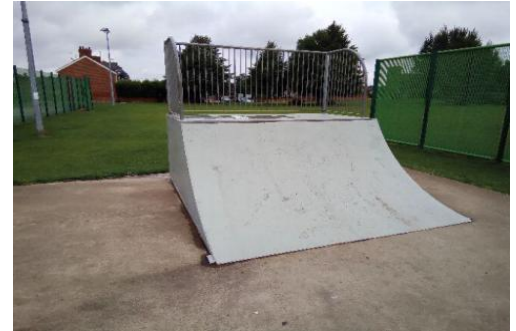
**Item:** Quarter Pipe  
**Manufacturer:** Not Identified  
**Surface Type:** Bitmac  
**Item Quantity:** 1  
**Equipment Compliance:** Yes  
**Surface Area Compliance:** Yes

Graffiti present - Removal required

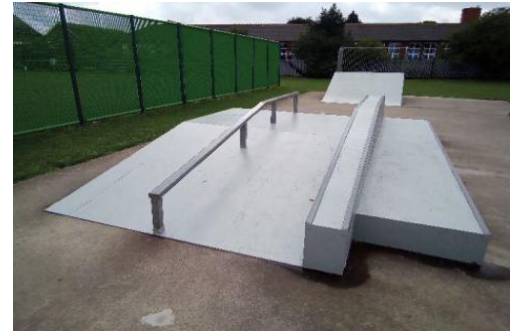
**Item:** Fun Box  
**Manufacturer:** Not Identified  
**Surface Type:** Bitmac  
**Item Quantity:** 1  
**Equipment Compliance:** No  
**Surface Area Compliance:** Yes

Graffiti present - Removal required

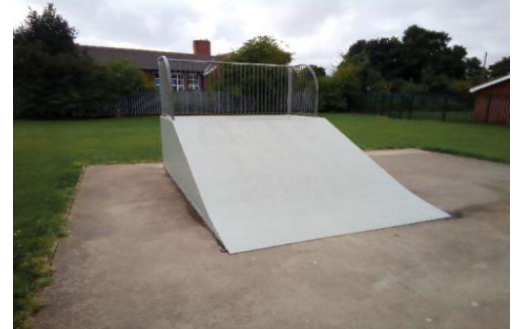
**Item:** Flat Ramp  
**Manufacturer:** Not Identified  
**Surface Type:** Bitmac  
**Item Quantity:** 1  
**Equipment Compliance:** Yes  
**Surface Area Compliance:** Yes

Graffiti present - Removal required

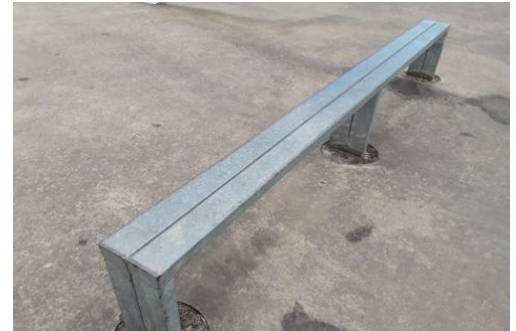
**Item:** Grind Rail  
**Manufacturer:** Not Identified  
**Surface Type:** Bitmac  
**Item Quantity:** 1  
**Equipment Compliance:** No  
**Surface Area Compliance:** Yes

Concrete edging low - Repair required

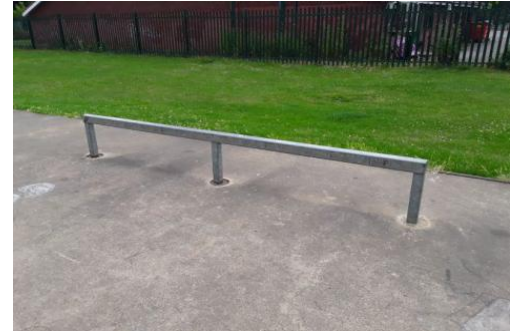
**Item:** Grind Rail  
**Manufacturer:** Not Identified  
**Surface Type:** Bitmac  
**Item Quantity:** 1  
**Equipment Compliance:** No  
**Surface Area Compliance:** Yes

Concrete edging low - Repair required

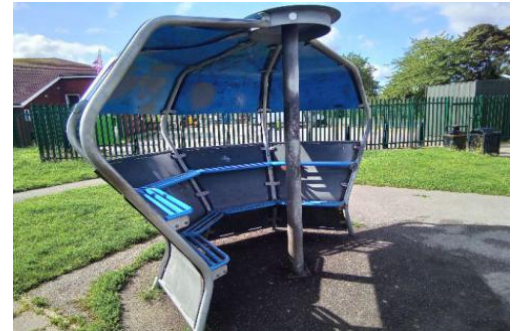
**Item:** Shelter  
**Manufacturer:** Owner/Operator  
**Surface Type:** Bitmac  
**Item Quantity:** 1  
**Equipment Compliance:** N/A  
**Surface Area Compliance:** N/A

Graffiti present - Removal required

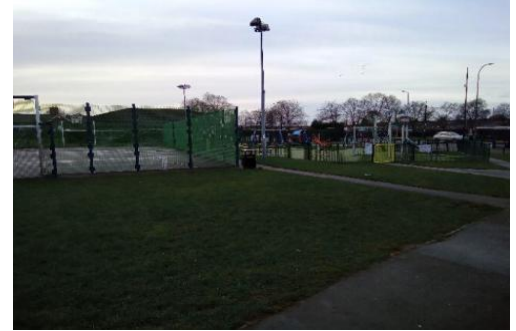
Several Burn marks on surface - Monitor

Graffiti on safety surface - Removal required

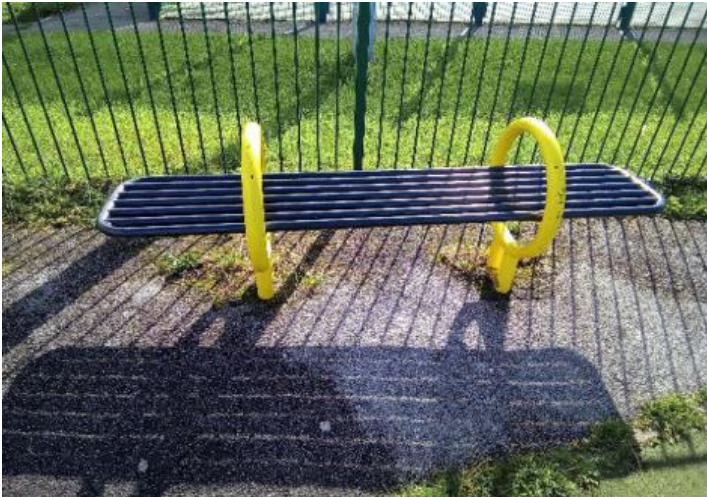
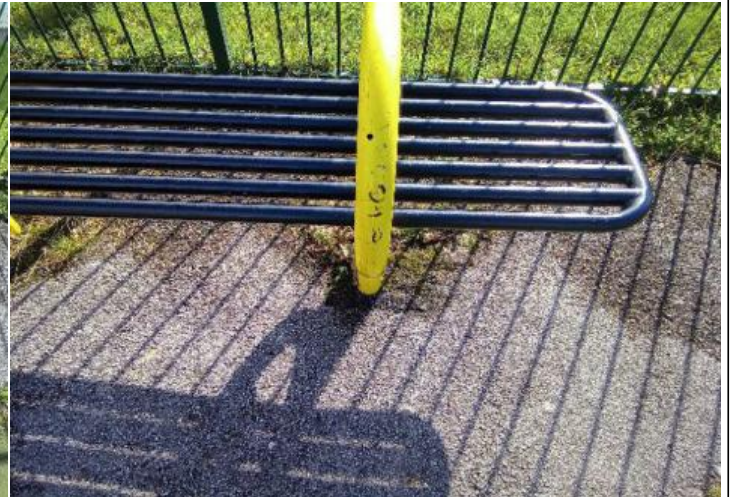
**Item:** Ancillary Items - Bench  
**Manufacturer:** Sutcliffe Play Limited

**Finding:** Graffiti present

**Action:** Removal required

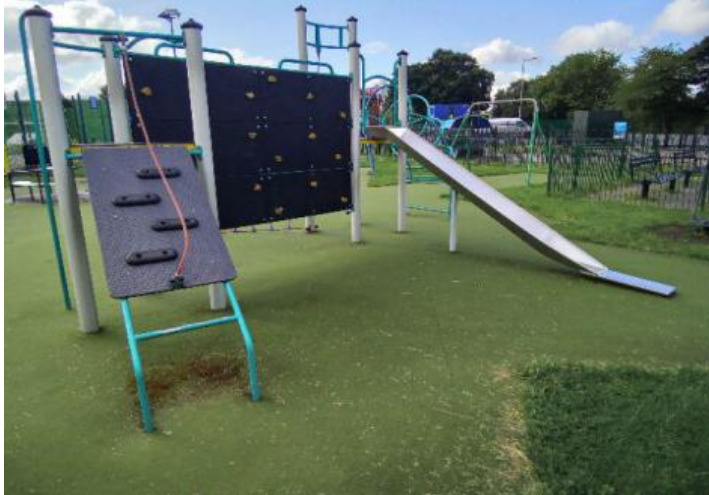
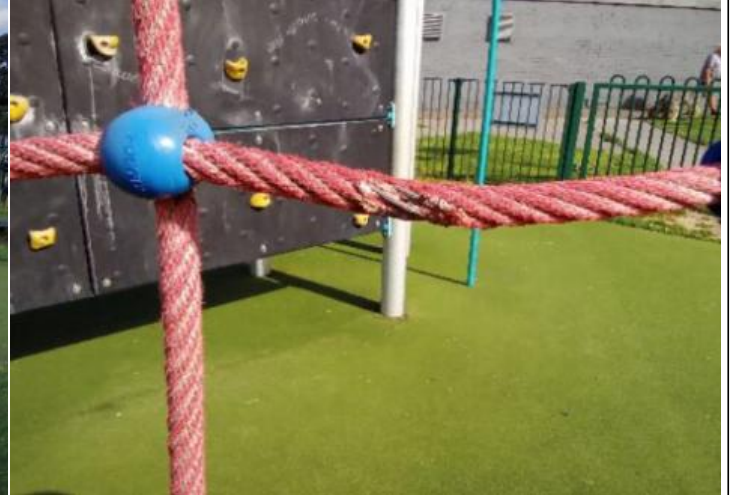
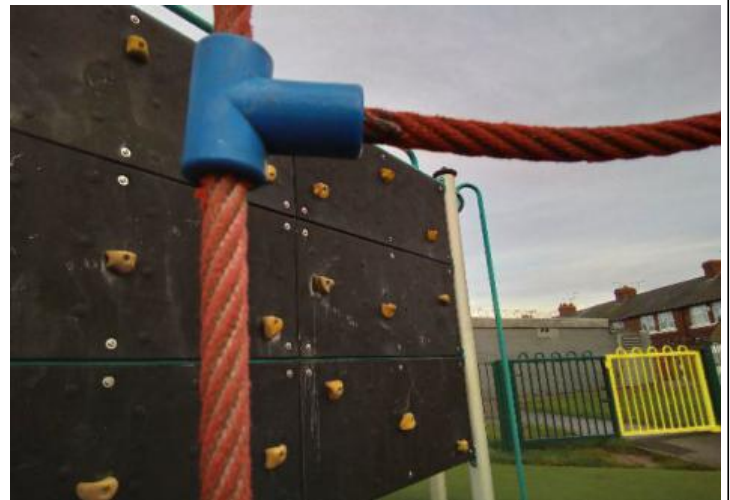
**Item:** Activity Equipment - Multi Play (Senior)  
**Manufacturer:** Sutcliffe Play Limited

**Finding:** Rope damaged

**Action:** Monitor

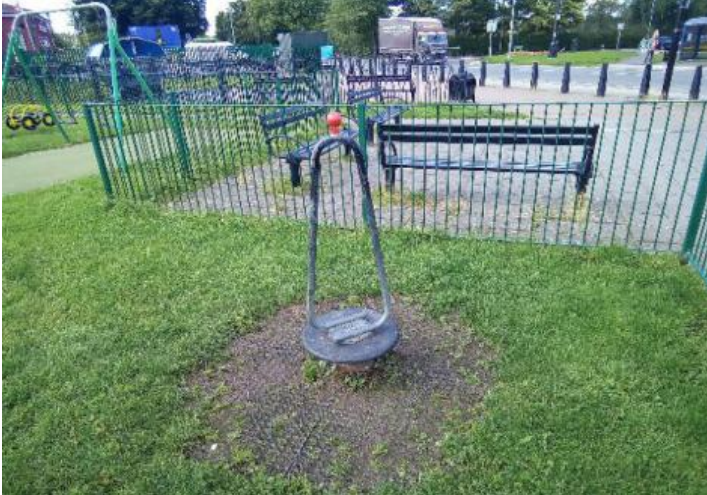
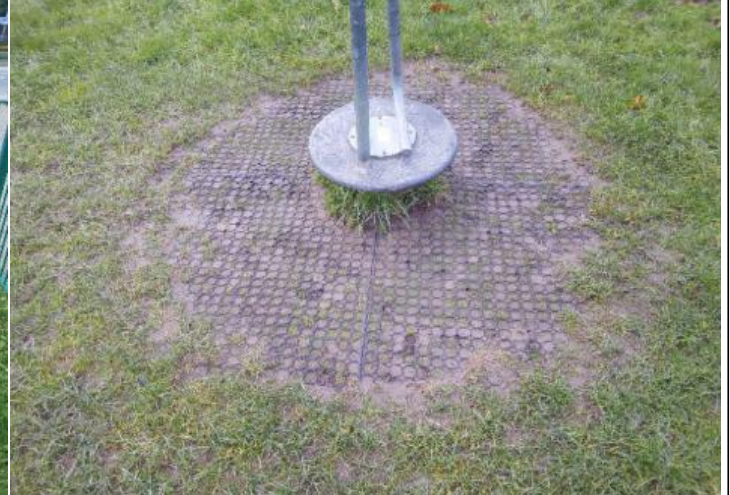
**Item:** Activity Equipment - Spinning Pole  
**Manufacturer:** Sutcliffe Play Limited

**Finding:** Safety surface compacted

**Action:** Repair required

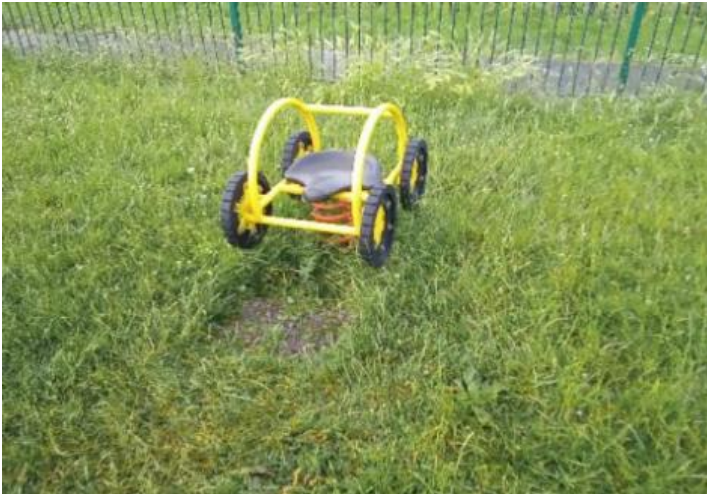
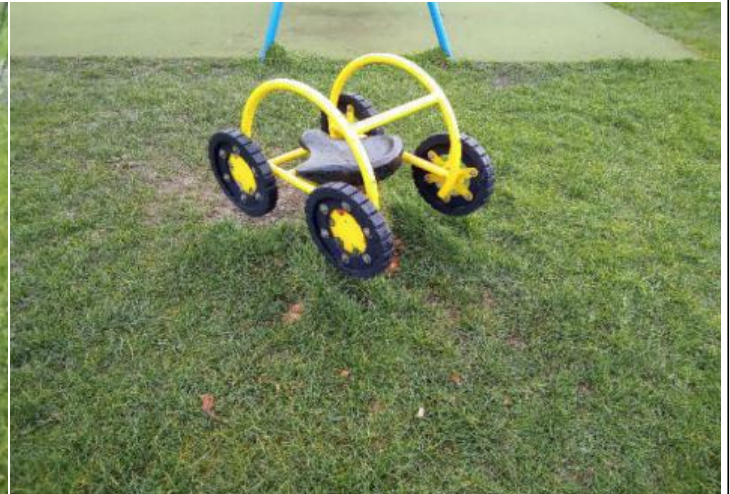
**Item:** Rocking Equipment - Spring Car  
**Manufacturer:** Sutcliffe Play Limited

**Finding:** Safety surface compacted

**Action:** Repair required

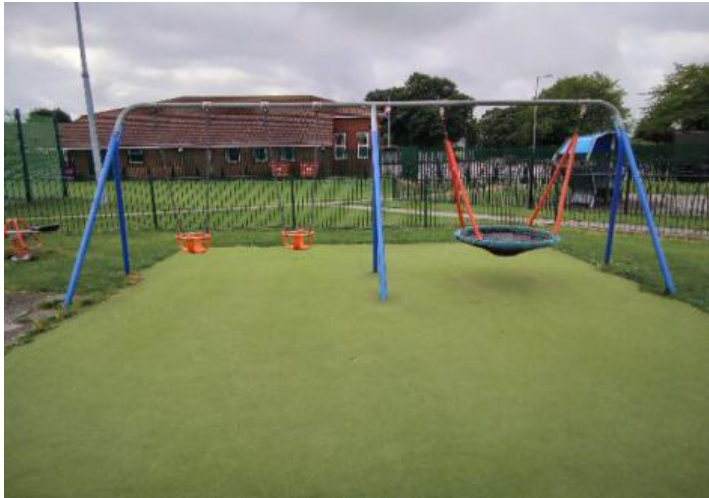
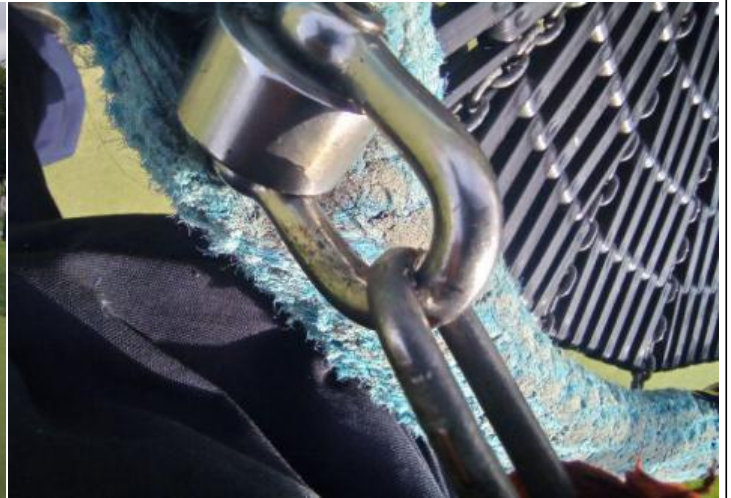
**Item:** Swings - 2 Bay 2 Cradle 1 Basket  
**Manufacturer:** Sutcliffe Play Limited

**Finding:** Chains wearing

**Action:** Monitor

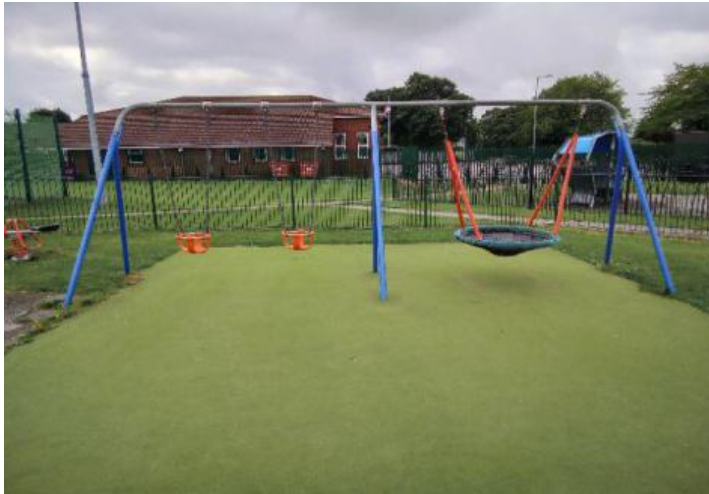
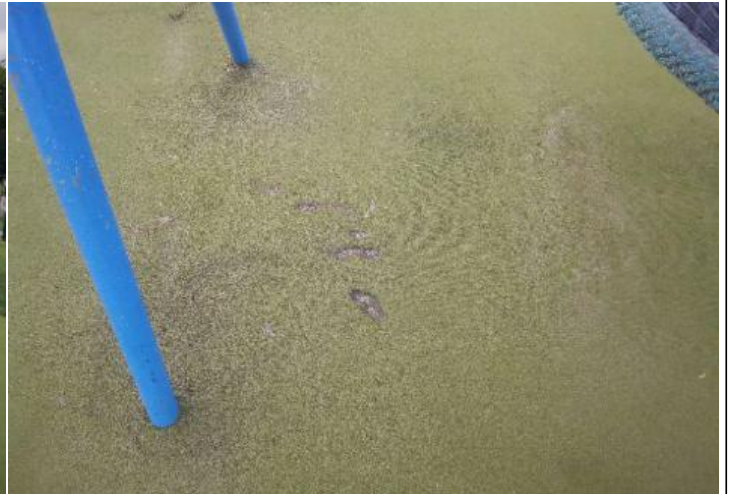
**Item:** Swings - 2 Bay 2 Cradle 1 Basket  
**Manufacturer:** Sutcliffe Play Limited

**Finding:** Surface damage

**Action:** Monitor

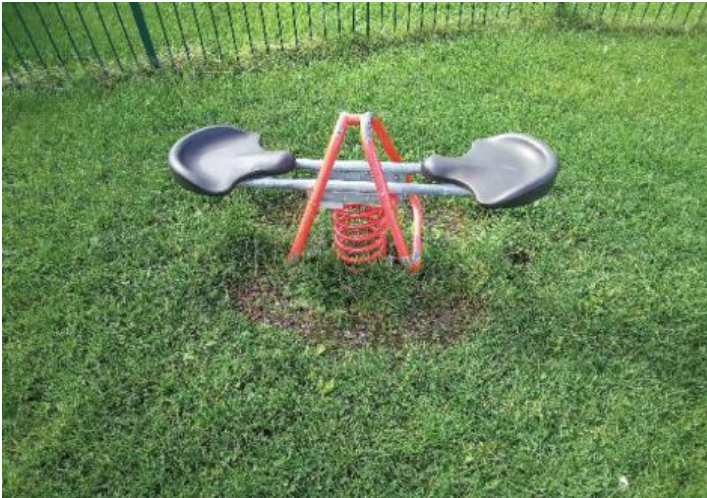
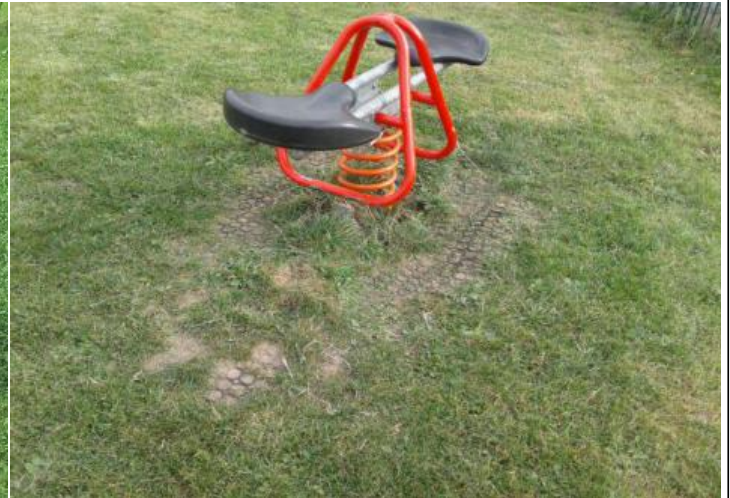
**Item:** Rocking Equipment - Spring See-Saw  
**Manufacturer:** Sutcliffe Play Limited

**Finding:** Safety surface compacted

**Action:** Repair required

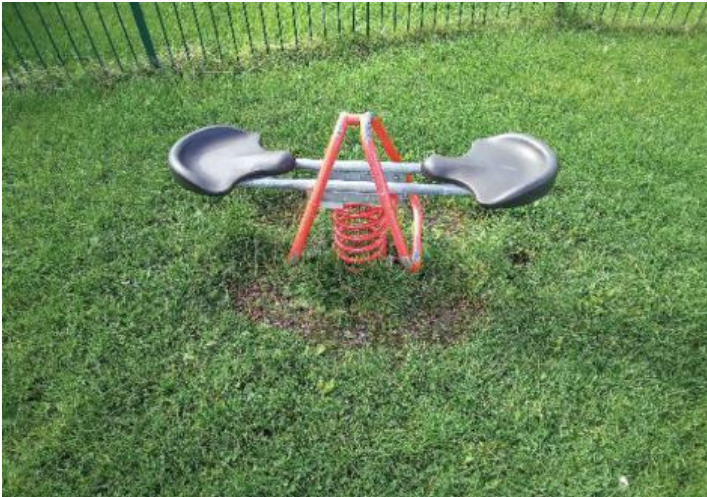
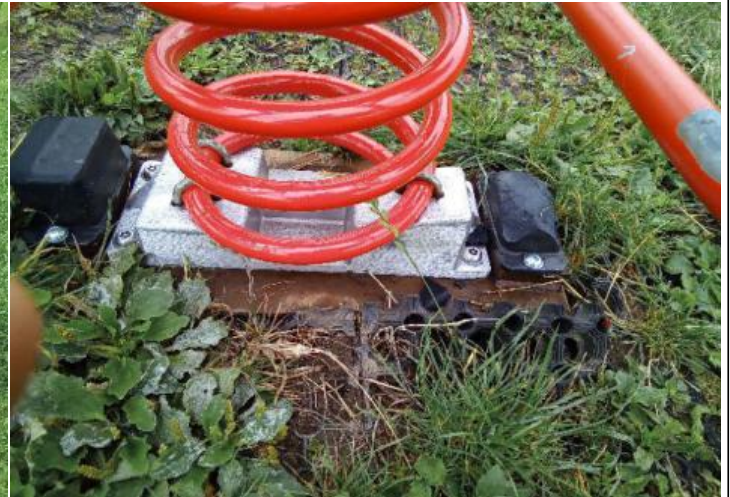
**Item:** Rocking Equipment - Spring See-Saw  
**Manufacturer:** Sutcliffe Play Limited

**Finding:** Rubber bumper damaged

**Action:** Repair required

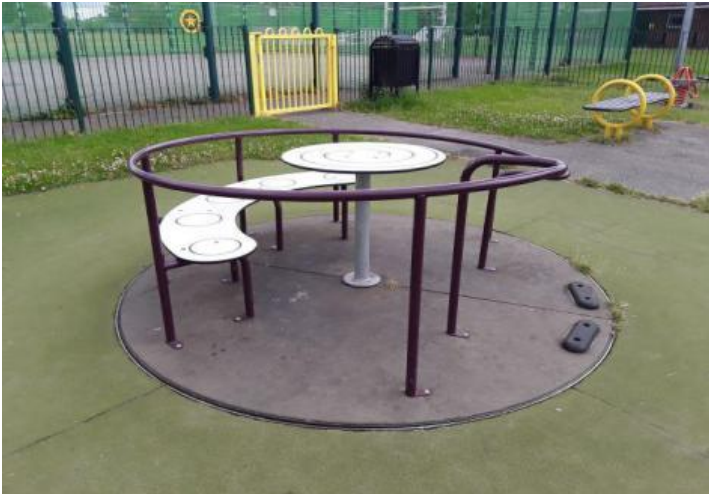
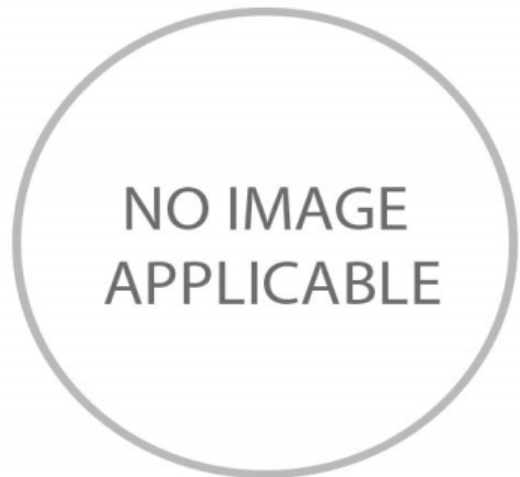
**Item:** Rotor Play - Inclusive Roundabout  
**Manufacturer:** Sutcliffe Play Limited  
**Risk Level:** V - Very Low Risk  
**Surface:** Carpet System

**Finding:** Platform catching

**Action:** Inspection required

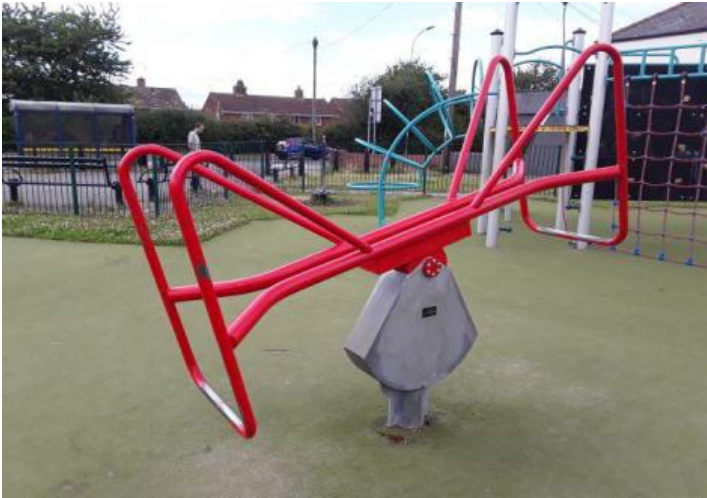
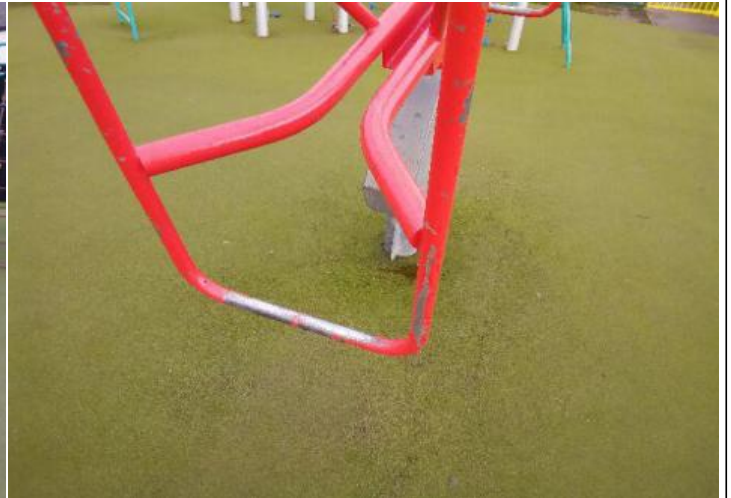
**Item:** Rocking Equipment - Stand up SeeSaw  
**Manufacturer:** Sutcliffe Play Limited

**Finding:** Paint peeling

**Action:** Monitor

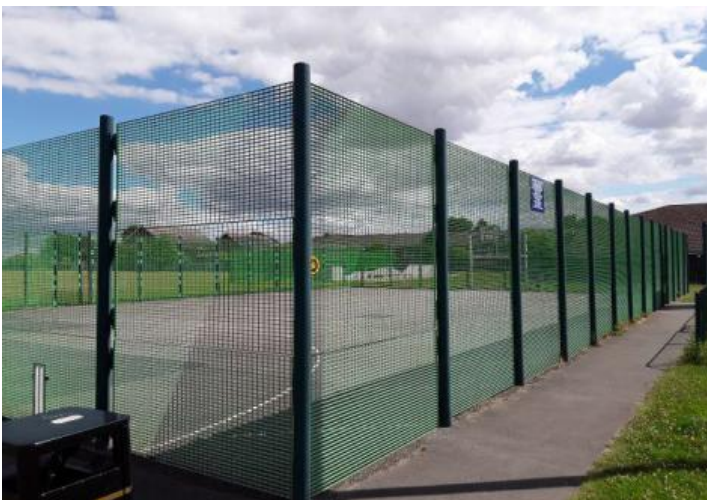
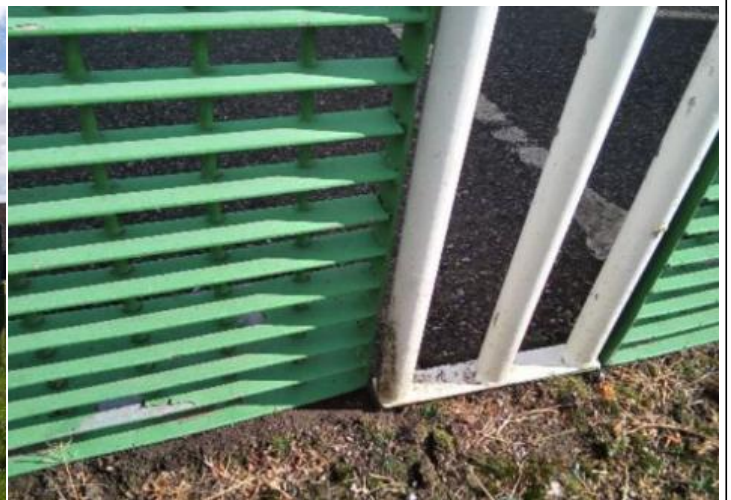
**Item:** Multi Use Games Area - Multi Use Games Area (MUGA)  
**Manufacturer:** Parkdale Play & Leisure Ltd

**Finding:** Welds broken cricket stumps

**Action:** Repair required

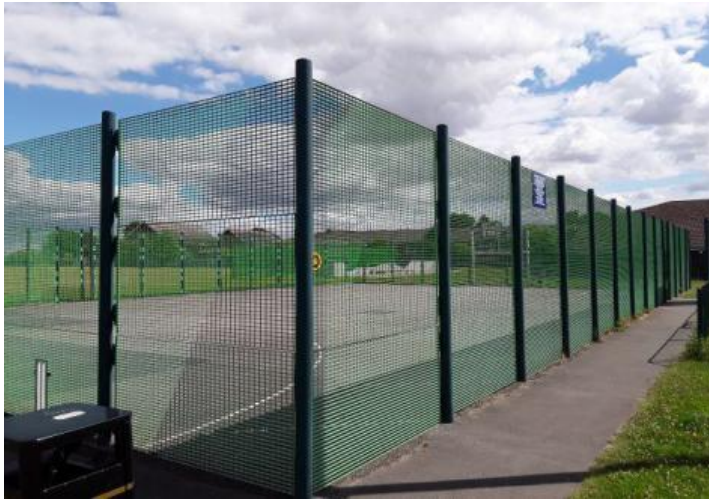
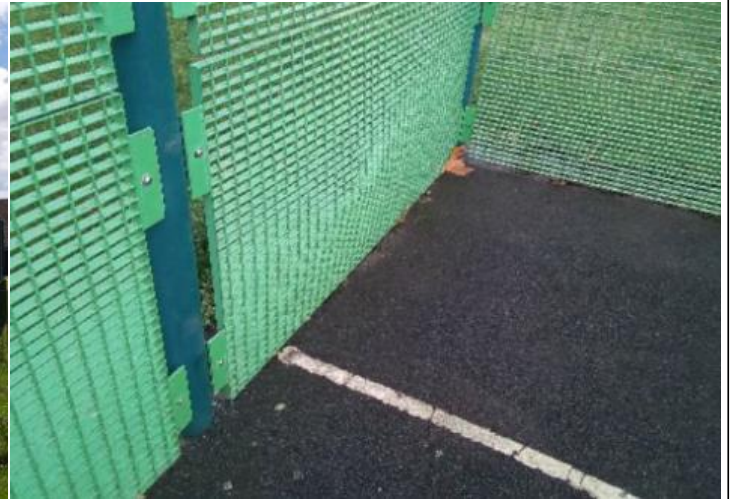
**Item:** Multi Use Games Area - Multi Use Games Area (MUGA)  
**Manufacturer:** Parkdale Play & Leisure Ltd  
**Risk Level:** V - Very Low Risk  
**Surface:** Bitmac

**Finding:** Panel damaged

**Action:** Monitor

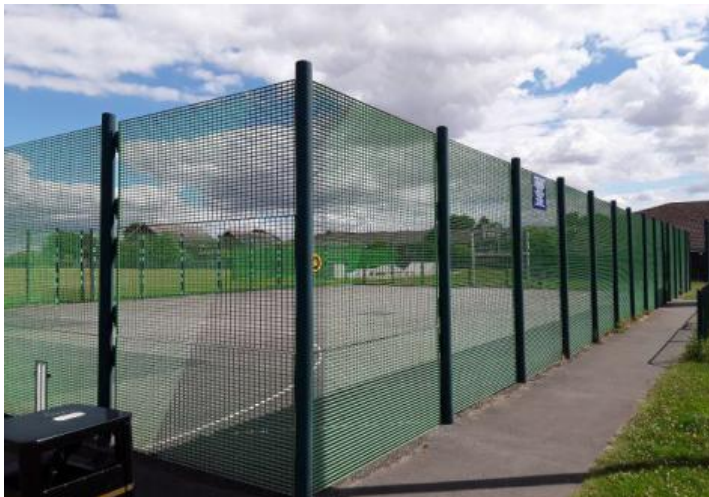
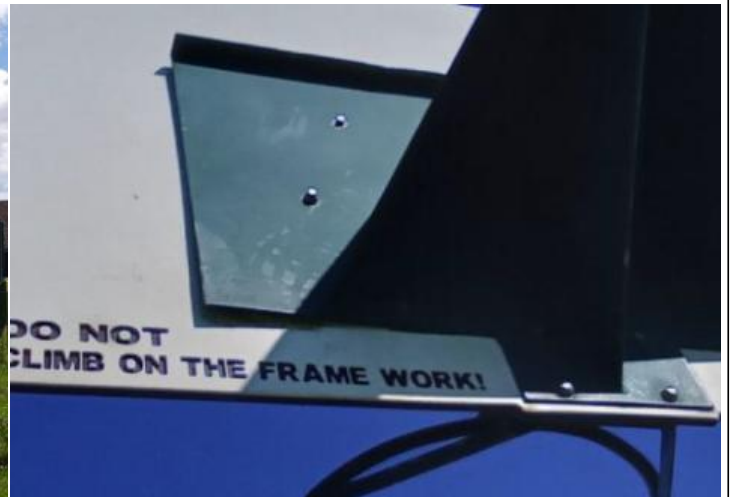
**Item:** Multi Use Games Area - Multi Use Games Area (MUGA)  
**Manufacturer:** Parkdale Play & Leisure Ltd  
**Risk Level:** V - Very Low Risk  
**Surface:** Bitmac

**Finding:** 2 nuts missing on back of backboard

**Action:** Repair required

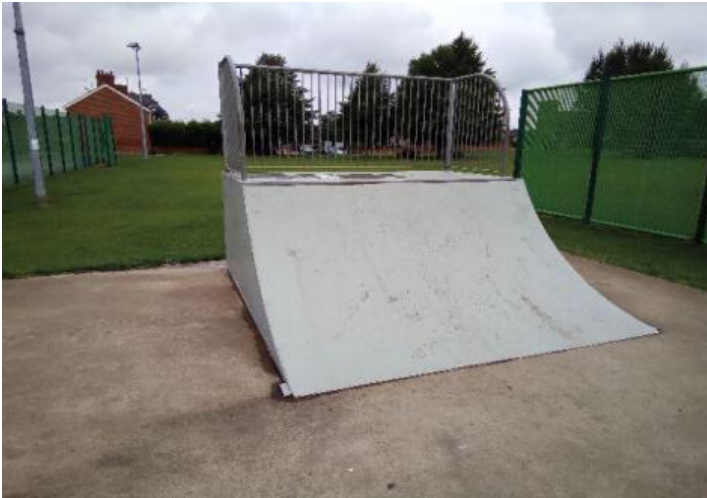
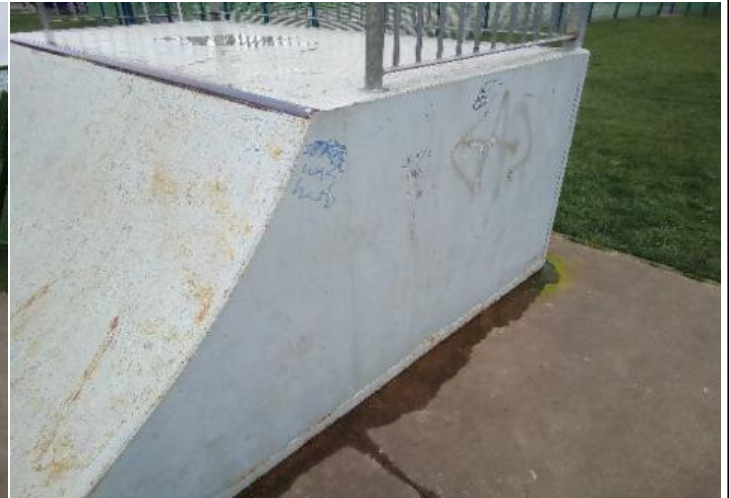
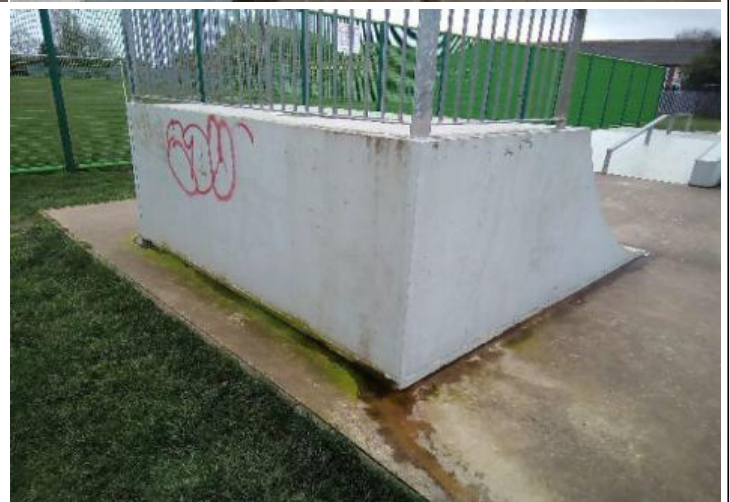
**Item:** Wheeled Sports - Quarter Pipe  
**Manufacturer:** Not Identified

**Finding:** Graffiti present

**Action:** Removal required

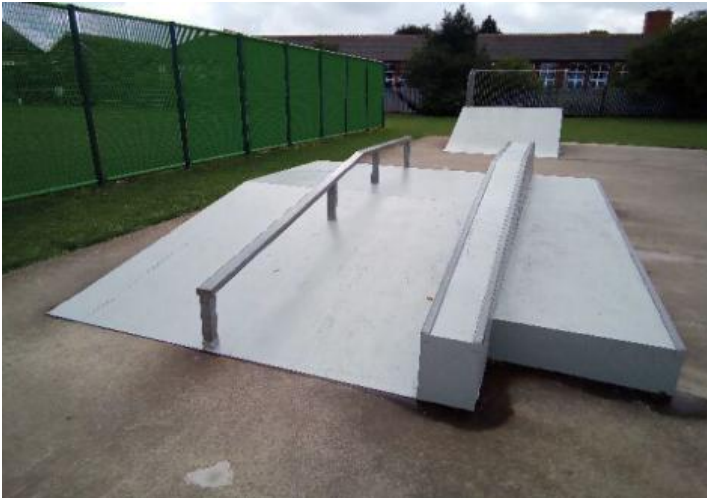
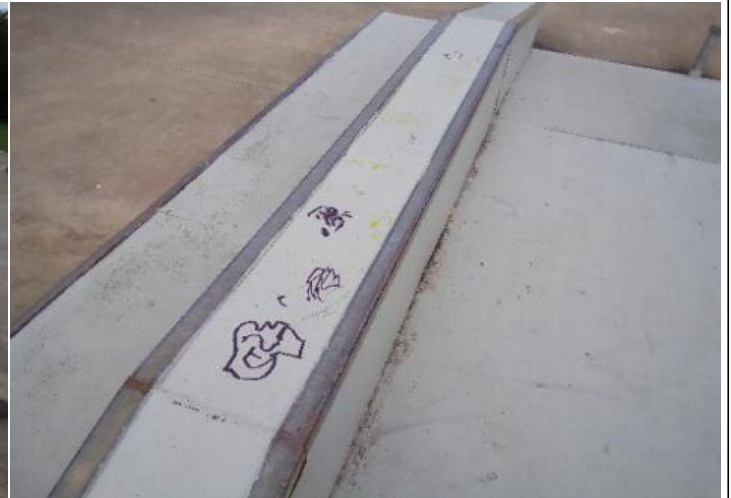
**Item:** Wheeled Sports - Fun Box  
**Manufacturer:** Not Identified

**Finding:** Graffiti present

**Action:** Removal required

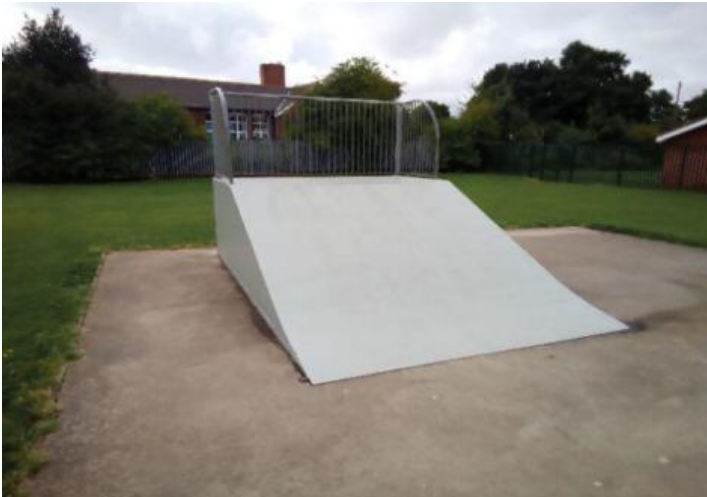
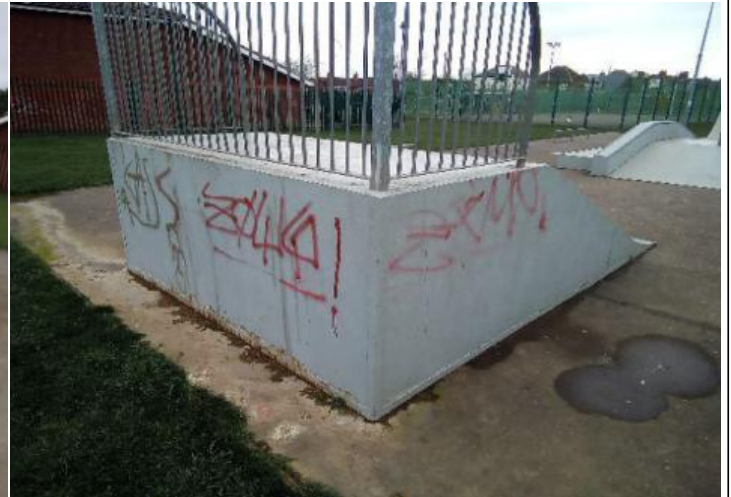
**Item:** Wheeled Sports - Flat Ramp  
**Manufacturer:** Not Identified

**Finding:** Graffiti present

**Action:** Removal required

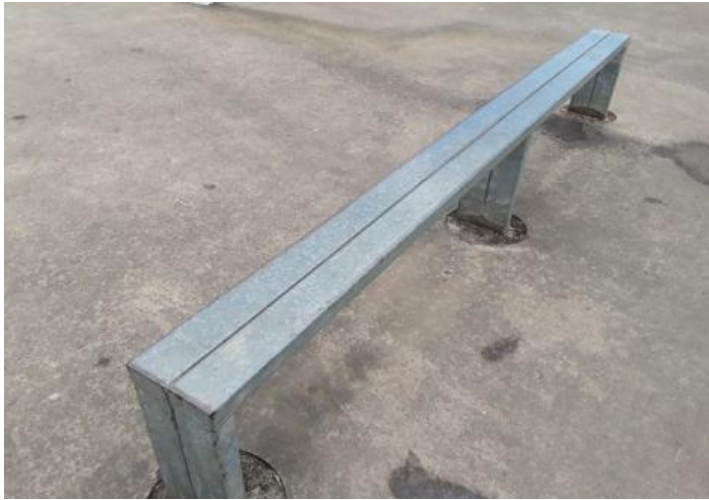
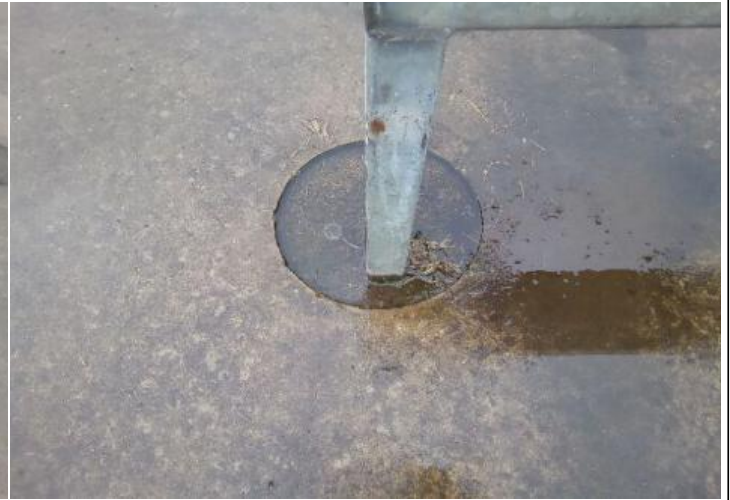
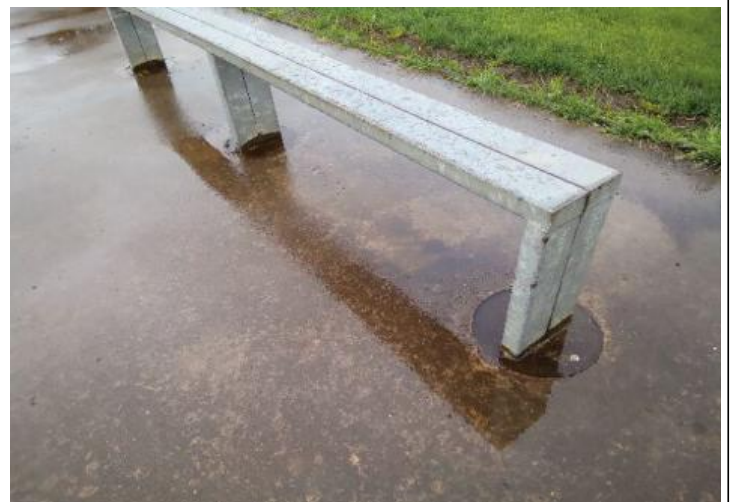
**Item:** Wheeled Sports - Grind Rail  
**Manufacturer:** Not Identified

**Finding:** Concrete edging low

**Action:** Repair required

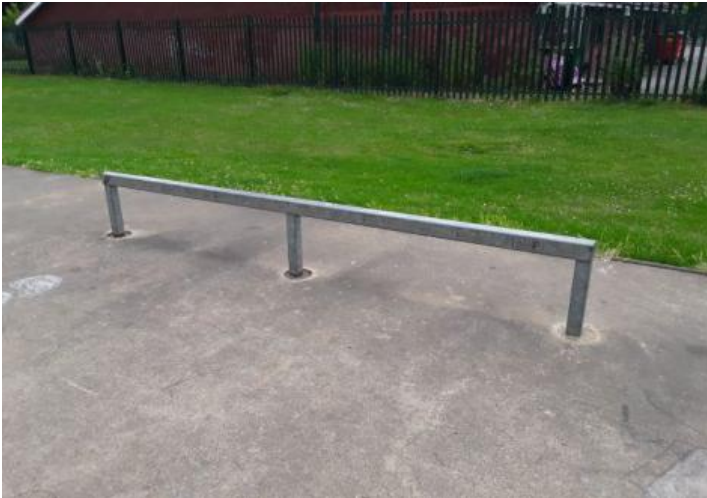
**Item:** Wheeled Sports - Grind Rail  
**Manufacturer:** Not Identified

**Finding:** Concrete edging low

**Action:** Repair required

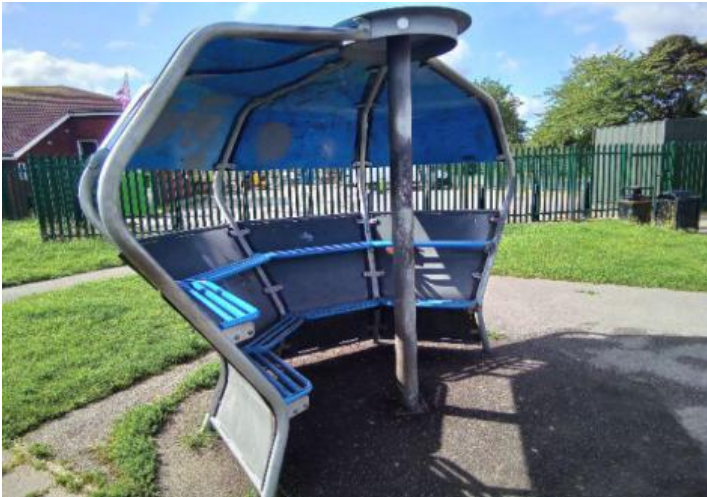
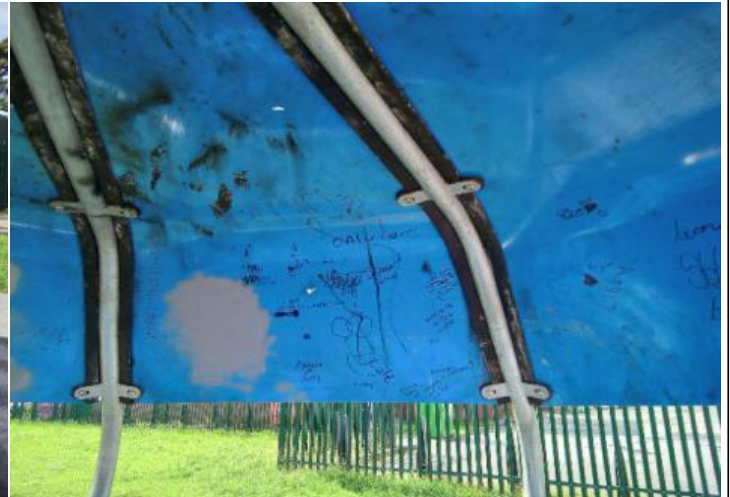
**Item:** Ancillary Items - Shelter  
**Manufacturer:** Owner/Operator

**Finding:** Graffiti present

**Action:** Removal required

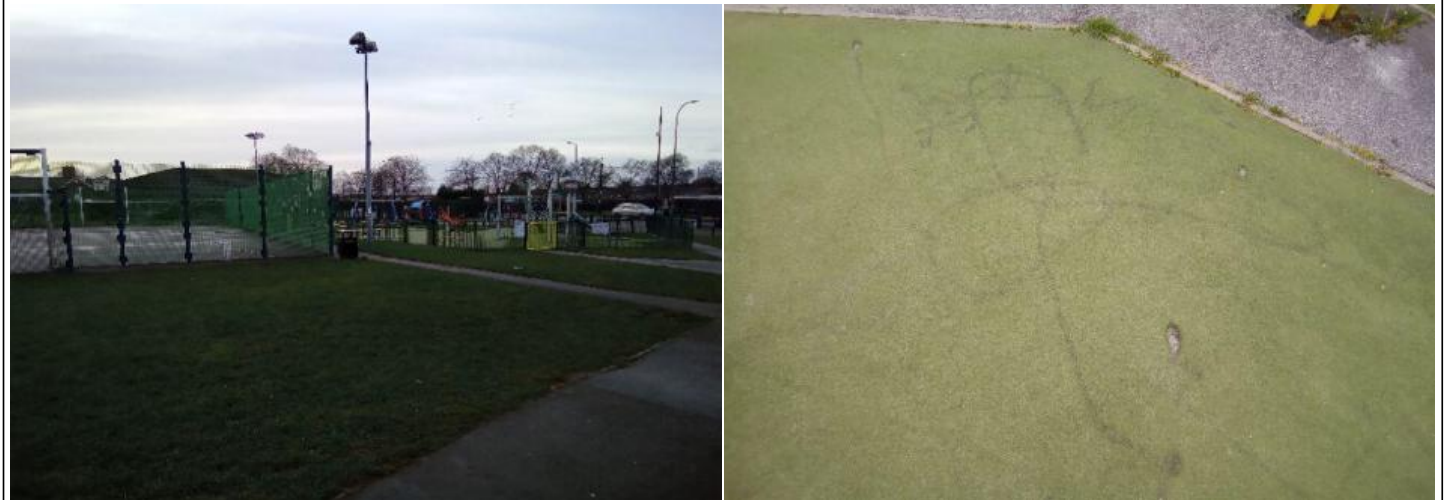
<b>Item:</b>	Ancillary Items - Site General	<b>Risk Level:</b>	V - Very Low Risk
<b>Manufacturer:</b>	Owner/Operator	<b>Surface:</b>	N/A

**Finding:** Several Burn marks on surface      **Action:** Monitor

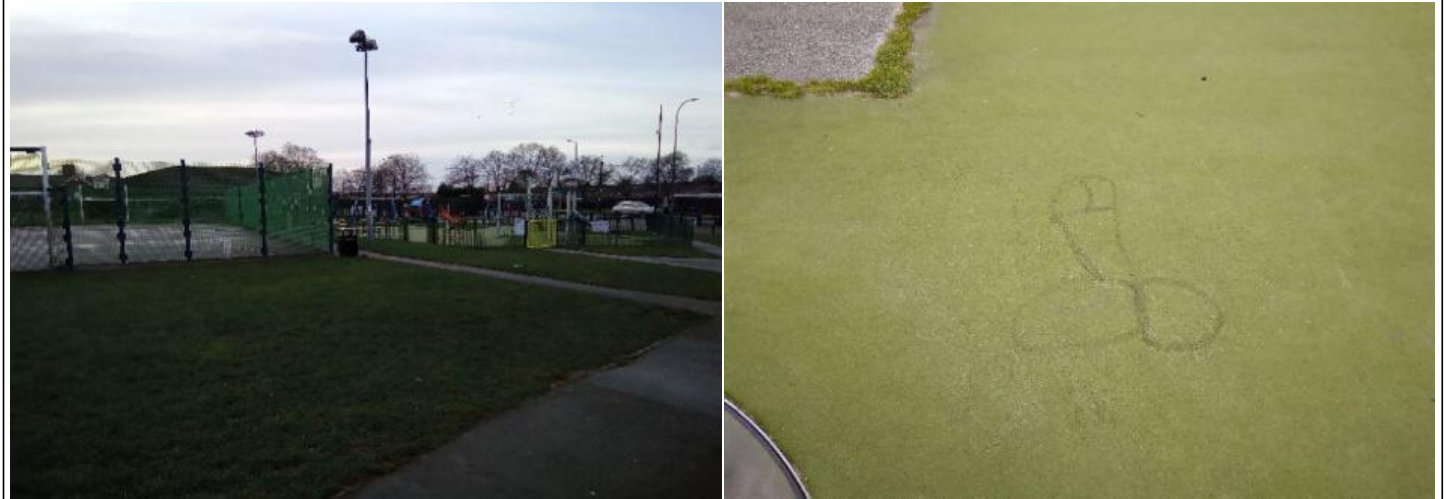
<b>Item:</b>	Ancillary Items - Site General	<b>Risk Level:</b>	N - Risk Assessment not Undertaken
<b>Manufacturer:</b>	Owner/Operator	<b>Surface:</b>	N/A

**Finding:** Graffiti on safety surface      **Action:** Removal required
