the **play** inspection company

Annual Inspection

Rotherham Metropolitan Borough Council

Green Arbour Road, Thurcroft, Rotherham, S66 9DD

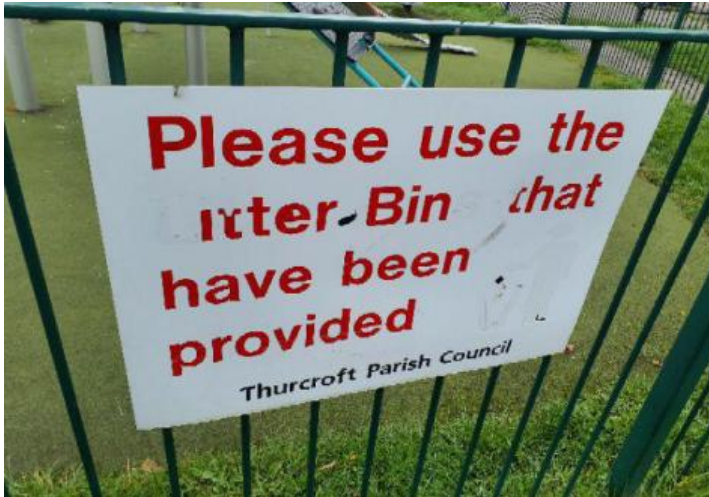
Finding: It is recommended that signage, with information including the site address, contact information for maintenance issues and emergency contact details are provided for the facility

Action: Provide in accordance with the recommendations

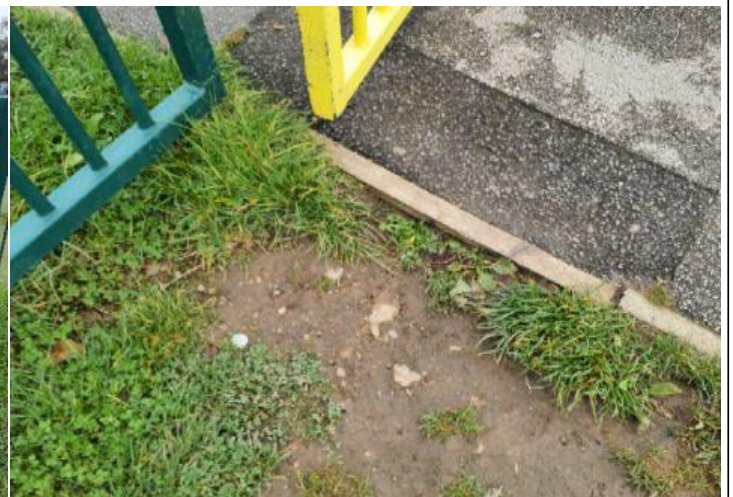
Finding: There are trip hazards present

Action: Reinstate surrounding surfaces to level to remove the trip points

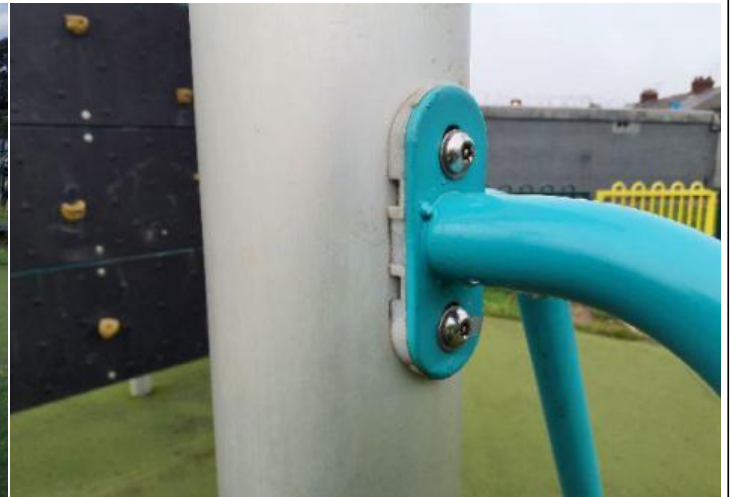
Finding: There is/are bolt cap covers missing or damaged on the item
Action: Replace missing or damaged bolt cap covers

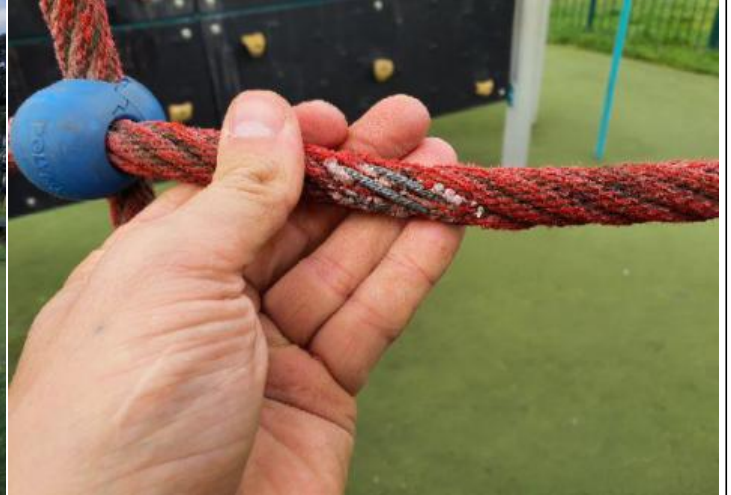
Finding: The ropes/nets are worn/damaged in places

Action: Monitor for any further deterioration and repair or replace as required

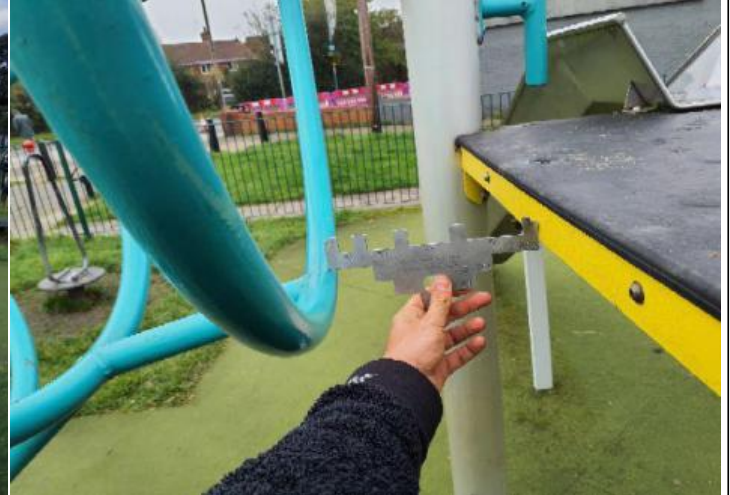
Finding: The item fails to meet the requirements of BS EN 1176 Part 1 4.2.7.2 for head and neck entrapment in the framework

Action: Monitor - No remedial work recommended

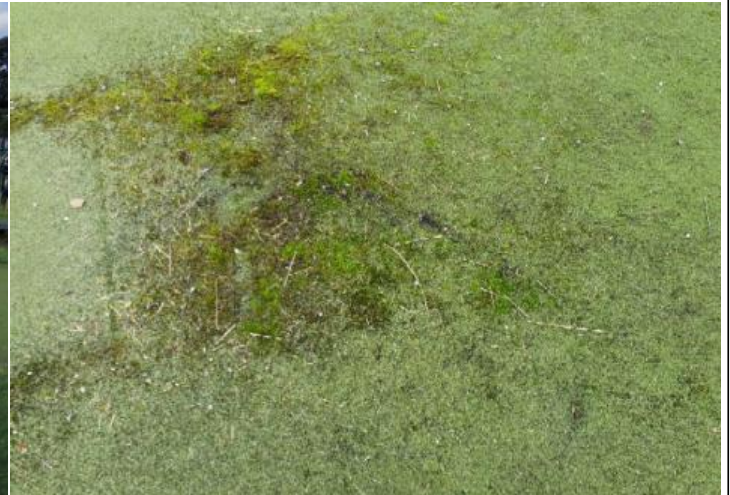
Finding: There is algae, silt or moss growth on the surface resulting in slippery conditions

Action: Clean and treat appropriately

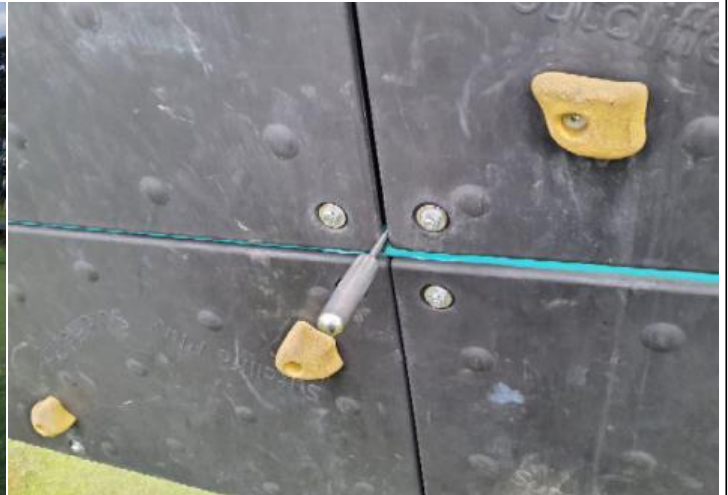
Finding: There is/are finger entrapment/s in the framework and the item fails to meet the requirements of BS EN 1176 Part 1 4.2.7.6 Entrapment of fingers

Action: Monitor - No remedial work recommended

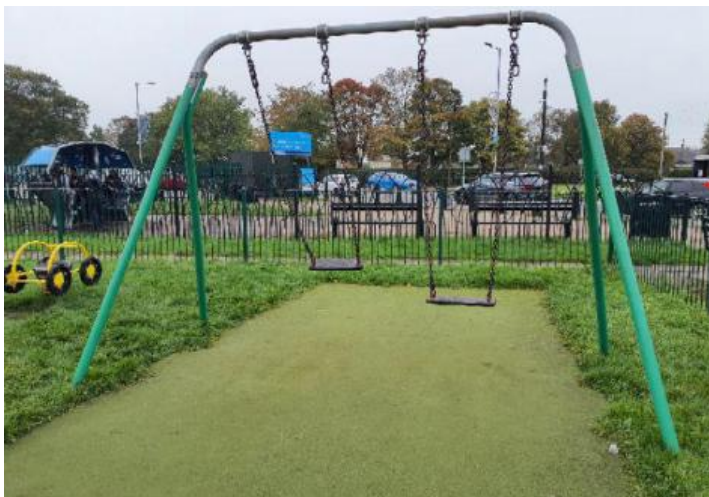
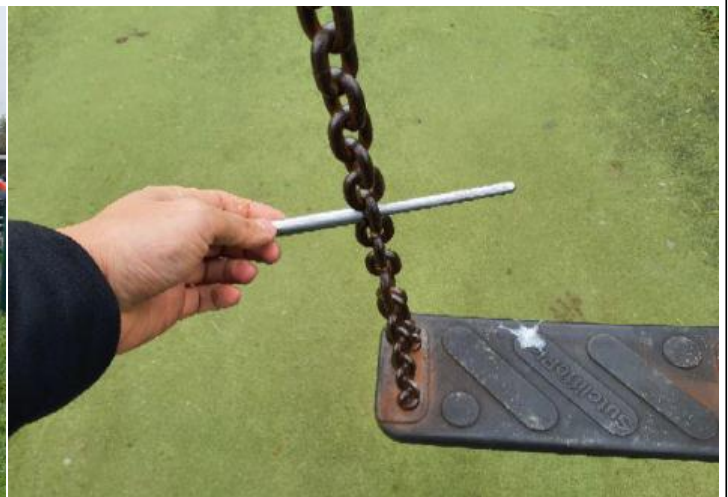
Finding: The chain openings are in excess of the 8.6mm as recommended by BS EN 1176

Action: Monitor - No remedial work recommended

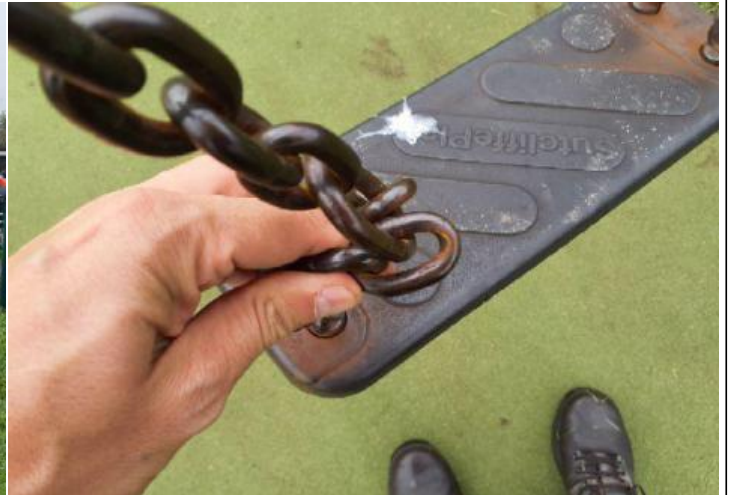
Finding: There is some notable evidence of chain wear

Action: Monitor for any further deterioration and replace when 40% worn

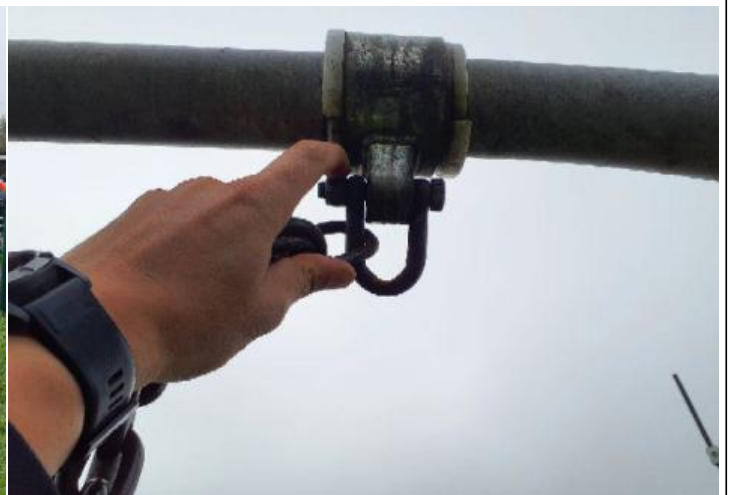
Finding: There is some wear to the shackles.

Action: Monitor for any further deterioration and replace when 40% worn

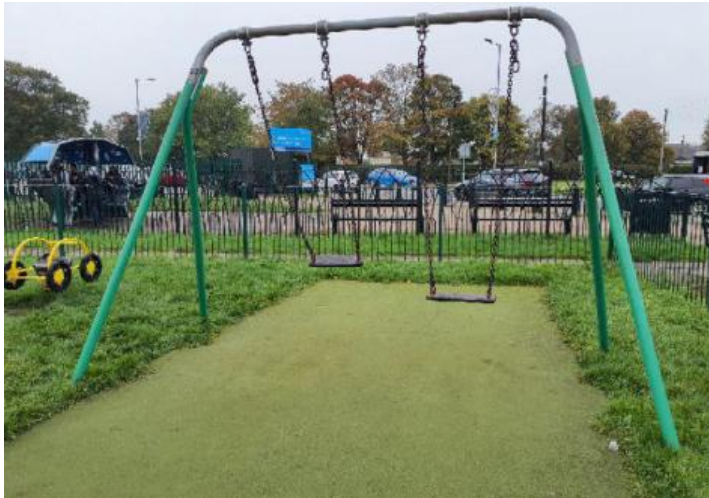
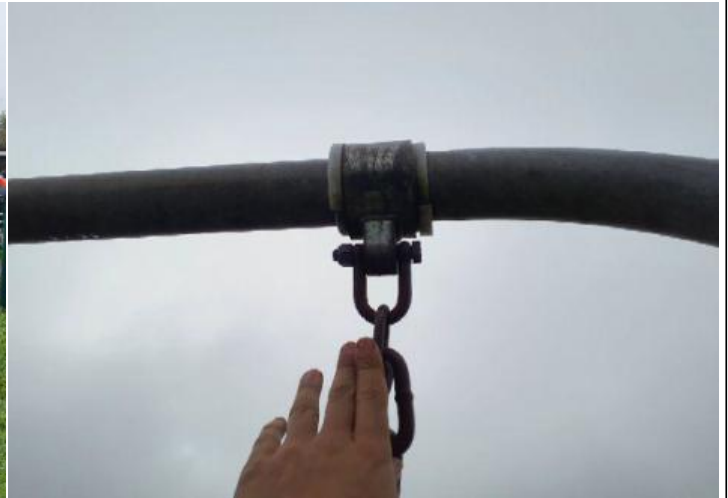
Finding: The bushes are showing signs of wear

Action: Monitor for any further deterioration and replace as required

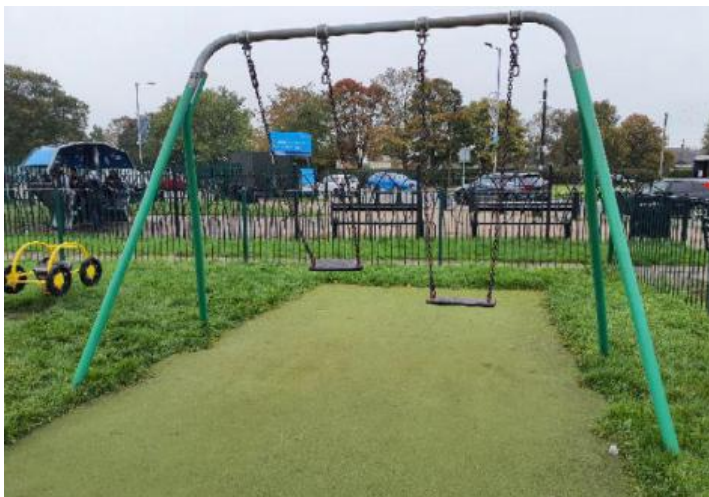
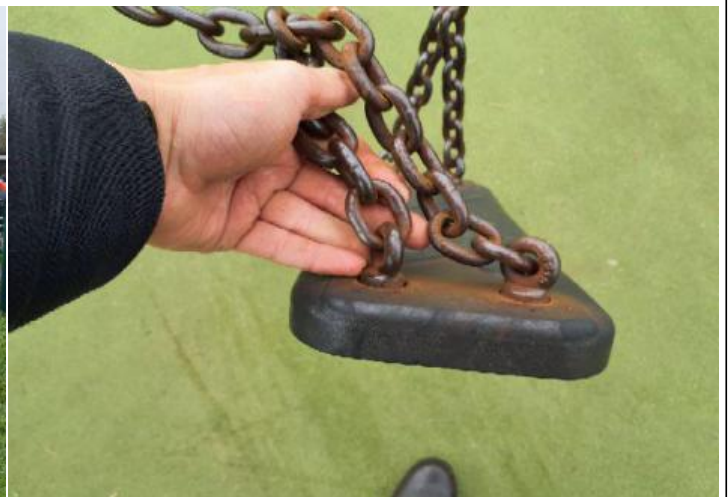
Finding: The swing seat connectors are loose

Action: Tighten to secure

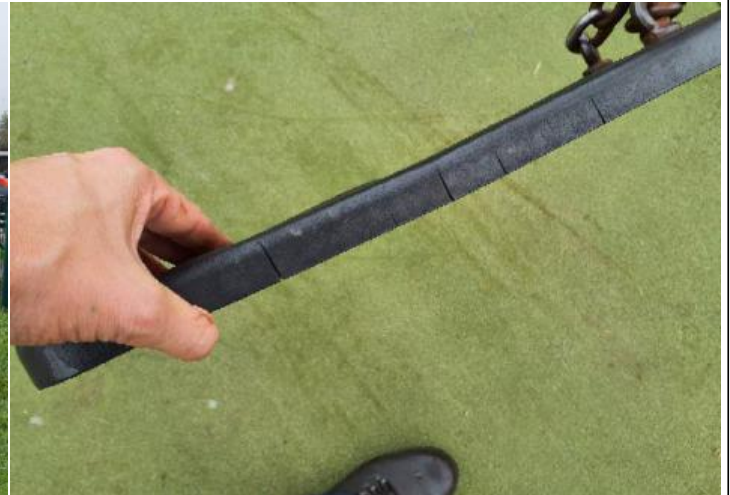
Finding: The seat has minor damage or wear

Action: Monitor for any further deterioration and replace as required

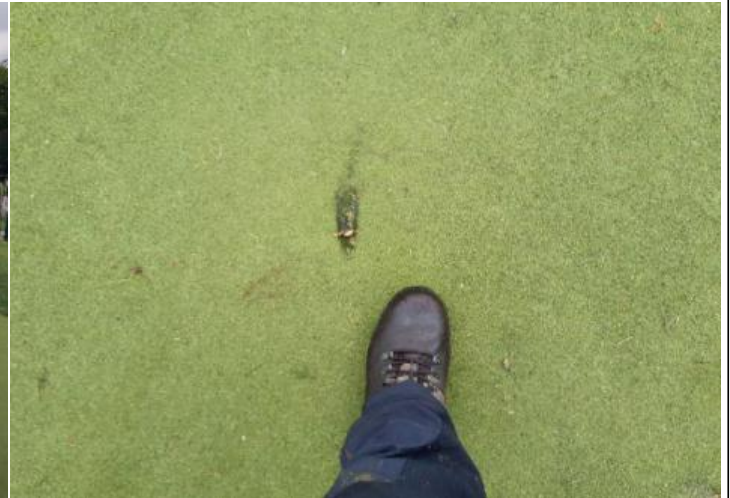
Finding: There is some minor damage to the surface

Action: Monitor for any further deterioration and repair as required

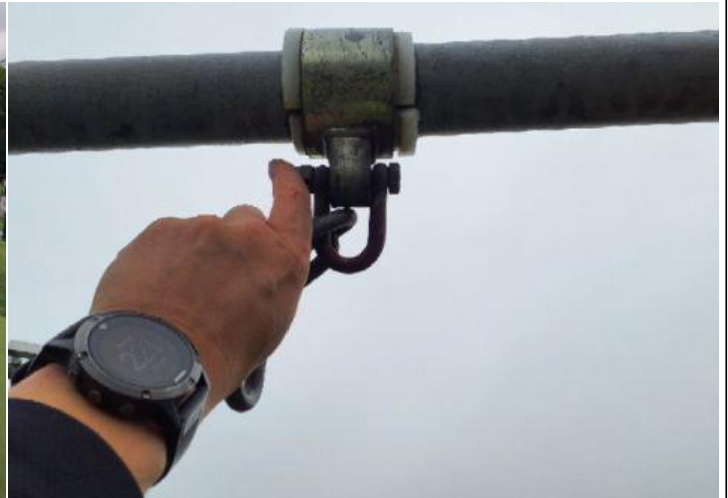
Finding: There is some wear to the shackles.

Action: Monitor for any further deterioration and replace when 40% worn

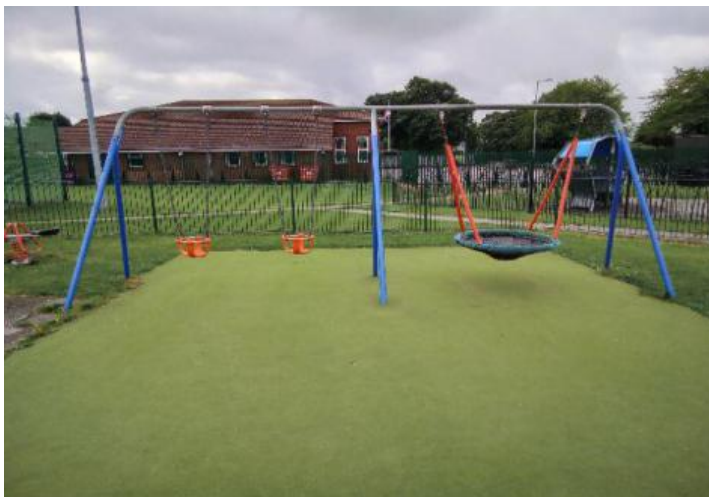
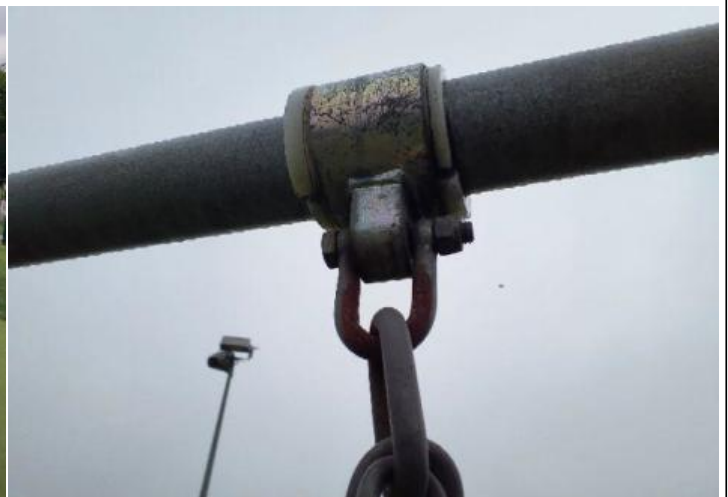
Finding: The bushes are showing signs of wear

Action: Monitor for any further deterioration and replace as required

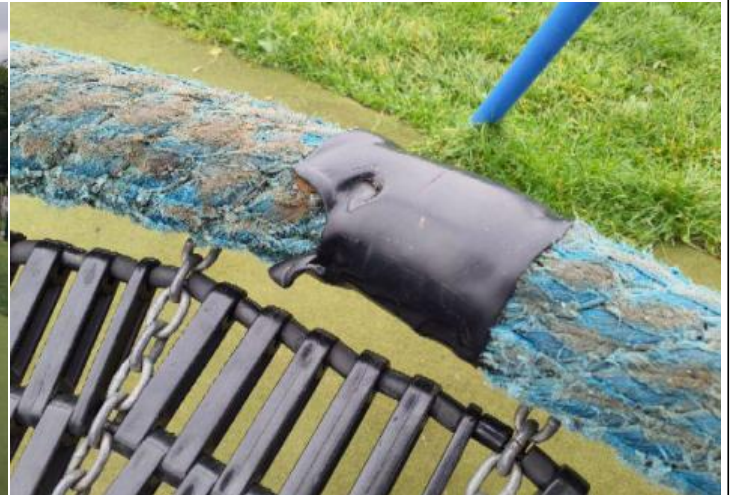
Finding: The seat has minor damage or wear

Action: Monitor for any further deterioration and replace as required

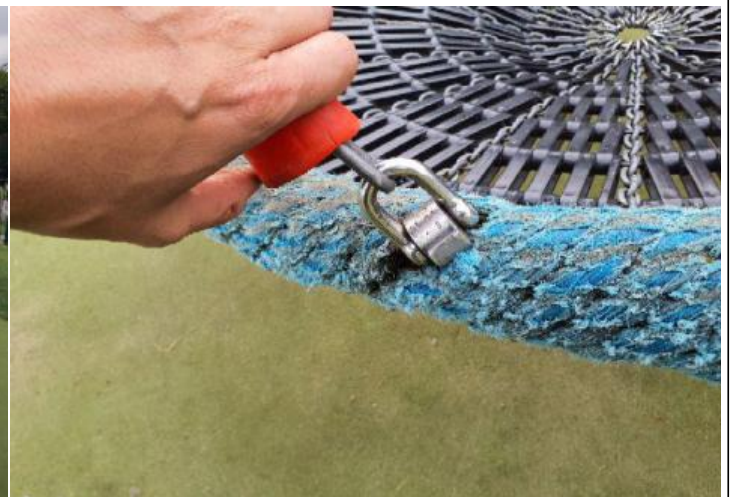
Finding: The bushes are worn or missing

Action: Replace worn or missing bushes

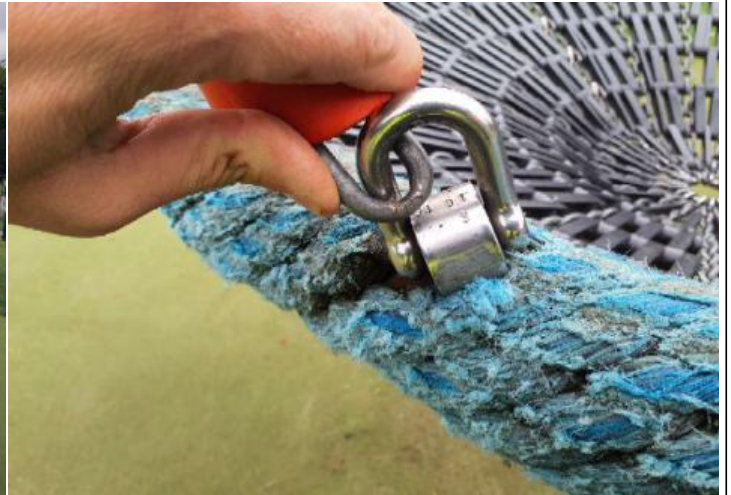
Finding: There is some notable evidence of chain wear

Action: Monitor for any further deterioration and replace when 40% worn

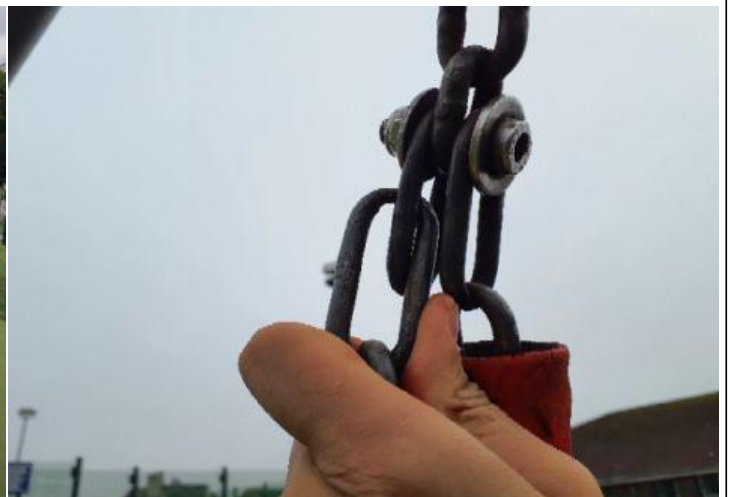
Finding: The chain links are worn in excess of 40% and require renewing

Action: Replace worn chains

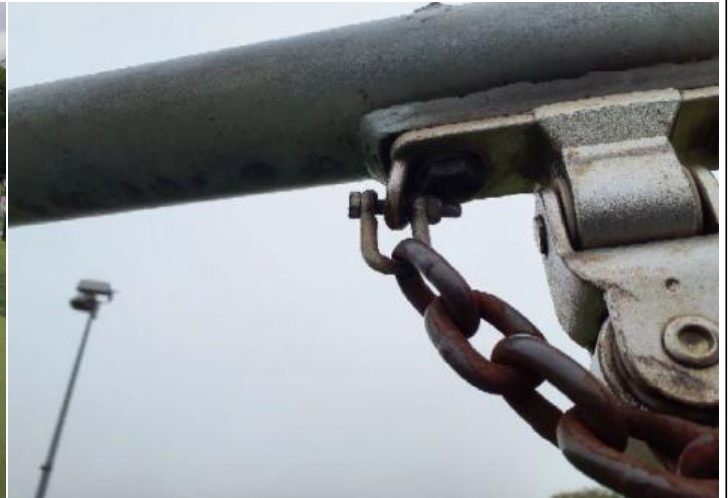
Finding: There is some wear to the shackles.

Action: Monitor for any further deterioration and replace when 40% worn

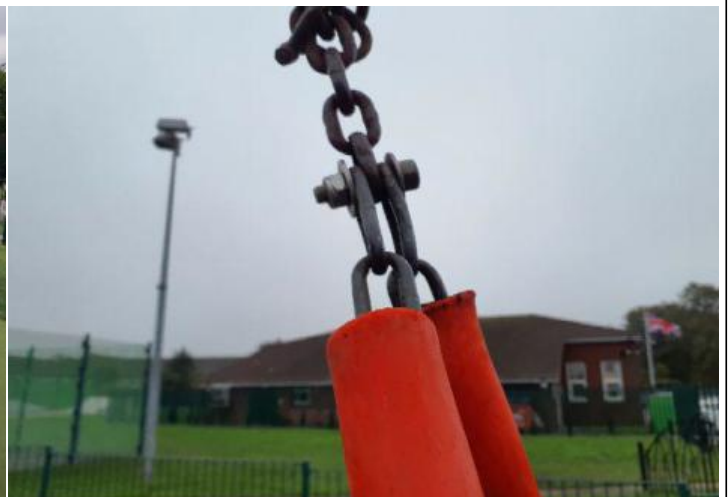
Finding: Chain links are slightly bent

Action: Monitor for any further deterioration and replace as required

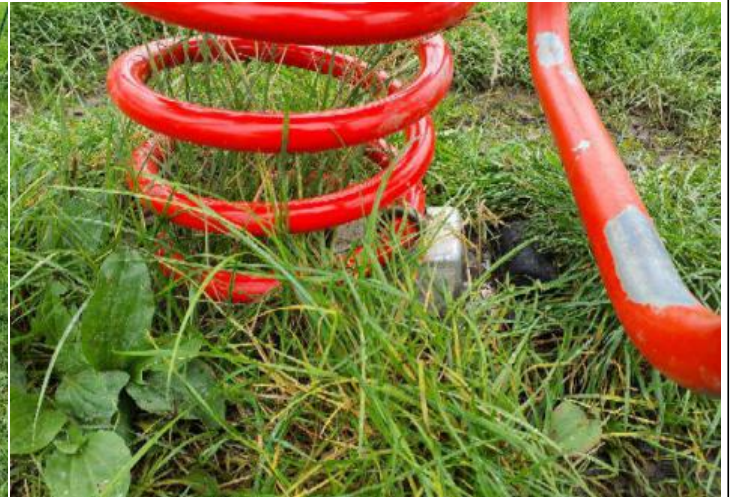
Finding: The spring clamps are loose

Action: Tighten all loose fixings

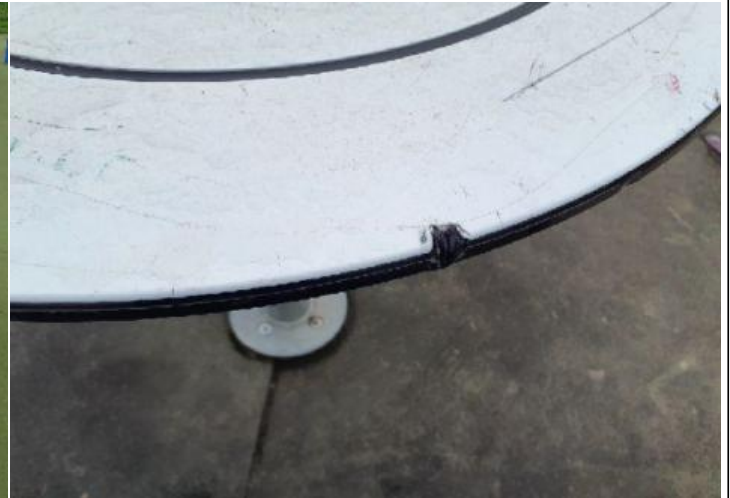
Finding: The item has been damaged

Action: Monitor for any further deterioration and replace as required

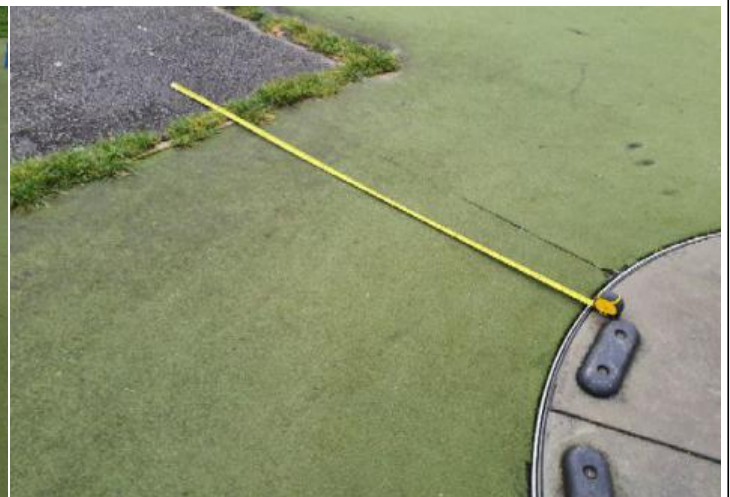
Finding: The surfacing dimensions are short and do not meet with the requirements of the current applicable standard

Action: Monitor - no remedial action recommended

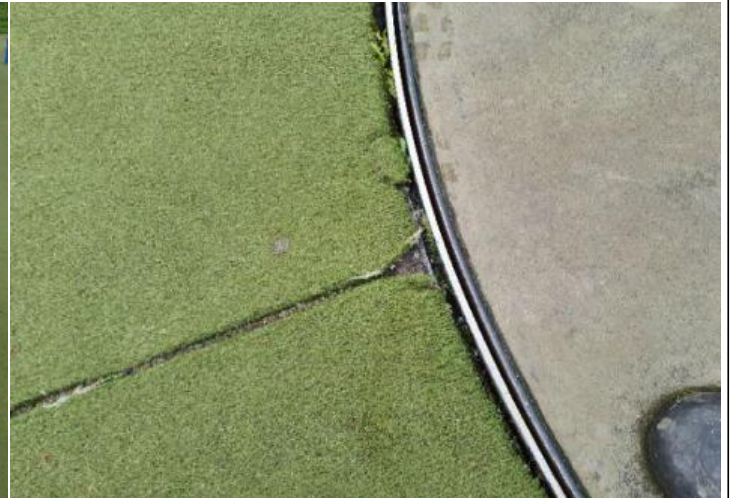
Finding: There is some minor damage to the surface
Action: Monitor for any further deterioration and repair as required

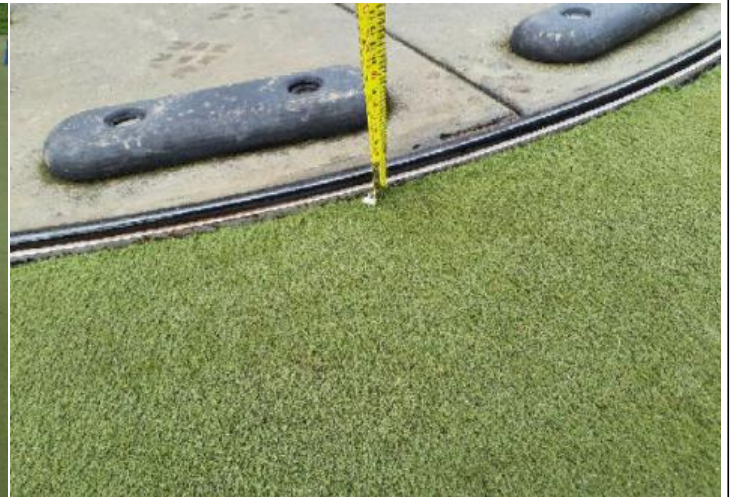
Finding: There is a vertical displacement between the top surface of the platform and the ground in excess of 20mm and fails the requirements of BS EN 1176 Part 5
Action: Monitor - No remedial work recommended

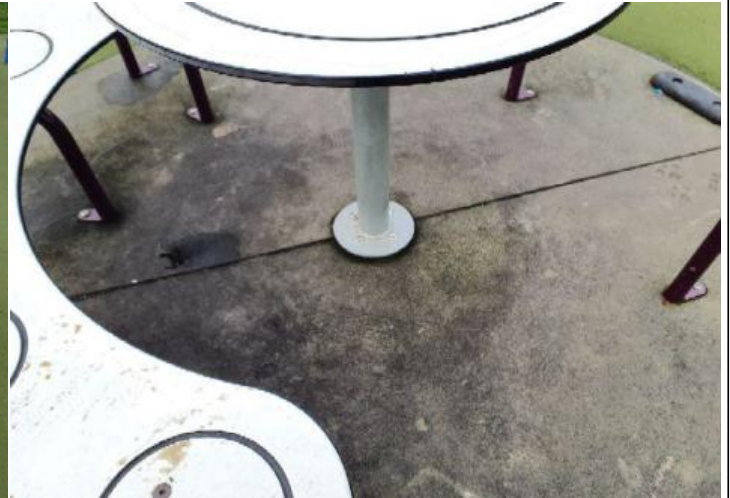
Finding: The bearing is worn / damaged and the item is not operating correctly
Action: Repair / replace

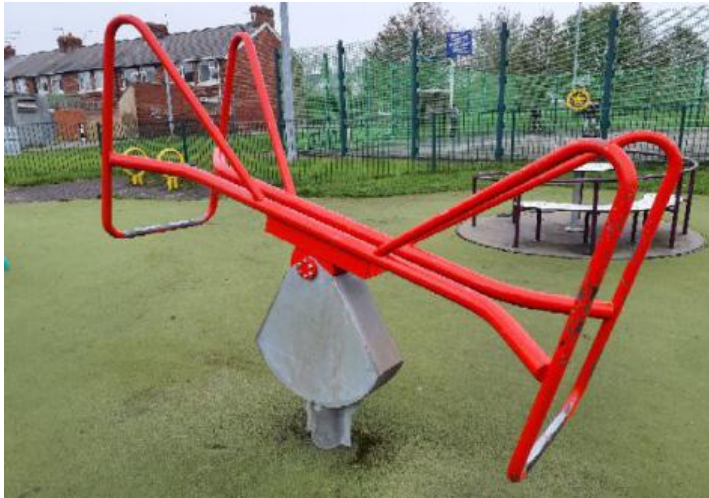
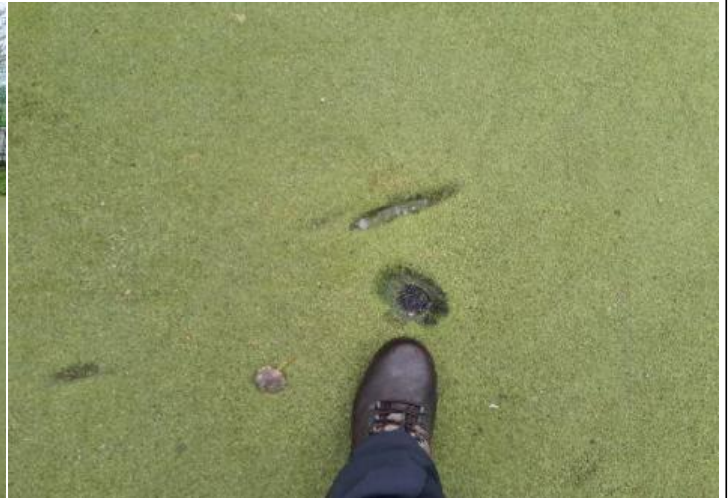
Finding: There is some minor damage to the surface

Action: Monitor for any further deterioration and repair as required

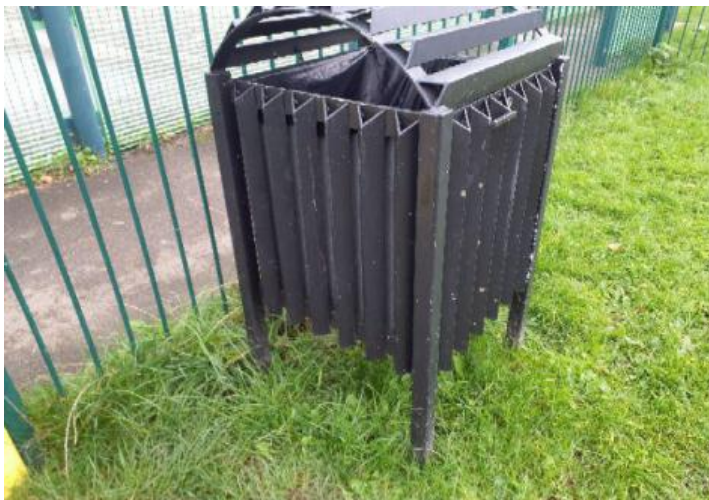
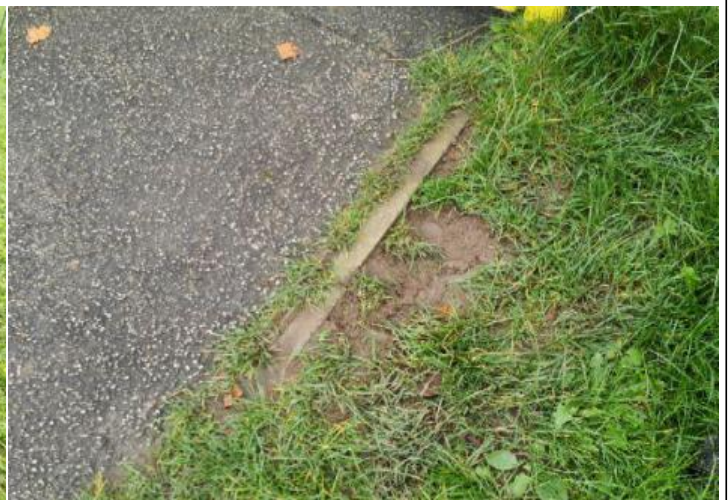
Finding: There are trip hazards present

Action: Reinstate surrounding surfaces to level to remove the trip points

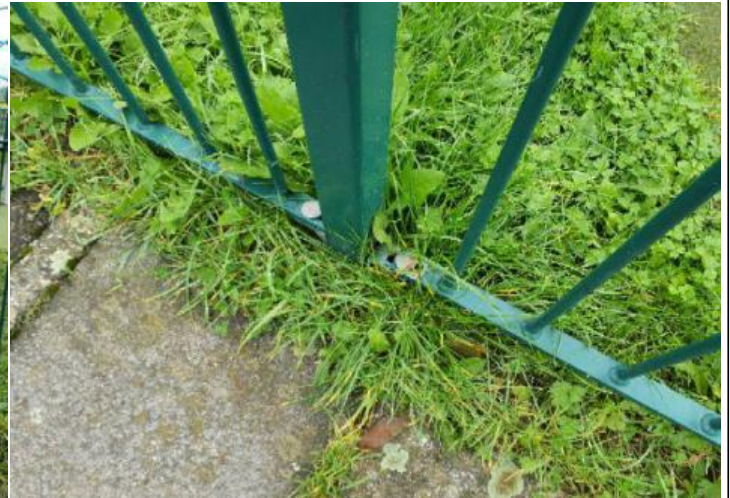
Finding: A number of fixings have worked loose around the fencing
Action: Secure all loose fixings

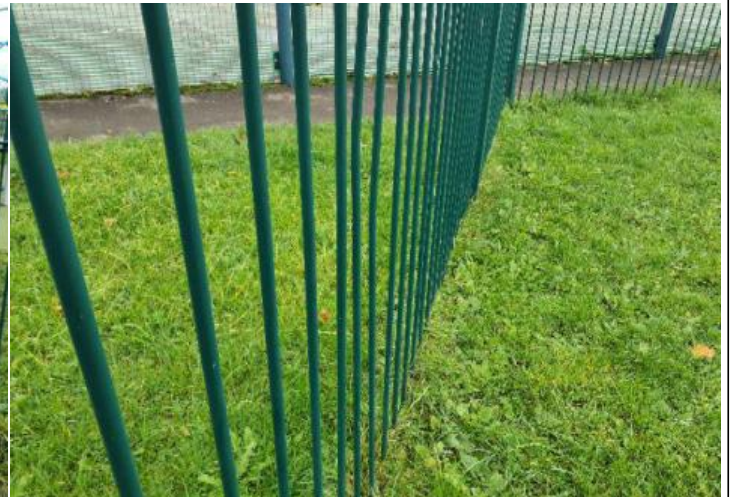
Finding: There is some damage to the fence sections
Action: Monitor for any further deterioration and repair as required

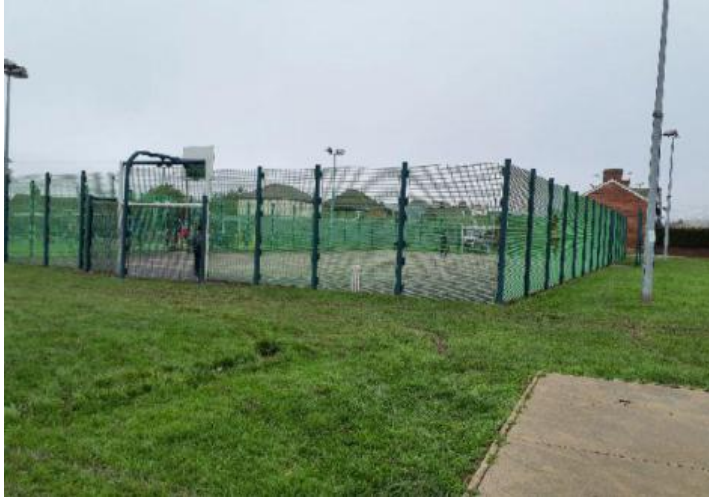
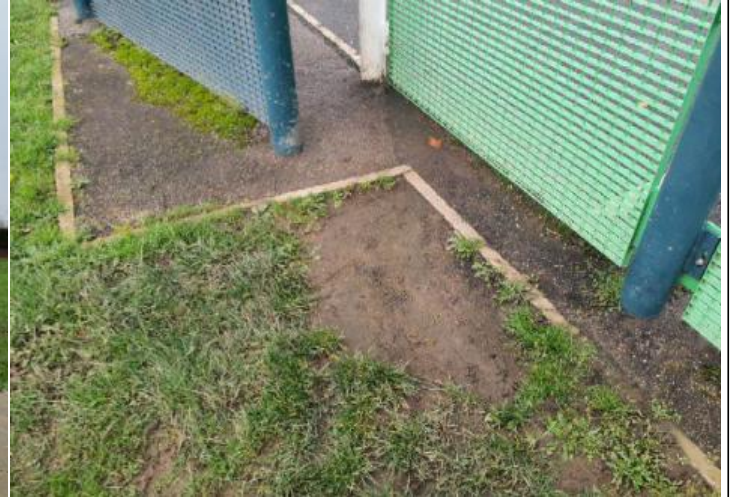
Finding: There are trip hazards present

Action: Reinstate surrounding surfaces to level to remove the trip points

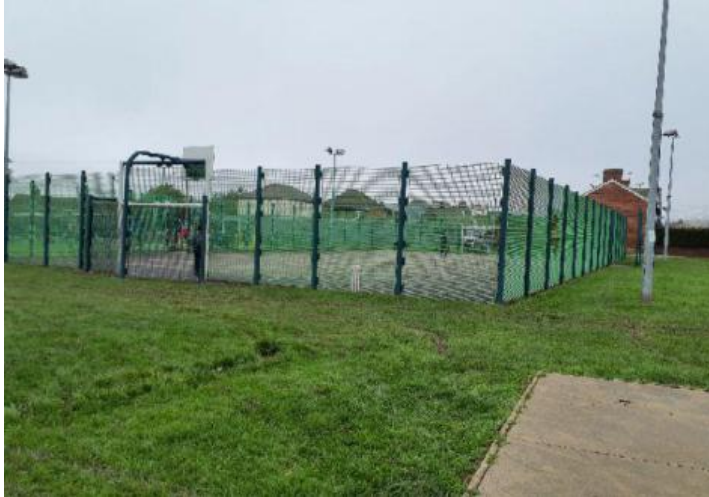
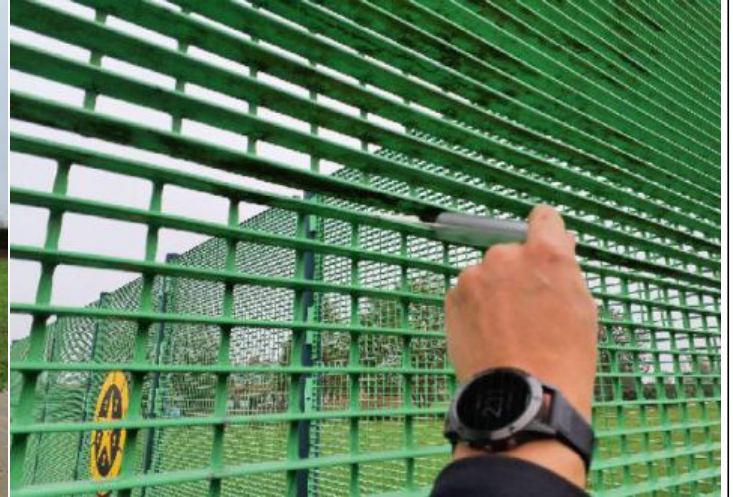
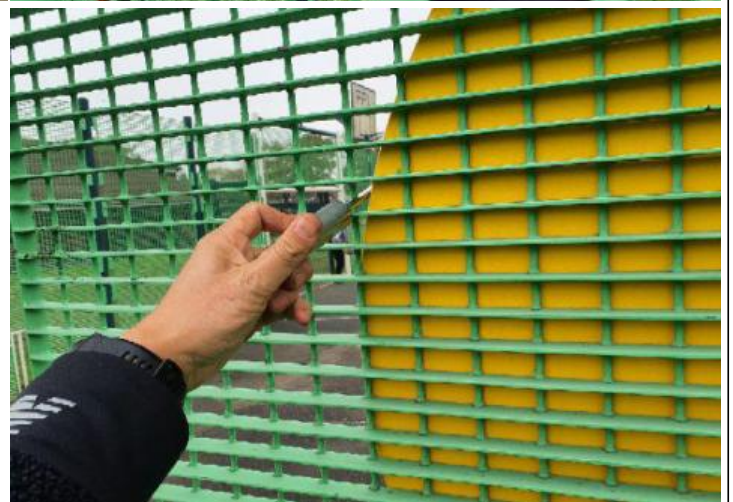
Finding: There is/are finger entrapments in the framework and the item fails to meet the requirements of BS EN 15312 Clause 4.4.2.2 Entrapment of fingers

Action: Monitor - No remedial work recommended

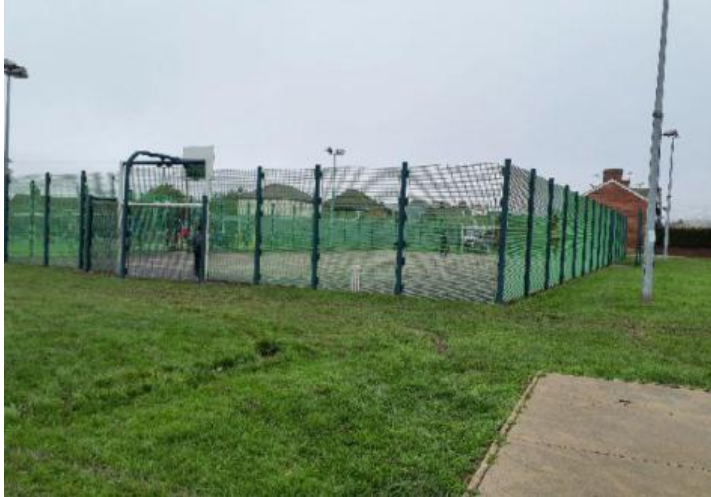
Finding: A clearly visible facility sign should be provided in a prominent position with the wording as detailed BS EN 15312- the equipment is not intended for children less than 3 years old- the warning - Do not climb on the framework or nets- the warning - Do not hang on the ring (if provided)- the warning - Do not wear rings or other jewellery- name and telephone number of the administrator- number to call in case of accident

Action: Provide signage to BS EN 15312

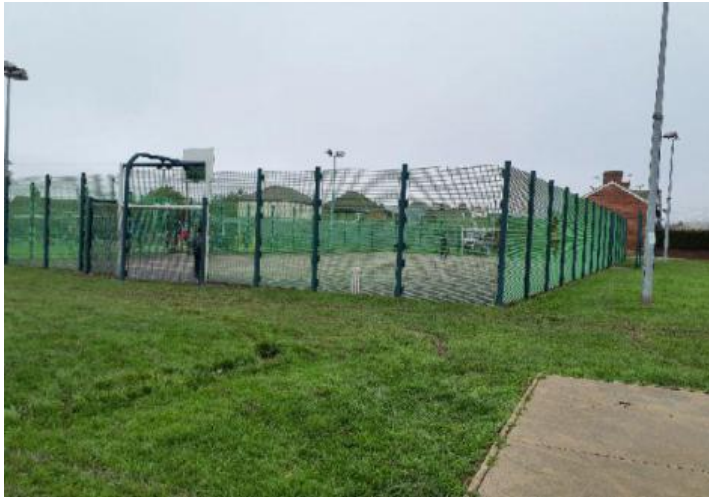
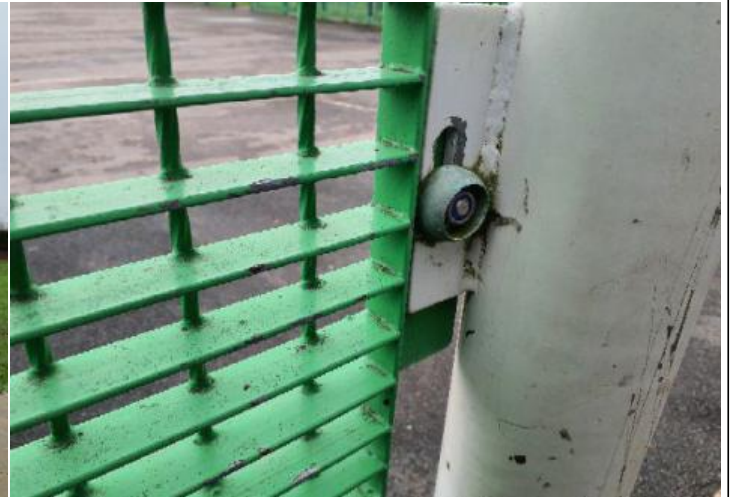
Finding: There is/are bolt cap covers missing or damaged on the item

Action: Replace missing or damaged bolt cap covers

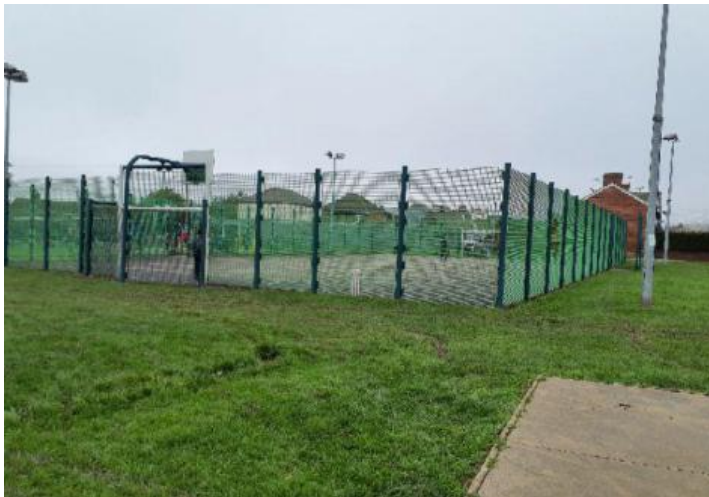
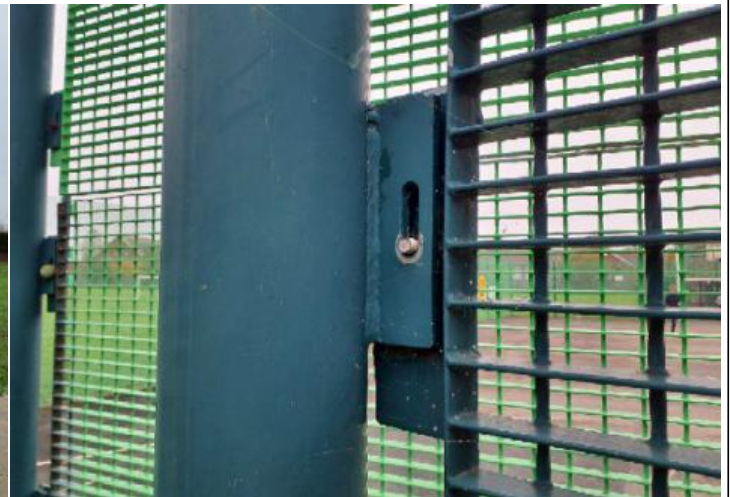
Finding: There is or are fixings missing on the item

Action: Replace all missing fixings

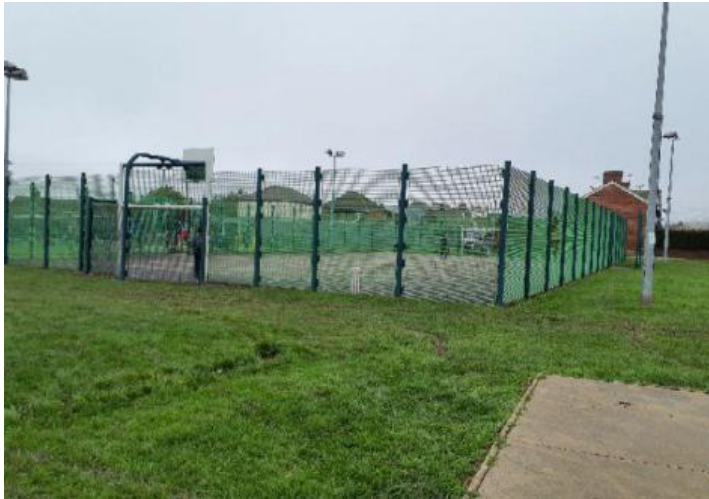
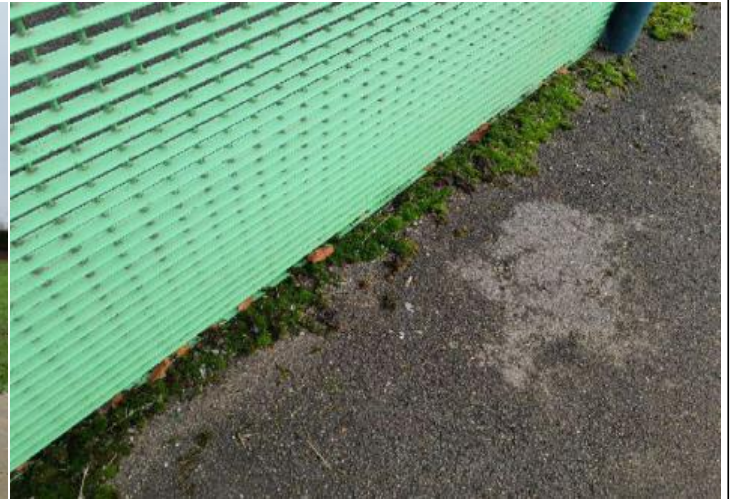
Finding: There is algae, silt or moss growth on the surface resulting in slippery conditions
Action: Clean and treat appropriately

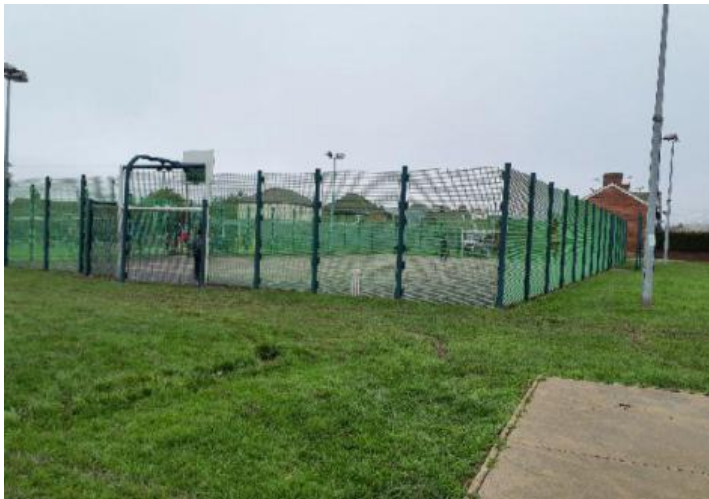
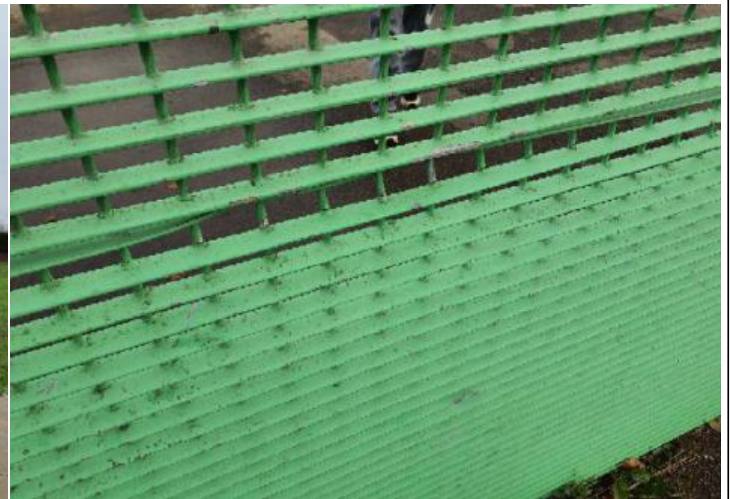
Finding: There is some damage to the fence sections
Action: Monitor for any further deterioration and repair as required

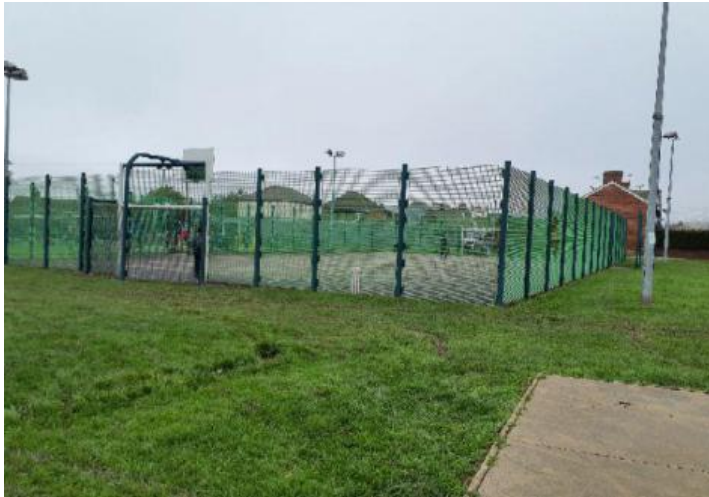
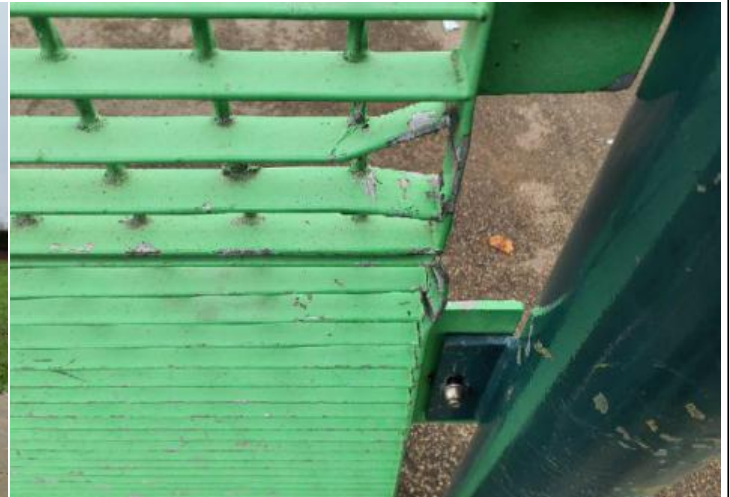
Finding: The weld(s) on this item have failed

Action: Repair item

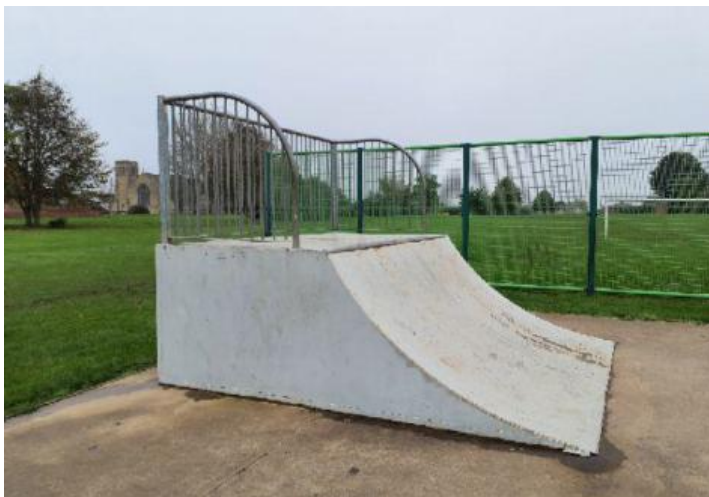
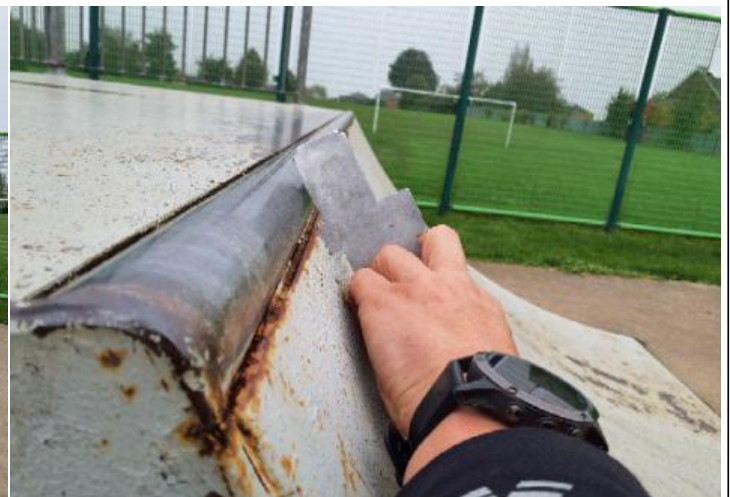
Finding: The coping projects less than 5mm and fails the requirements of BS EN 14974

Action: Monitor - No remedial work recommended

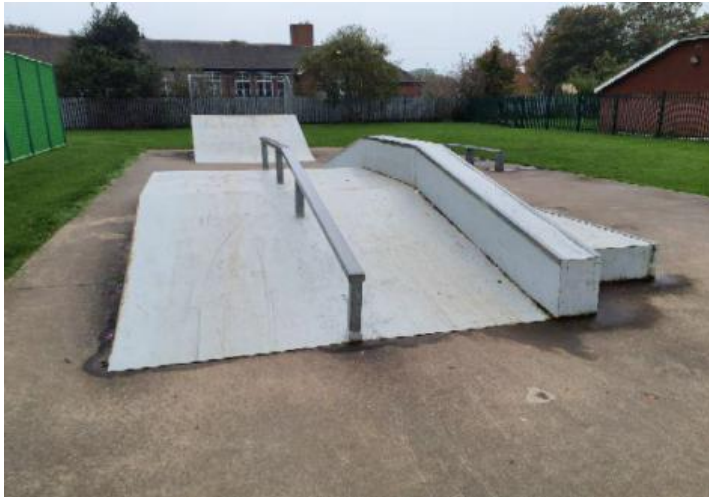
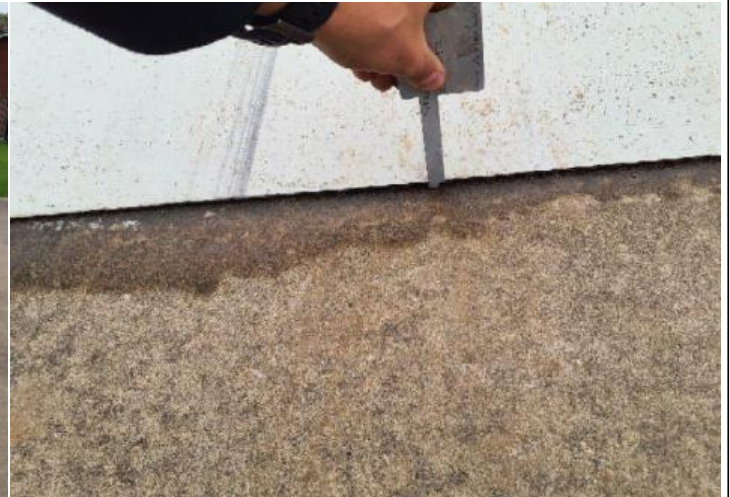
Finding: The kicker plate protrudes more than 5mm above the surrounding surface level, BS EN 14974 recommends a maximum of 5mm with 3mm preferred

Action: Adjust height to ensure a maximum of 5mm change in level

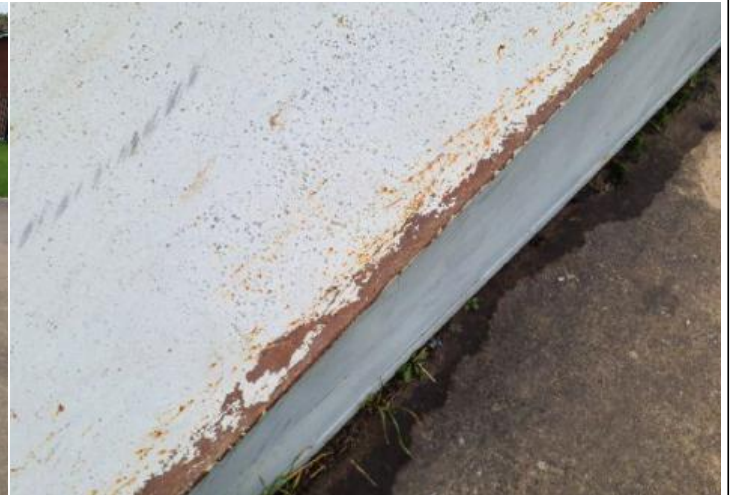
Finding: The paintwork on this item has been damaged or worn exposing the metal underneath which is rusting / corroding

Action: Treat affected areas and repaint
