the **play** inspection company

Annual Inspection

Rotherham Metropolitan Borough Council

Green Arbour Road, Thurcroft, Rotherham, S66 9DD

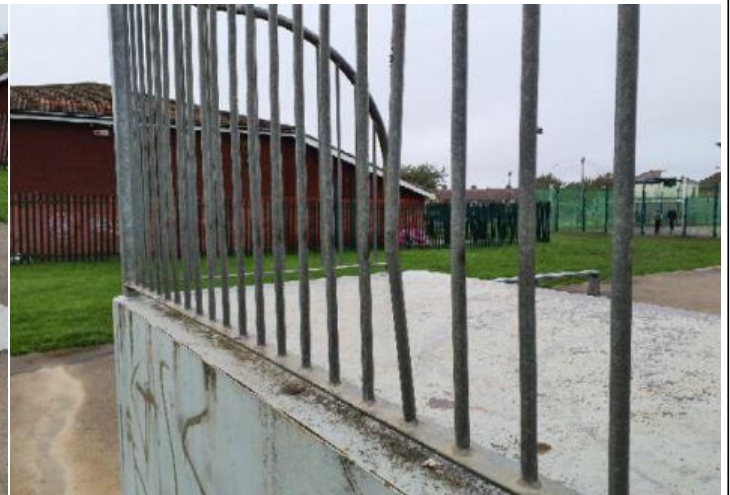
Finding: There is some damage to the barrier sections

Action: Monitor for any further deterioration and repair as required

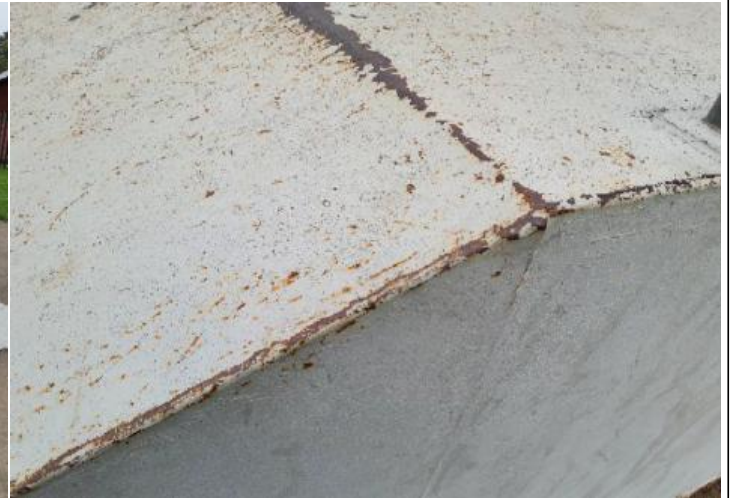
Finding: The paintwork on this item has been damaged or worn exposing the metal underneath which is rusting / corroding

Action: Treat affected areas and repaint

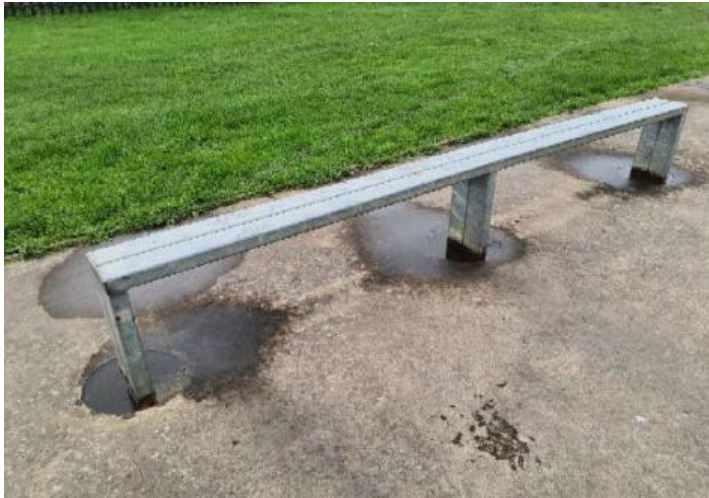
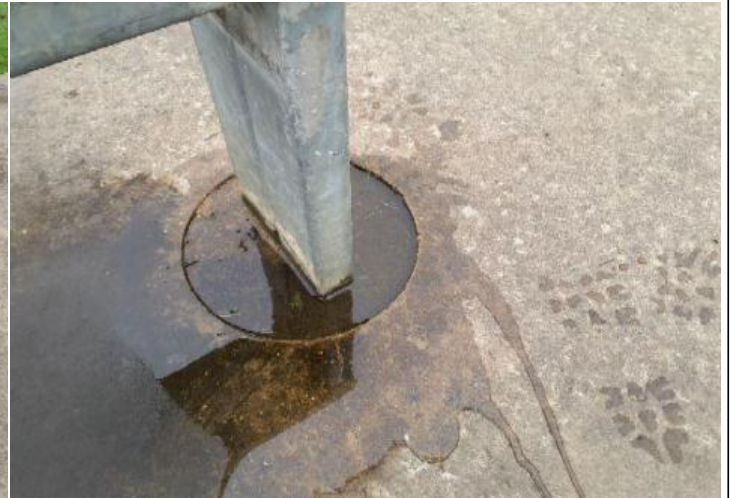
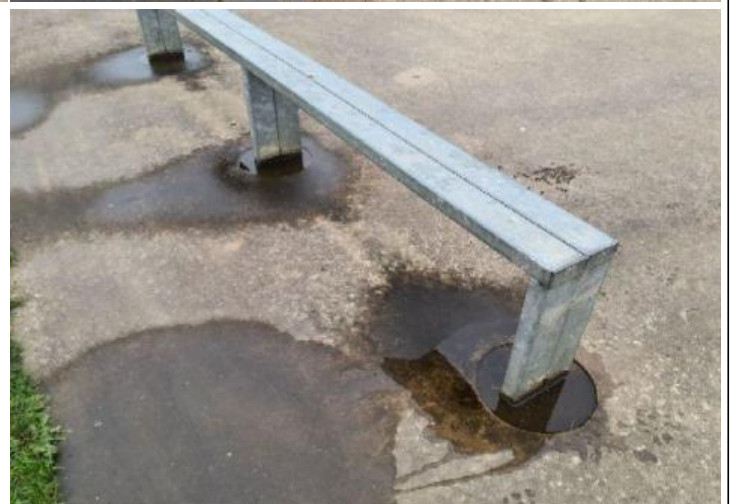
Finding: There is a change in the level of the rolling surface in excess of 3mm and the item fails the requirements of BS EN 14974 Clause 5.1.2.3
Action: Infill and remove the change in level

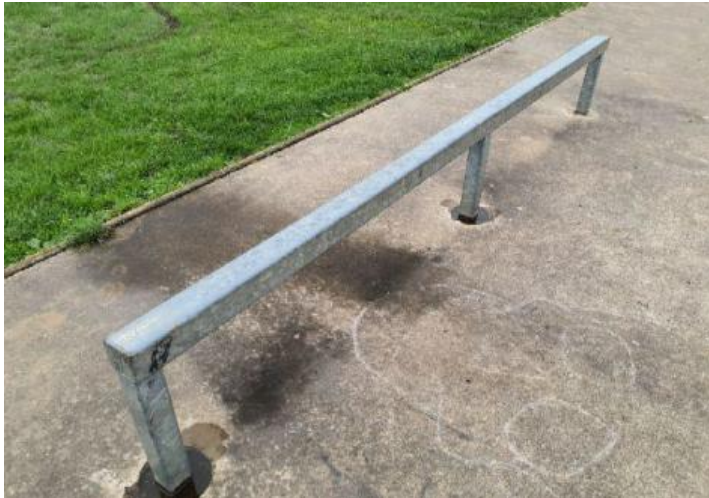
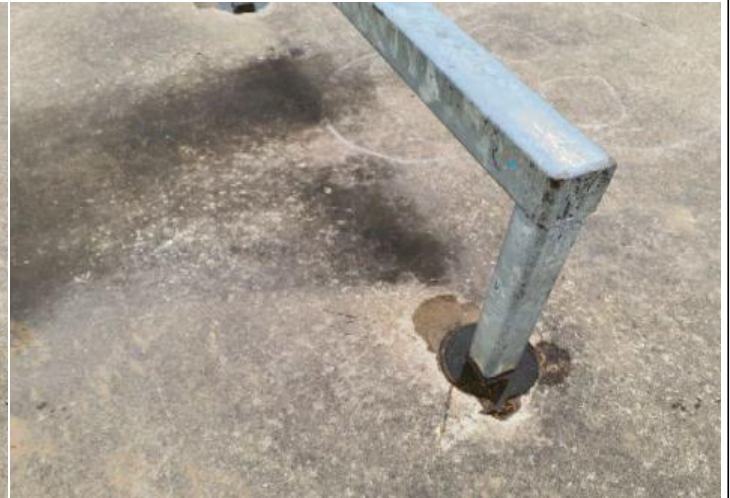
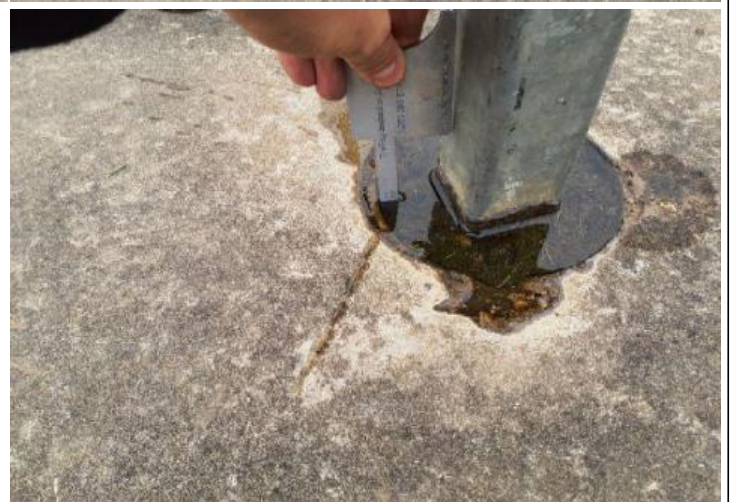
Finding: There is a change in the level of the rolling surface in excess of 3mm and the item fails the requirements of BS EN 14974 Clause 5.1.2.3
Action: Reinstate the surfacing to remove the change in level
