Hangmans Lane

Inspection Ref: 1720584

Site Ref: 18404

Operational Inspection - 25-July-2022 - 09:15 Inspector Terry Hill

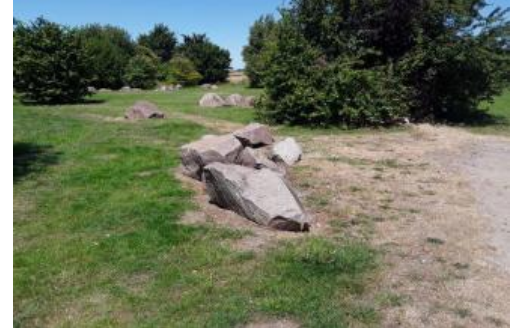
Item: Boulders
Manufacturer: Natural Feature
Surface Type: Grass
Item Quantity: 1
Equipment Compliance: N/A
Surface Area Compliance: N/A

This item is satisfactory - no work required -

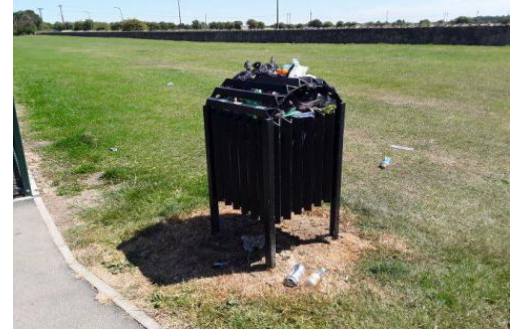
Item: Litter Bin
Manufacturer: Streetmaster
Surface Type: Grass
Item Part Number: Cardiff
Item Quantity: 1
Equipment Compliance: N/A
Surface Area Compliance: N/A
Total Findings: 1

Bin full - Emptying required

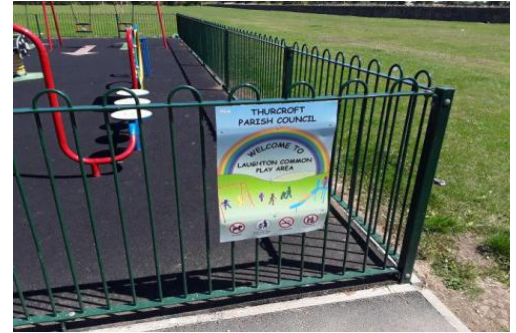
Item: Sign
Manufacturer: Owner/Operator
Surface Type: N/A
Item Quantity: 1
Equipment Compliance: N/A
Surface Area Compliance: N/A

Slight damage - Monitor

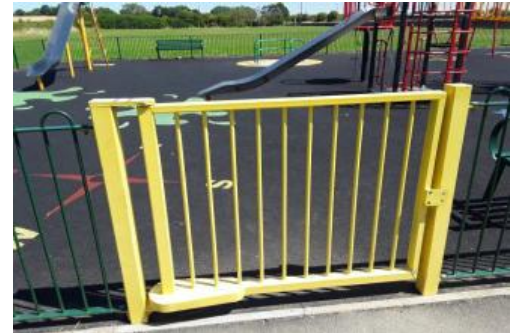
Item: Gate - Self Closing
Manufacturer: Play & Leisure Ltd
Surface Type: Wet Pour
Item Quantity: 2
Equipment Compliance: N/A
Surface Area Compliance: N/A

This item is satisfactory - no work required -

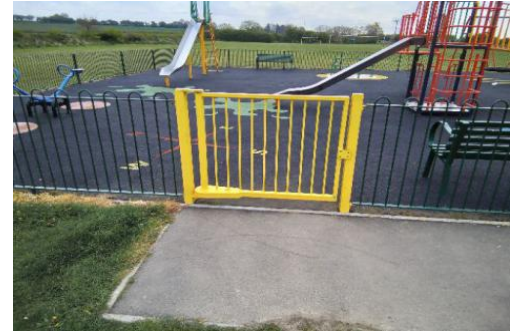
Item: Gate - Pedestrian
Manufacturer: A & E Group Ltd
Surface Type: Wet Pour
Item Quantity: 1
Equipment Compliance: N/A
Surface Area Compliance: N/A

Item satisfactory - No work required

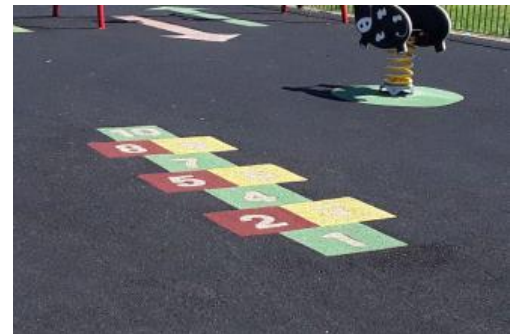
Item: Hopscotch
Manufacturer: Play & Leisure Ltd
Surface Type: Wet Pour
Item Quantity: 1
Equipment Compliance: N/A
Surface Area Compliance: N/A

This item is satisfactory - no work required -

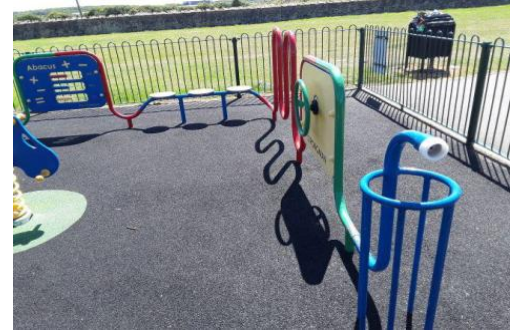
Item: Interactive Play
Manufacturer: Play & Leisure Ltd
Surface Type: Wet Pour
Item Quantity: 1
Equipment Compliance: No
Surface Area Compliance: Yes

Paint chipped - Monitor

Both End fittings missing - Replacement required

Unsure if bolt missing ? - Research required

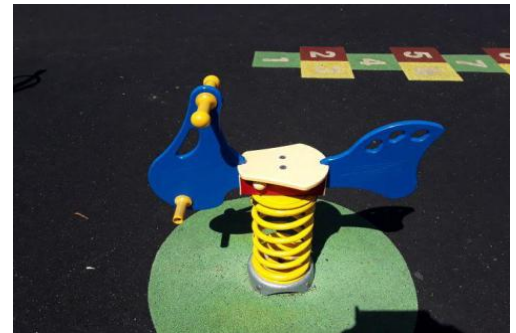
Item: Misc Springer
Manufacturer: Fahr Industries
Surface Type: Wet Pour
Item Quantity: 1
Equipment Compliance: No
Surface Area Compliance: Yes

Stopper missing - New stopper required

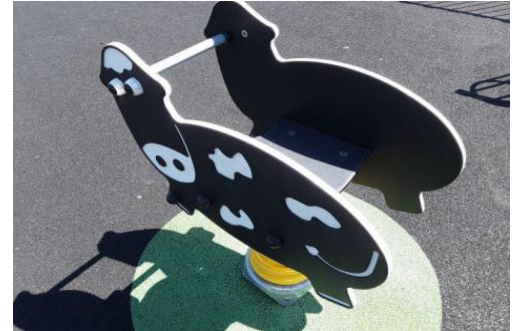
Item: Spring Cow
Manufacturer: Fahr Industries
Surface Type: Wet Pour
Item Quantity: 1
Equipment Compliance: Yes
Surface Area Compliance: Yes

Cup broken - New cup required

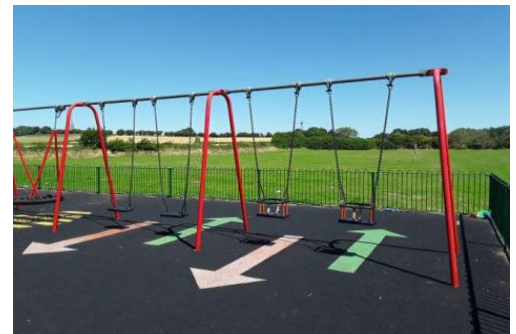
Item: 2 Bay (2 Flat, 2 Cradle)
Manufacturer: Play & Leisure Ltd
Surface Type: Wet Pour
Item Quantity: 1
Equipment Compliance: No
Surface Area Compliance: Yes

Swing seats low ,mimumum 400 mm - Repair required

Service, oil,grease required - Service required

Crotch strap split - Repair required

Metal exposed on cradle seat - Monitor

Bracket rusting - Monitor

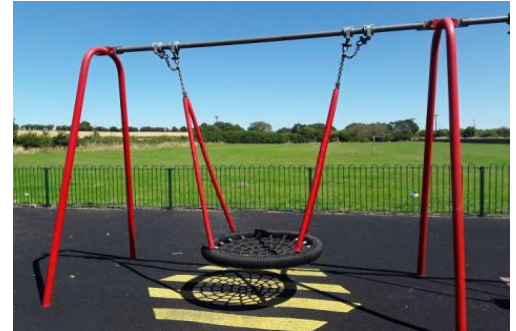
Item: Basket Swing - Type 1
Manufacturer: Play & Leisure Ltd
Surface Type: Wet Pour
Item Quantity: 1
Equipment Compliance: No
Surface Area Compliance: Yes

Seat low, minimum 400 mm - Repair required

Service required - Oil/grease required

Dog bites - Monitor

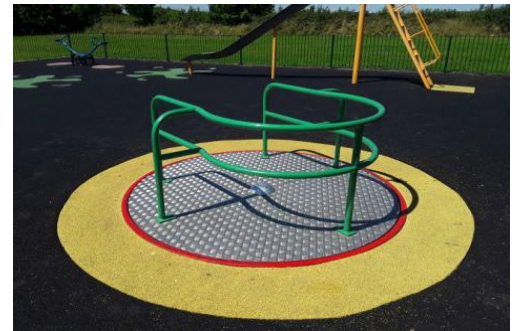
Item: Inclusive Roundabout
Manufacturer: Play & Leisure Ltd
Surface Type: Wet Pour
Item Quantity: 1
Equipment Compliance: No
Surface Area Compliance: Yes

Gap at Edge of roundabout - Possible finger trap ?

Yellow safety surface crumbling - Monitor

Safety surface lowering at edge - Monitor

Excessive movement in bearings - Monitor

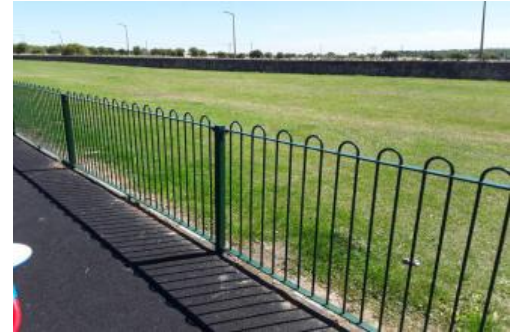
Item: Fence - Bow Top
Manufacturer: Play & Leisure Ltd
Surface Type: Wet Pour
Item Quantity: 1
Equipment Compliance: N/A
Surface Area Compliance: N/A

This item is satisfactory - no work required -

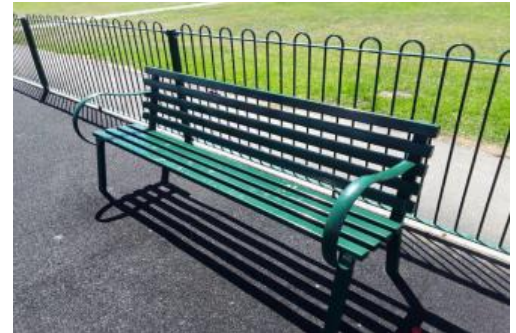
Item: Bench
Manufacturer: Play & Leisure Ltd
Surface Type: Wet Pour
Item Quantity: 2
Equipment Compliance: N/A
Surface Area Compliance: N/A

This item is satisfactory - no work required -

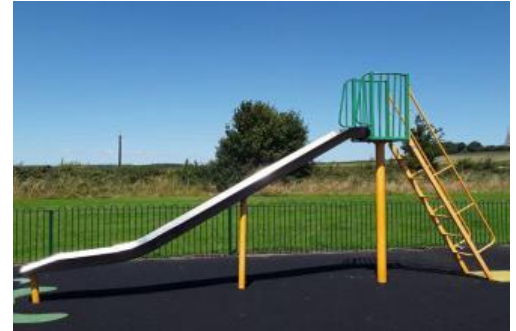
Item: Free Standing Slide
Manufacturer: Play & Leisure Ltd
Surface Type: Wet Pour
Item Quantity: 1
Equipment Compliance: No
Surface Area Compliance: Yes

This item is satisfactory - no work required -

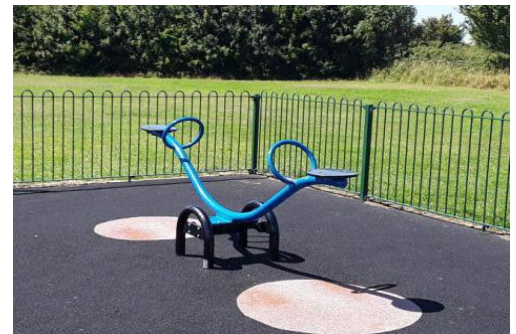
Item: See Saw
Manufacturer: Play & Leisure Ltd
Surface Type: Wet Pour
Item Quantity: 1
Equipment Compliance: Yes
Surface Area Compliance: Yes

Paint chipped - Monitor

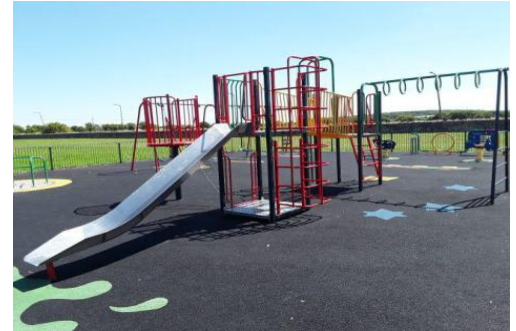
Item: Multi Play (Junior)
Manufacturer: Play & Leisure Ltd
Surface Type: Wet Pour
Item Quantity: 1
Equipment Compliance: No
Surface Area Compliance: Yes

Safety surface shrinking - Monitor

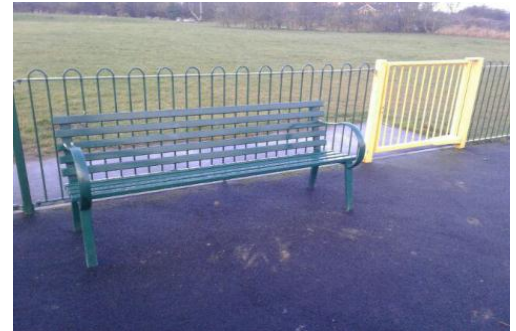
Item: Bench
Manufacturer: Unknown
Surface Type: Wet Pour
Item Quantity: 1
Equipment Compliance: N/A
Surface Area Compliance: N/A

Item satisfactory - No work required

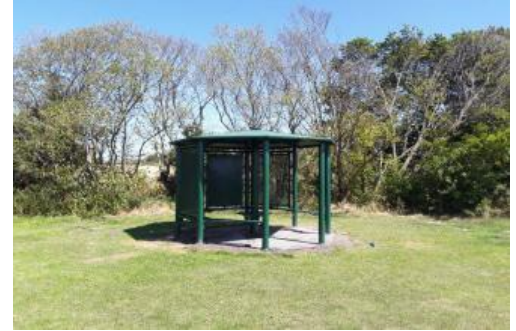
Item: Shelter
Manufacturer: Play & Leisure Ltd
Surface Type: Grass
Item Quantity: 1
Equipment Compliance: N/A
Surface Area Compliance: N/A

This item is satisfactory - no work required -

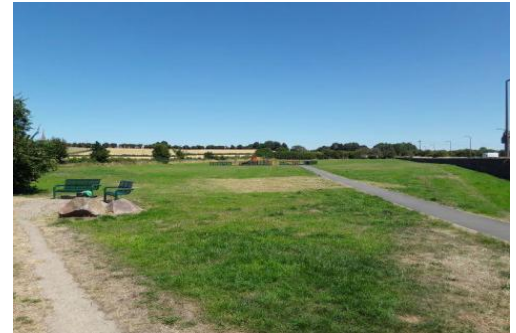
Item: Site General
Manufacturer: Owner/Operator
Surface Type: N/A
Item Quantity: 1
Equipment Compliance: N/A
Surface Area Compliance: N/A

Safety surface shrinking - Monitor

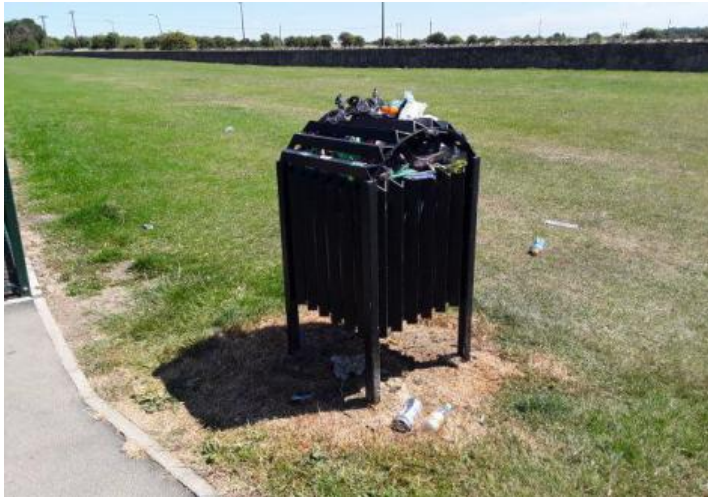
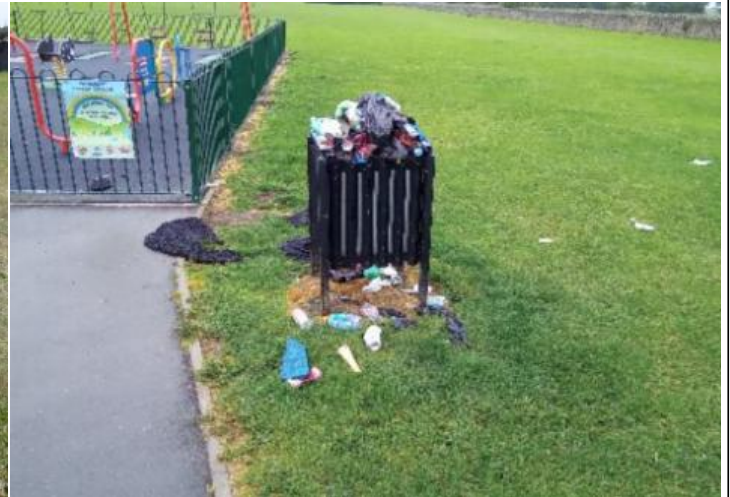
Item: Ancillary Items - Litter Bin
Manufacturer: Streetmaster

Finding: Bin full

Action: Emptying required

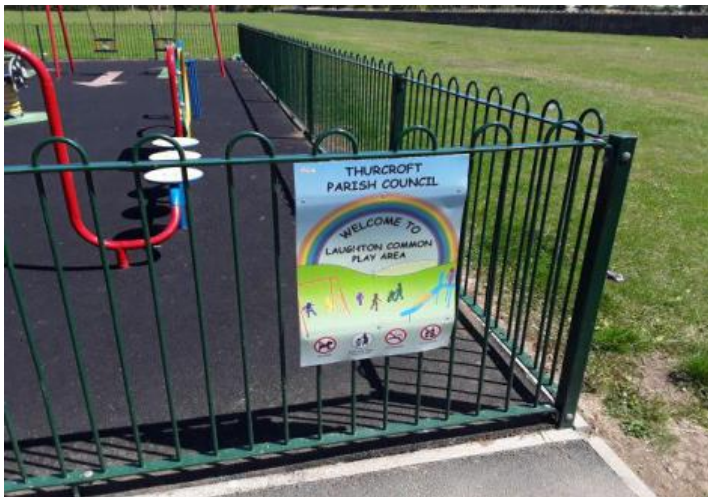
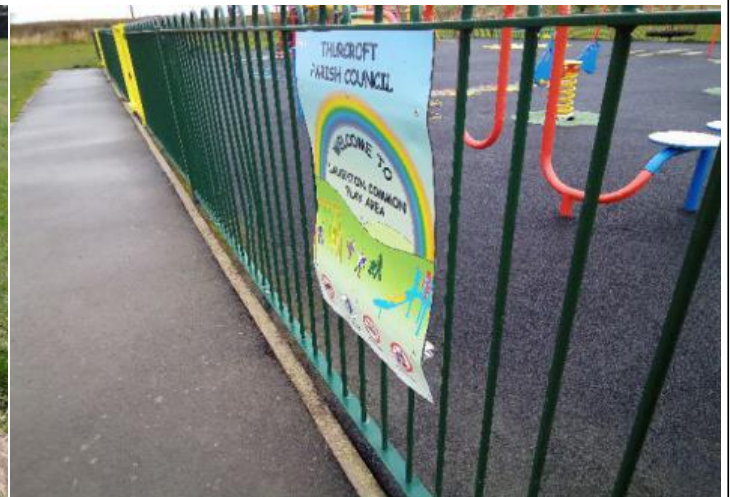
Item: Ancillary Items - Sign
Manufacturer: Owner/Operator

Finding: Slight damage

Action: Monitor

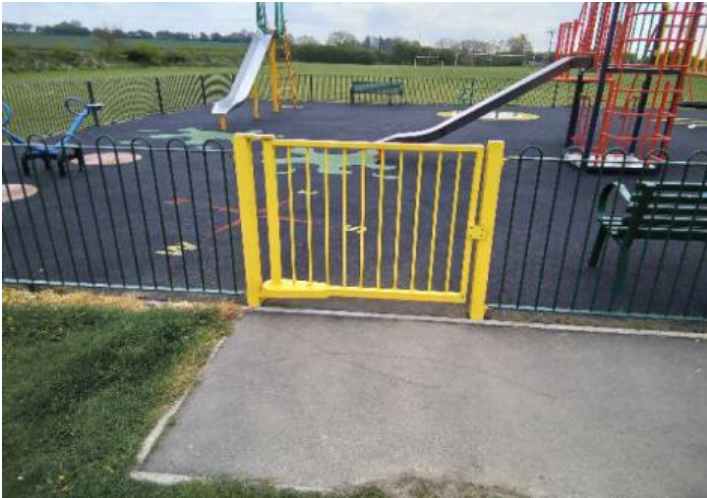
Item: Gates - Gate - Pedestrian
Manufacturer: A & E Group Ltd

Finding: Item satisfactory

Action: No work required

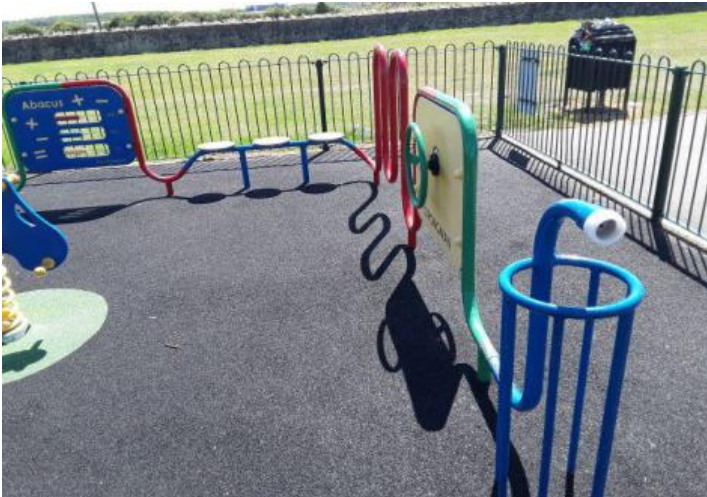
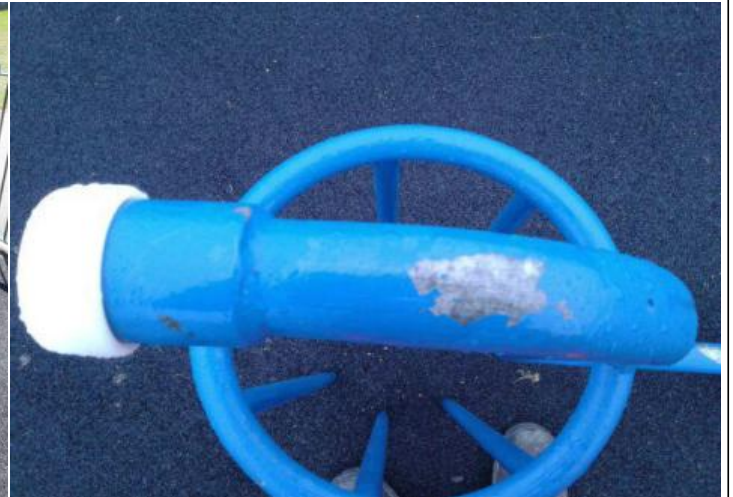
Item: Other - Interactive Play
Manufacturer: Play & Leisure Ltd

Finding: Paint chipped

Action: Monitor

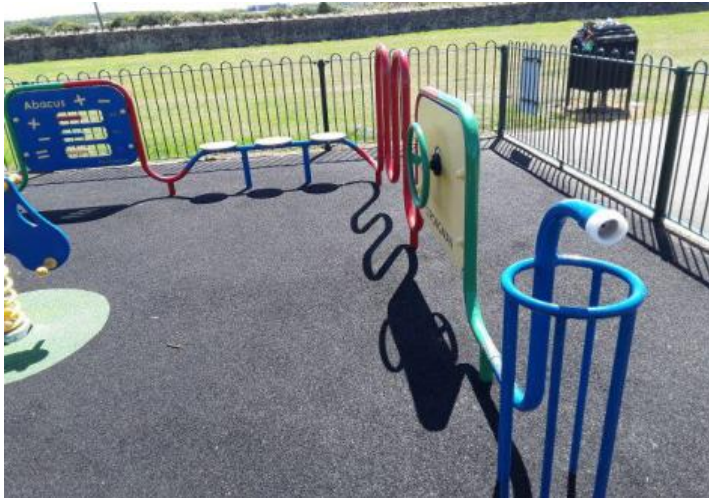
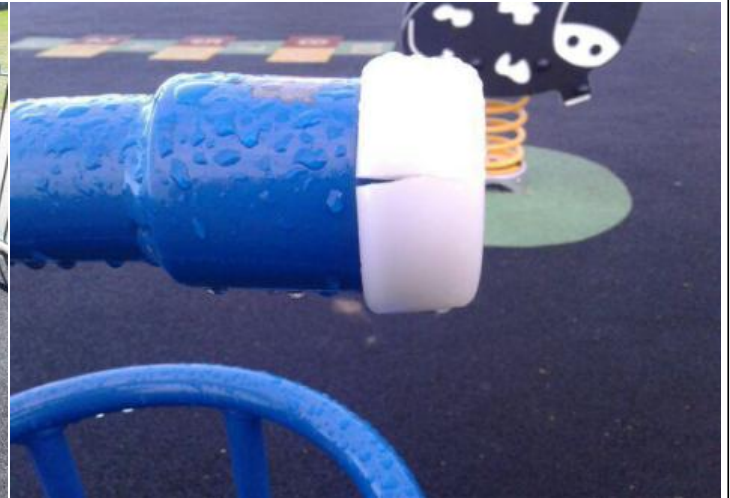
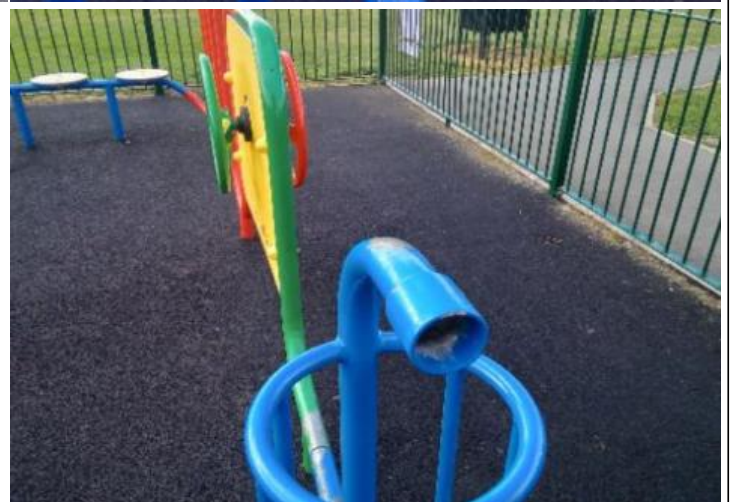
Item: Other - Interactive Play
Manufacturer: Play & Leisure Ltd

Finding: Both End fittings missing

Action: Replacement required

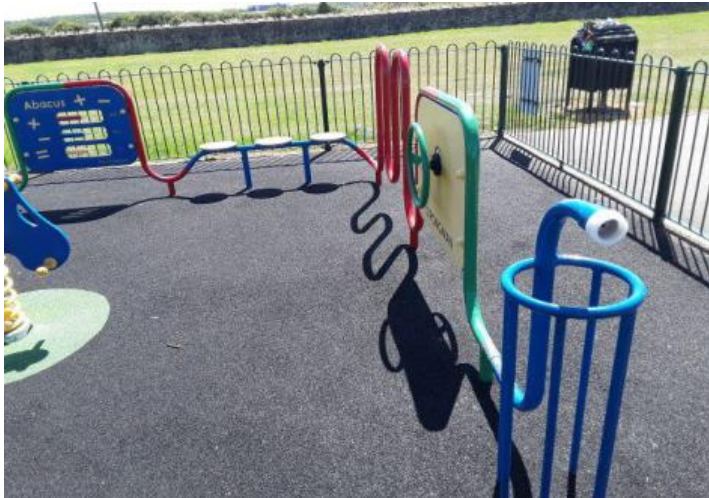
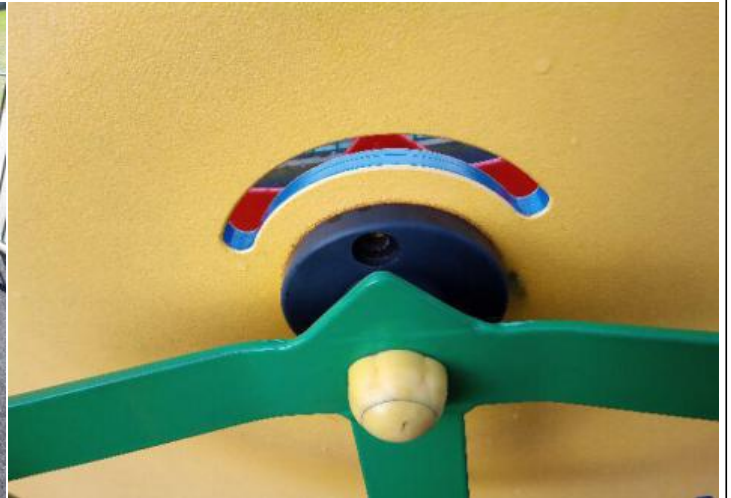
Item: Other - Interactive Play
Manufacturer: Play & Leisure Ltd

Finding: Unsure if bolt missing ?

Action: Research required

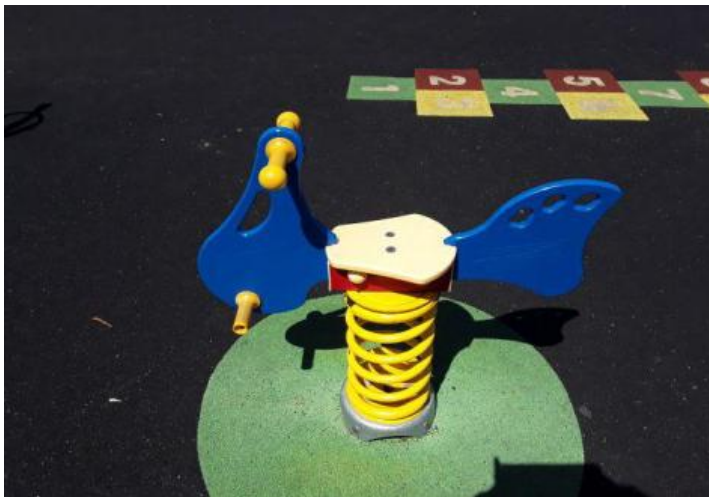
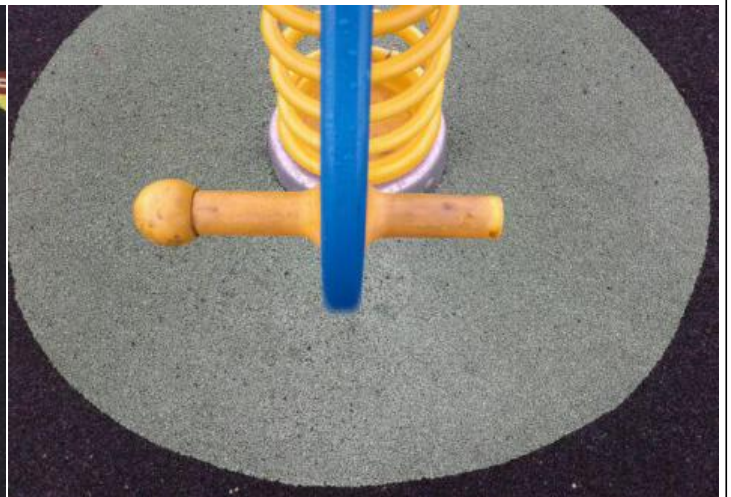
Item: Rocking Equipment - Misc Springer
Manufacturer: Fahr Industries

Finding: Stopper missing

Action: New stopper required

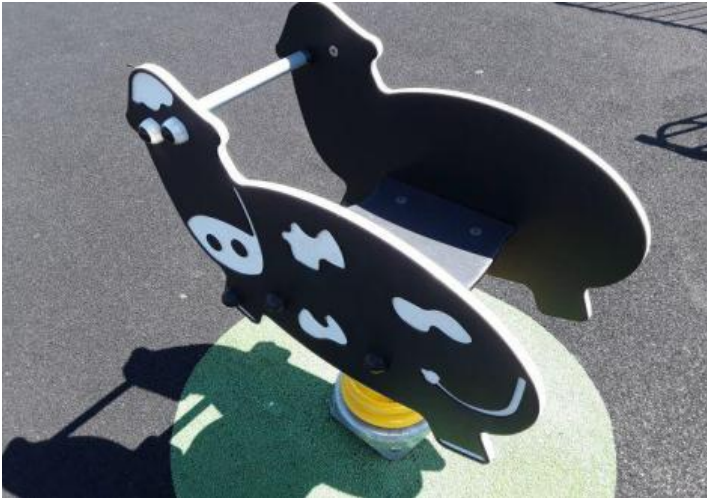
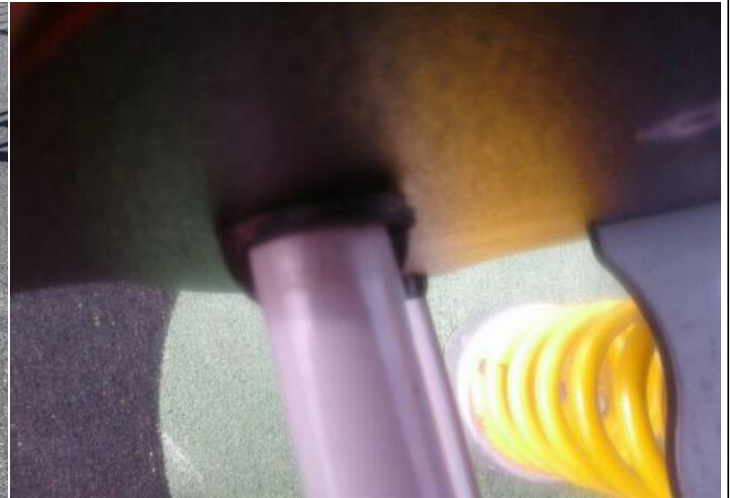
Item: Rocking Equipment - Spring Cow
Manufacturer: Fahr Industries

Finding: Cup broken

Action: New cup required

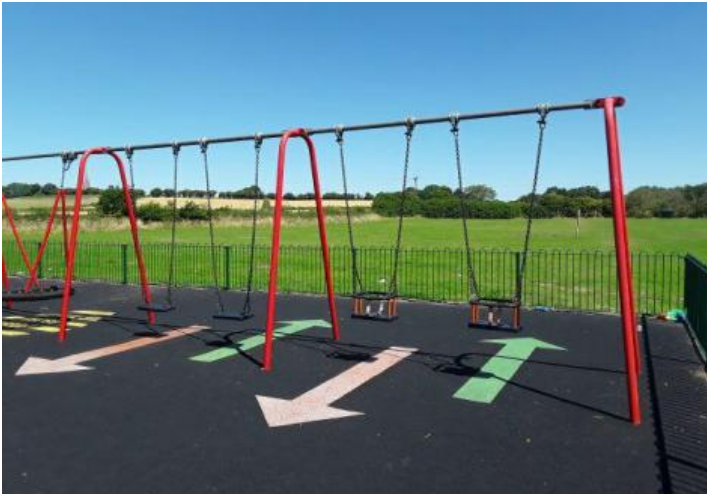
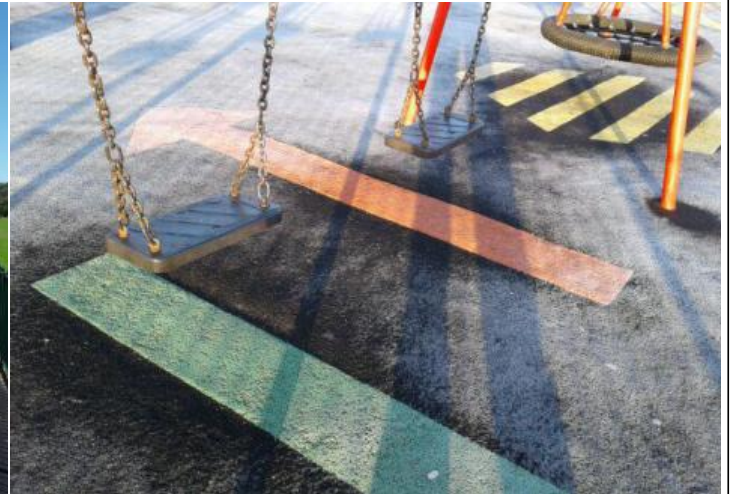
Item: Swings - 2 Bay (2 Flat, 2 Cradle)
Manufacturer: Play & Leisure Ltd

Finding: Swing seats low ,mimumum 400 mm

Action: Repair required

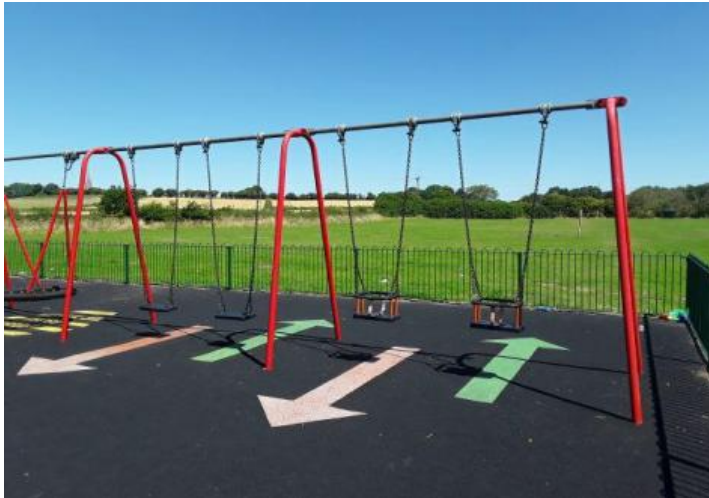
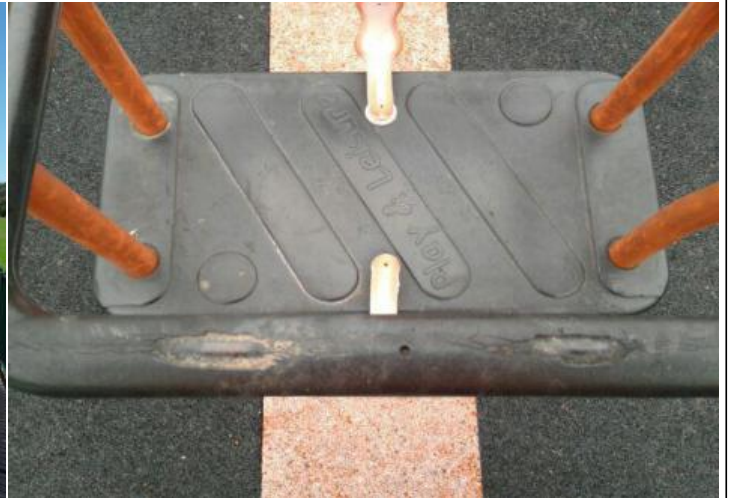
Item: Swings - 2 Bay (2 Flat, 2 Cradle)
Manufacturer: Play & Leisure Ltd

Finding: Metal exposed on cradle seat

Action: Monitor

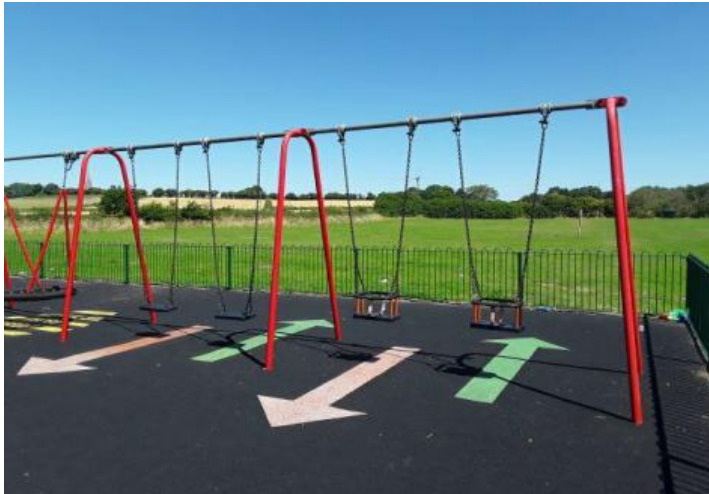
Item: Swings - 2 Bay (2 Flat, 2 Cradle)
Manufacturer: Play & Leisure Ltd

Finding: Service, oil,grease required

Action: Service required

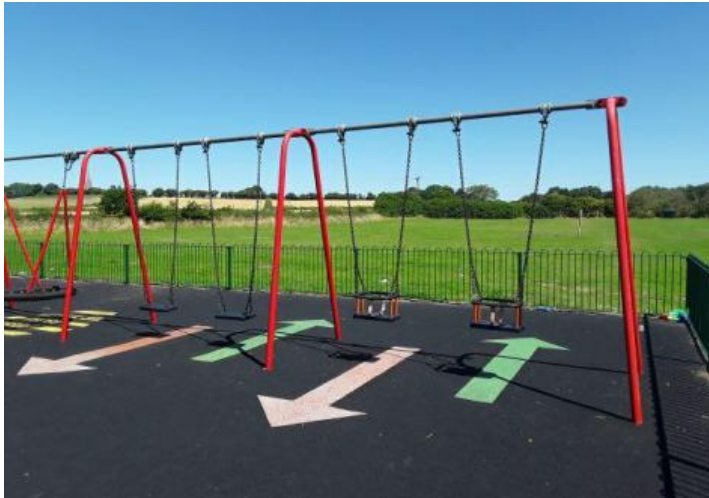
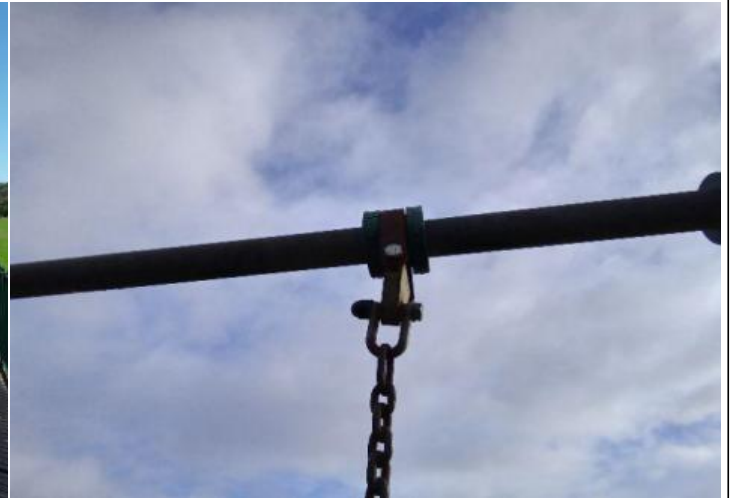
Item: Swings - 2 Bay (2 Flat, 2 Cradle)
Manufacturer: Play & Leisure Ltd

Finding: Bracket rusting

Action: Monitor

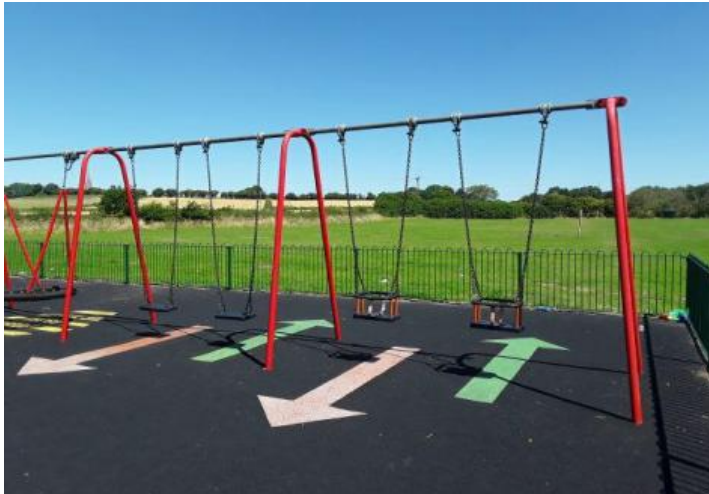
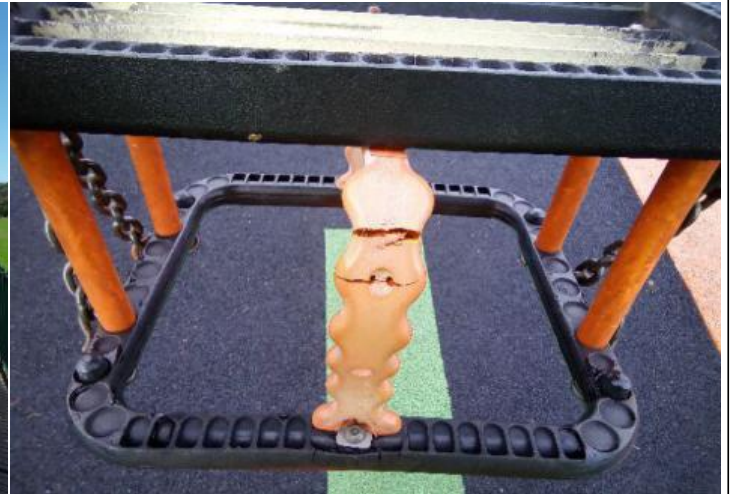
Item: Swings - 2 Bay (2 Flat, 2 Cradle)
Manufacturer: Play & Leisure Ltd

Finding: Crotch strap split

Action: Repair required

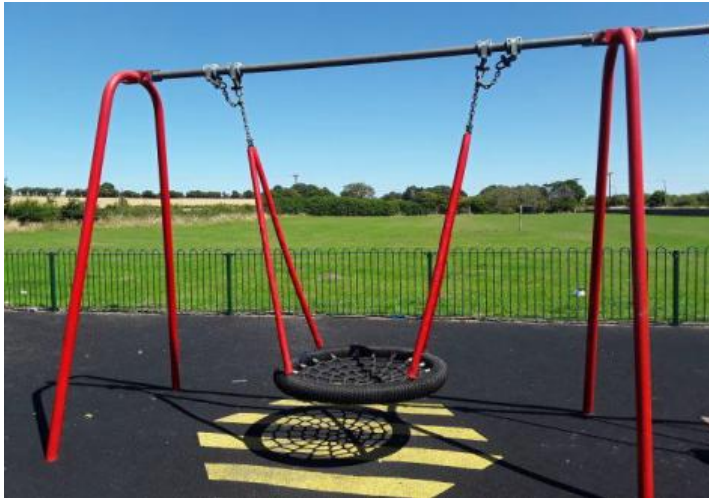
Item: Swings - Basket Swing - Type 1
Manufacturer: Play & Leisure Ltd

Finding: Seat low, minimum 400 mm

Action: Repair required

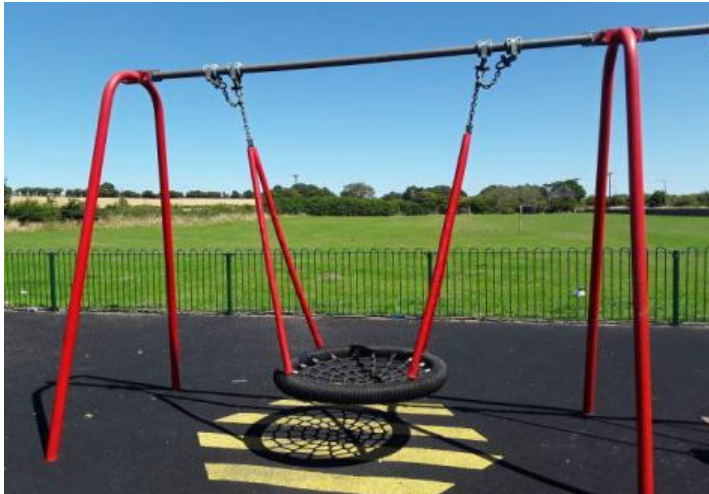
Item: Swings - Basket Swing - Type 1
Manufacturer: Play & Leisure Ltd

Finding: Service required

Action: Oil/grease required

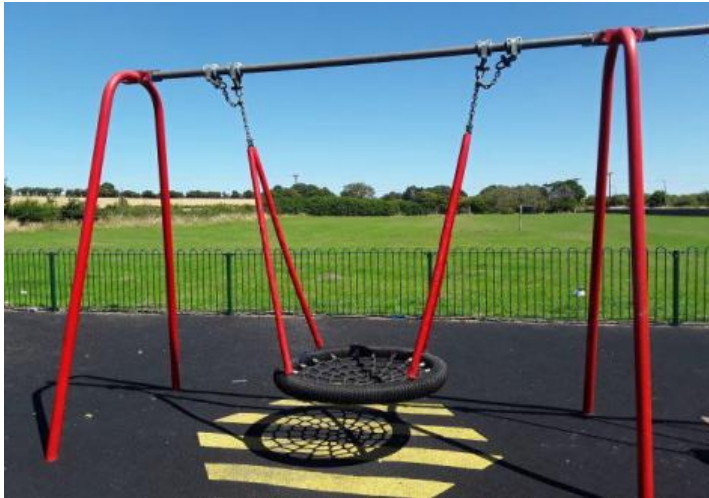
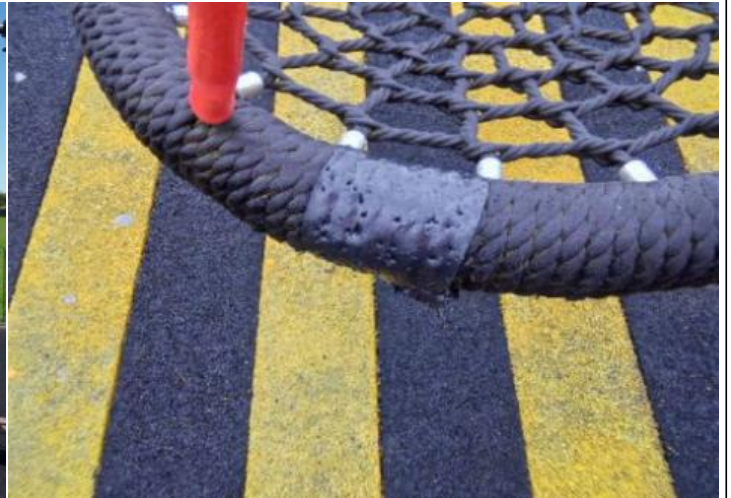
Item: Swings - Basket Swing - Type 1
Manufacturer: Play & Leisure Ltd

Finding: Dog bites

Action: Monitor

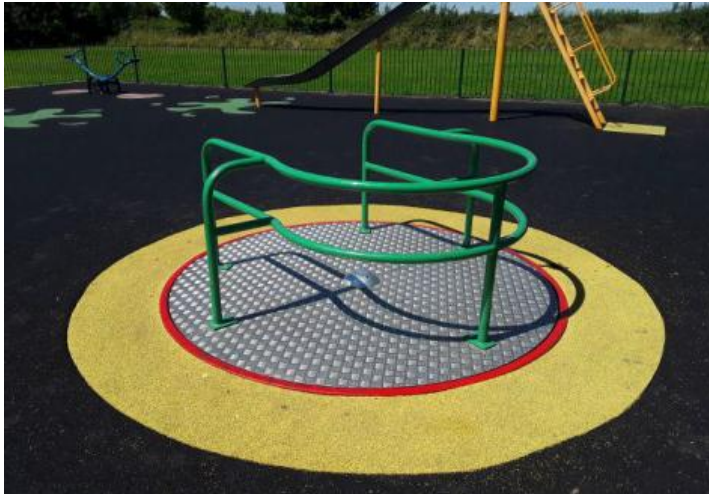
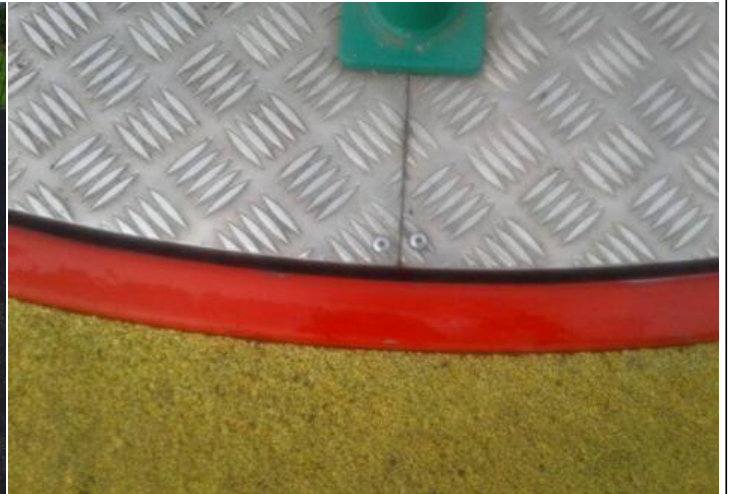
Item: Rotor Play - Inclusive Roundabout
Manufacturer: Play & Leisure Ltd

Finding: Gap at Edge of roundabout

Action: Possible finger trap ?

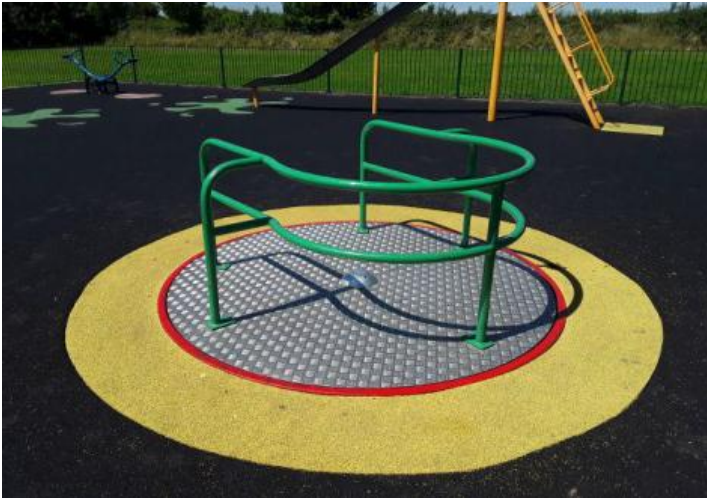
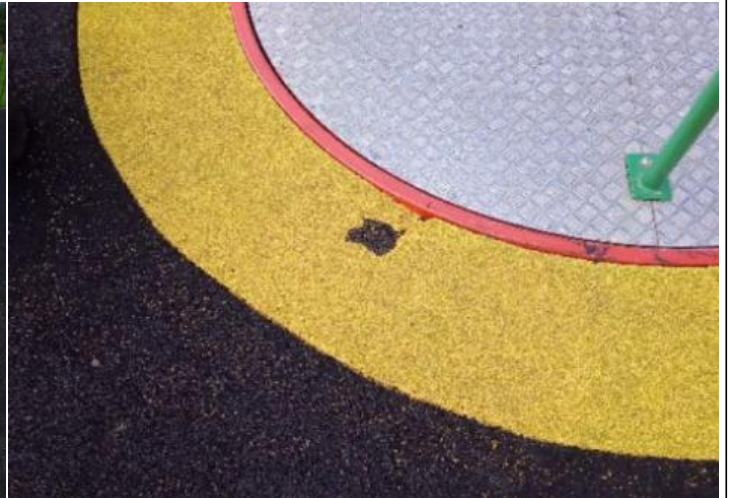
Item: Rotor Play - Inclusive Roundabout
Manufacturer: Play & Leisure Ltd

Finding: Yellow safety surface crumbling

Action: Monitor

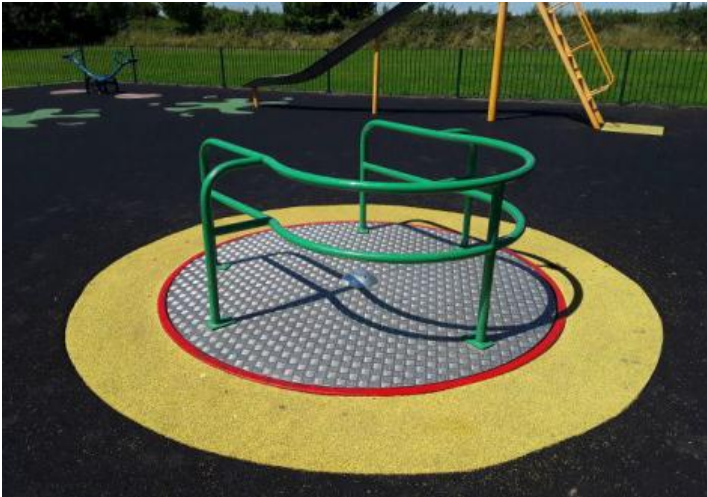
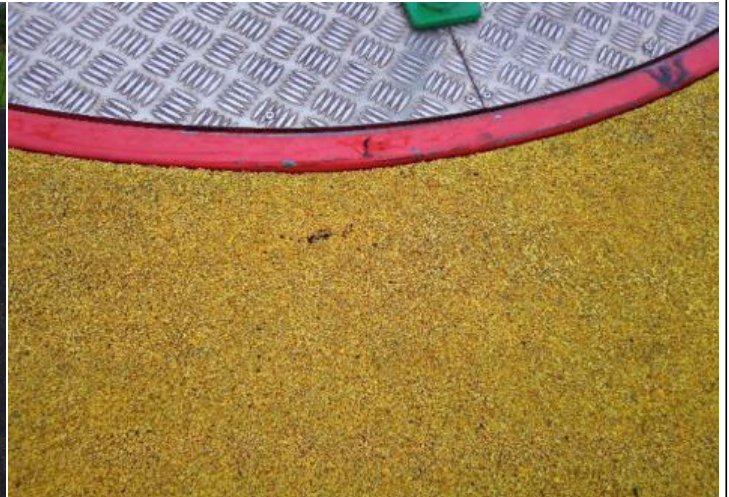
Item: Rotor Play - Inclusive Roundabout
Manufacturer: Play & Leisure Ltd

Finding: Safety surface lowering at edge

Action: Monitor

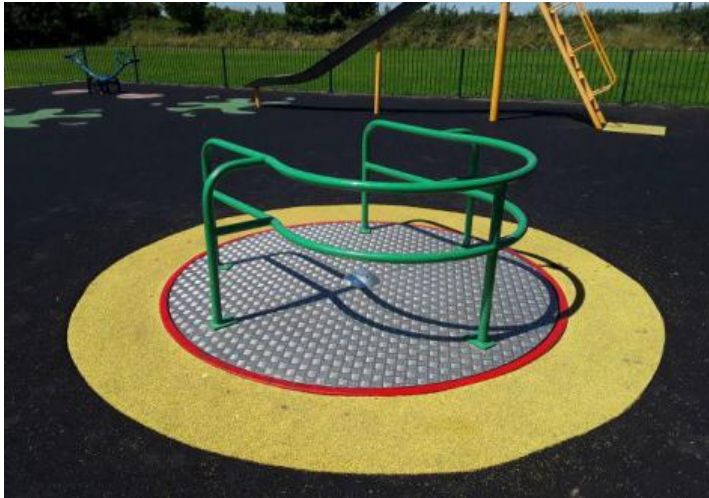
Item: Rotor Play - Inclusive Roundabout
Manufacturer: Play & Leisure Ltd

Finding: Excessive movement in bearings

Action: Monitor

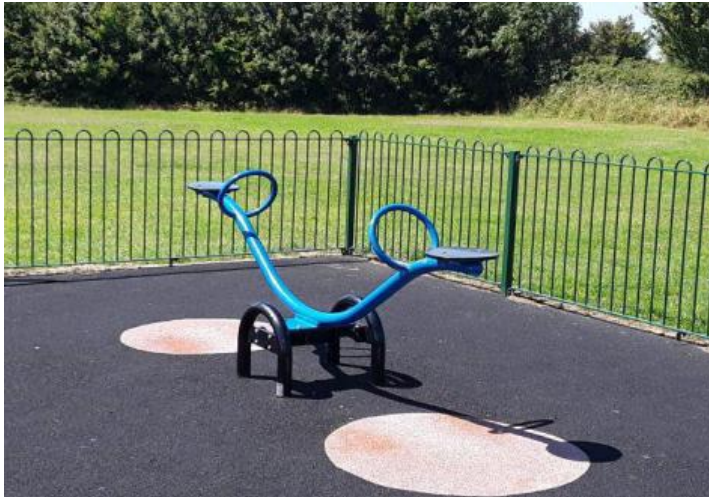
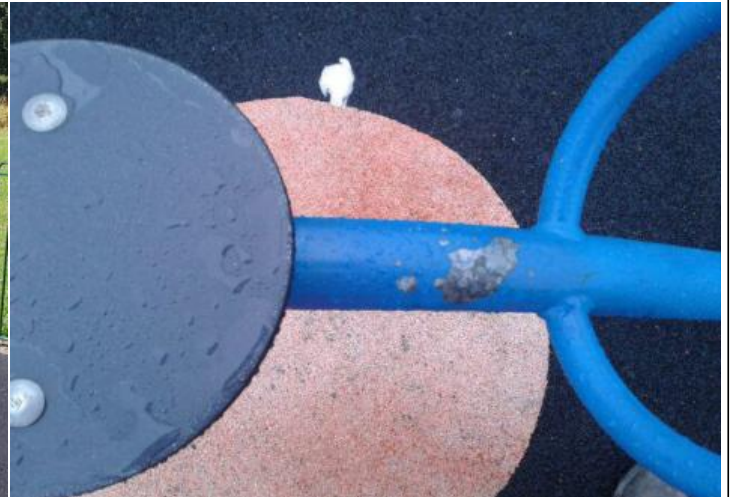
Item: Rocking Equipment - See Saw
Manufacturer: Play & Leisure Ltd

Finding: Paint chipped

Action: Monitor

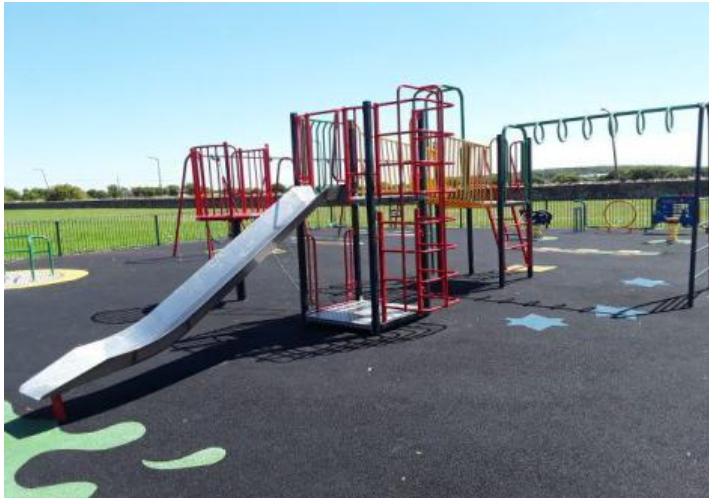
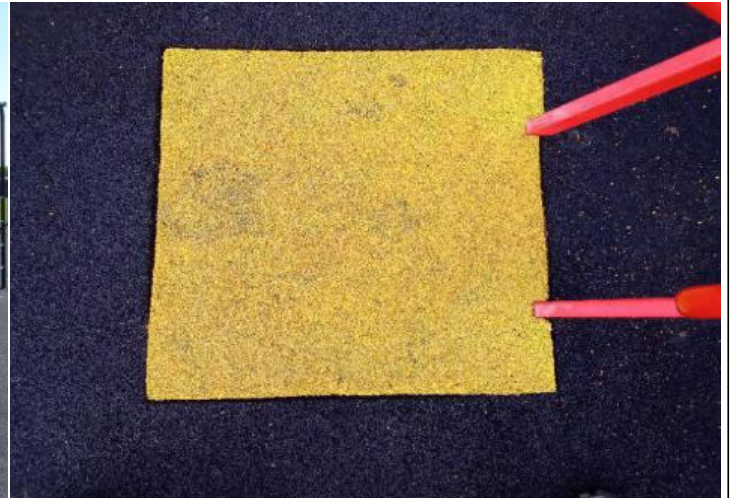
Item: Activity Equipment - Multi Play (Junior)
Manufacturer: Play & Leisure Ltd

Finding: Safety surface shrinking

Action: Monitor

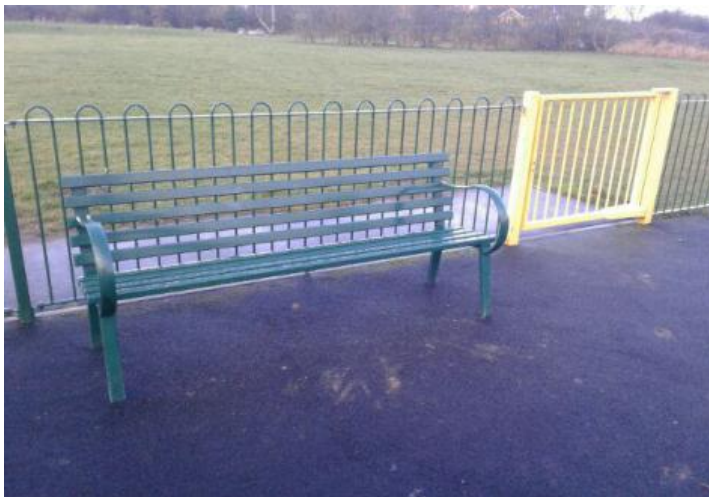
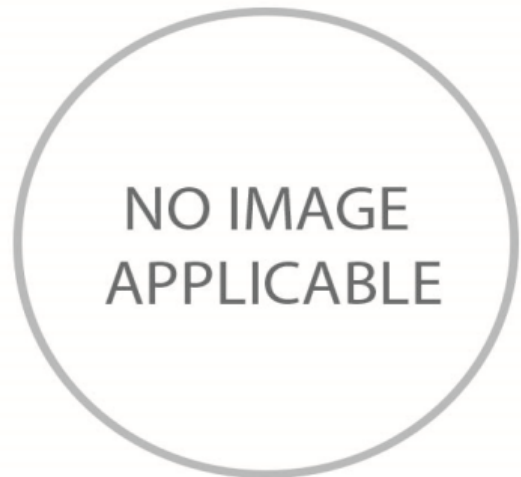
Item: Ancillary Items - Bench
Manufacturer: Unknown

Finding: Item satisfactory

Action: No work required

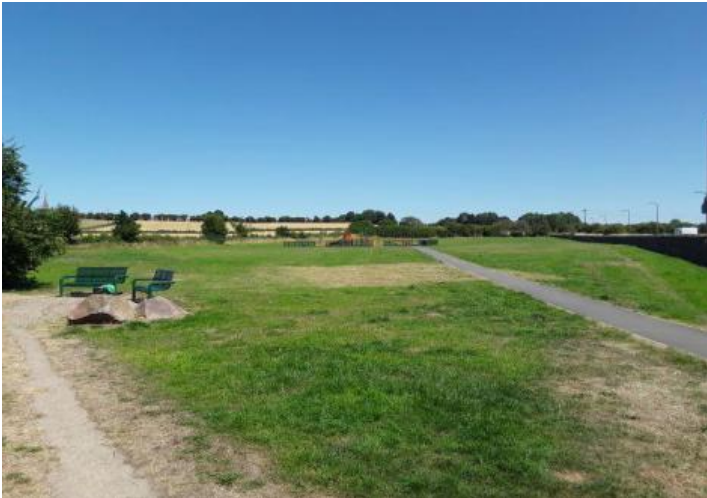
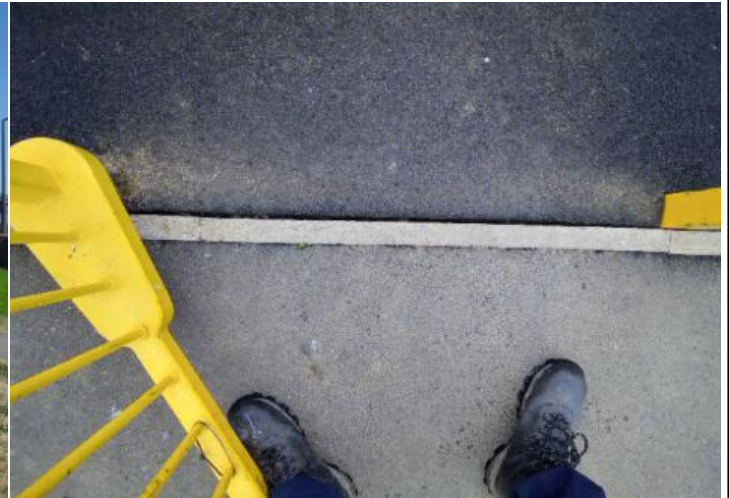
Item: Ancillary Items - Site General
Manufacturer: Owner/Operator

Finding: Safety surface shrinking

Action: Monitor
