Brampton Road

Inspection Ref: 2174040

Operational Inspection - 18-September-2023 - 10:57 Inspector Terry Hill

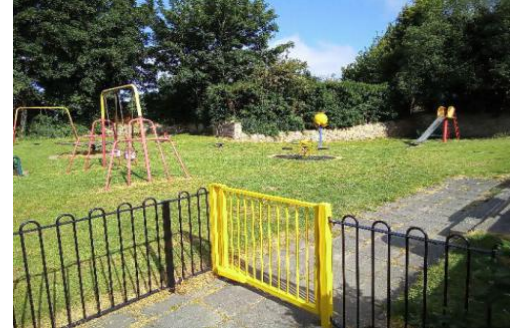
Total Findings: 4

Brickwork removed - Repair required

Brickwork , missing, decaying - Repair required

Damage to brick wall - Repair required

Finding: Brickwork , missing, decaying

Finding: Damage to brick wall

Action: Repair required

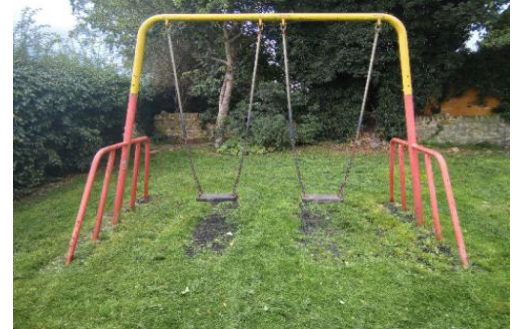
Total Findings: 4

Seats decaying - Monitor

Finding: Seats decaying
