Annual Inspection

Rotherham Metropolitan Borough Council

Brampton Road

Inspection Ref: 2203189

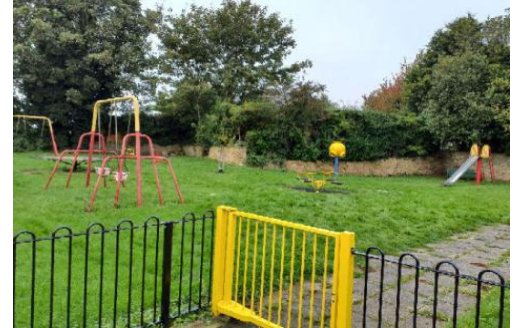
Item: Site General
Manufacturer: Owner/Operator
Surface Type: N/A
Item Quantity: 1
Equipment Compliance: N/A
Surface Area Compliance: N/A

It is recommended that signage, with information including the site address, contact information for maintenance issues and emergency contact details are provided for the facility - Provide in accordance with the recommendations

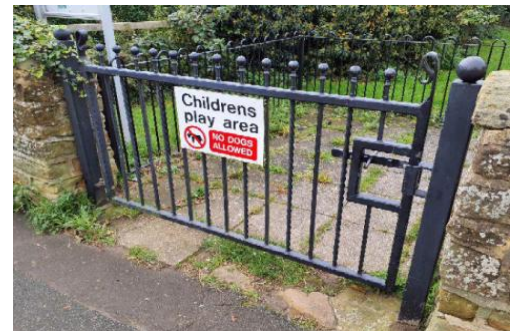
Item: Gate
Manufacturer: Owner/Operator
Surface Type: N/A
Item Quantity: 1
Equipment Compliance: N/A
Surface Area Compliance: N/A

There are trip hazards present - Reinstate surrounding surfaces to level to remove the trip points

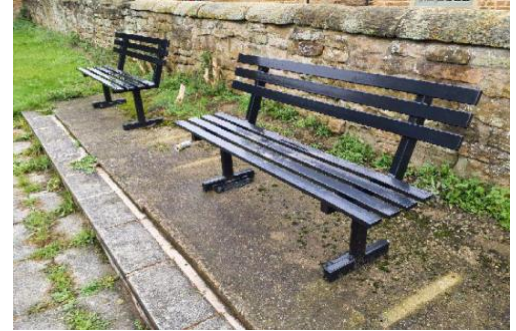
Item: Bench
Manufacturer: Owner/Operator
Surface Type: Concrete
Item Quantity: 2
Equipment Compliance: N/A
Surface Area Compliance: N/A

There are trip hazards present - Reinstate surrounding surfaces to level to remove the trip points

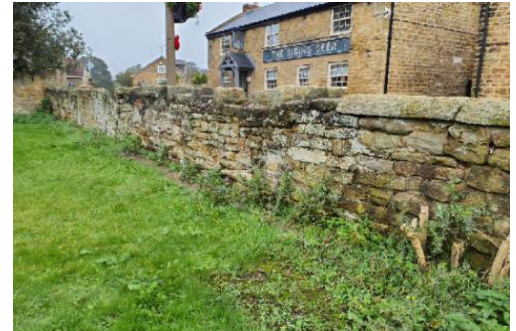
Item: Wall
Manufacturer: Owner/Operator
Surface Type: N/A
Item Quantity: 1
Equipment Compliance: N/A
Surface Area Compliance: N/A

The masonry is loose, degrading or damaged - Replace or repair as required

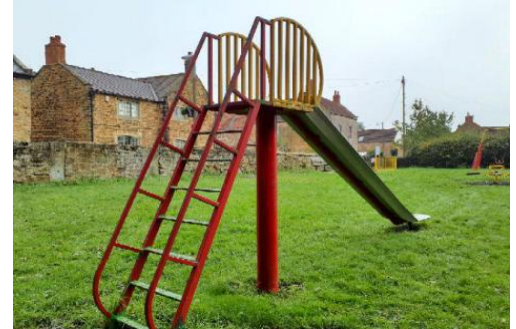
Item: Free Standing Slide
Manufacturer: Not Identified
Surface Type: Grass
Item Quantity: 1
Equipment Compliance: No
Surface Area Compliance: No

There are a number of dents in the slide surface - Monitor for any further deterioration and repair as required

The item is slightly loose in its foundations - Monitor for any further deterioration and repair as required

The paintwork on this item has been damaged or worn exposing the metal underneath which is rusting / corroding - Treat affected areas and repaint

There is/are finger entrapment/s in the framework and the item fails to meet the requirements of BS EN 1176 Part 1 4.2.7.6 Entrapment of fingers - Monitor - No remedial work recommended

The slide is predominately south facing and will catch the majority of the sun's heat during the day. Slide surfaces can become very warm during periods of sustained sunny weather - Monitor - No remedial work recommended

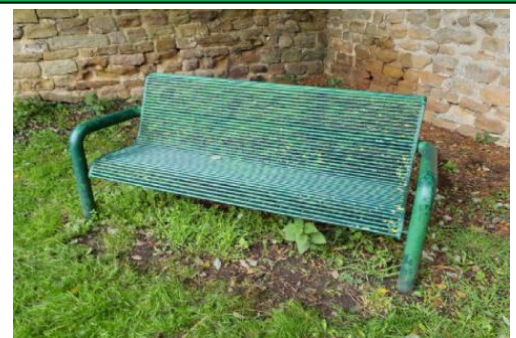
Item: Bench
Manufacturer: Owner/Operator
Surface Type: Grass
Item Quantity: 2
Equipment Compliance: N/A
Surface Area Compliance: N/A

The paintwork on this item has been damaged or worn exposing the metal underneath which is rusting / corroding - Treat affected areas and repaint

The surface has eroded in some areas and may be slippery in wet conditions - Reinstate the surface

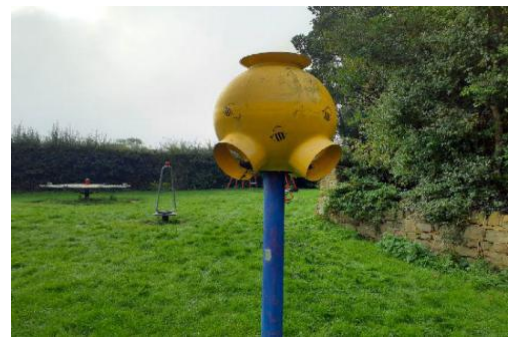
Item: Ball Shoot
Manufacturer: Wicksteed Playgrounds
Surface Type: Grass
Item Quantity: 1
Equipment Compliance: Yes
Surface Area Compliance: N/A

Finding 1
 The item has been damaged - Monitor for any further deterioration and replace as required

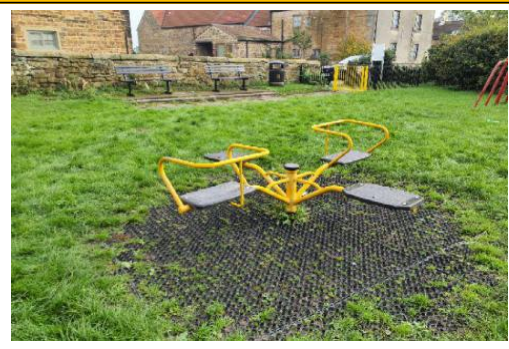
Item: Rotating Chairs
Manufacturer: Wicksteed Playgrounds
Surface Type: Grass Matrix Tiles
Item Quantity: 1
Equipment Compliance: No
Surface Area Compliance: Yes

Finding 1
 Parts of the steel structure protrude beyond the protected elements of the seat and fail to meet the requirements of BS EN 1176 Part 5 - Monitor - no remedial action recommended

Finding 2
 The seat has been damaged - Monitor for any further deterioration and replace as required

Finding 3
 The seats have been damaged or modified resulting in missing cradle seat enclosures which are required for the safe use of the item - Replace the seats with the full cradle design

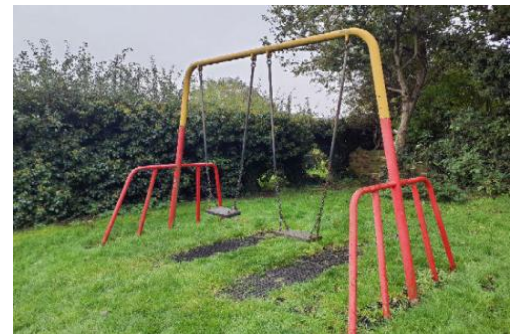
Item: 1 Bay 2 Seat (Flat)
Manufacturer: Not Identified
Surface Type: Grass Matrix Tiles
Item Quantity: 1
Equipment Compliance: No
Surface Area Compliance: Yes

The chain openings are in excess of the 8.6mm as recommended by BS EN 1176 - Monitor - No remedial work recommended

There is some notable evidence of chain wear - Monitor for any further deterioration and replace when 40% worn

There is some notable evidence of wear to the anti wrap bars - Monitor for any further deterioration and replace when 40% worn

The swing seat connectors have some wear present - Monitor for further deterioration and replace when 40% worn

There is some wear to the shackles. - Monitor for any further deterioration and replace when 40% worn

The bushes are worn or missing - Replace worn or missing bushes

The seat has minor damage or wear - Monitor for any further deterioration and replace as required

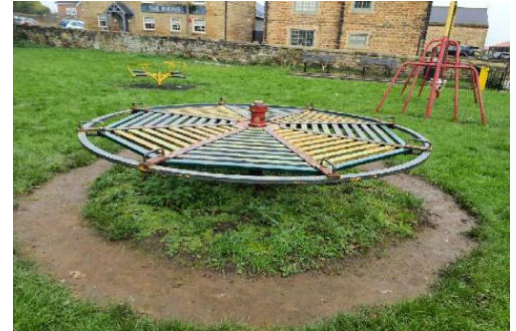
Item: Roundabout
Manufacturer: Hirst & Sons Ltd
Surface Type: Grass
Item Quantity: 1
Equipment Compliance: No
Surface Area Compliance: Yes

The grass has eroded within the impact area of the equipment exposing rocks and rubble and may not provide the necessary impact attenuating properties for the equipment fall height; the surface may also be slippery in wet weather - Reinstate the grass or provide an all weather surface

The paintwork on this item has been damaged or worn exposing the metal underneath which is rusting / corroding - Treat affected areas and repaint

There is/are finger entrapment/s in the framework and the item fails to meet the requirements of BS EN 1176 Part 1 4.2.7.6 Entrapment of fingers - Monitor - No remedial work recommended

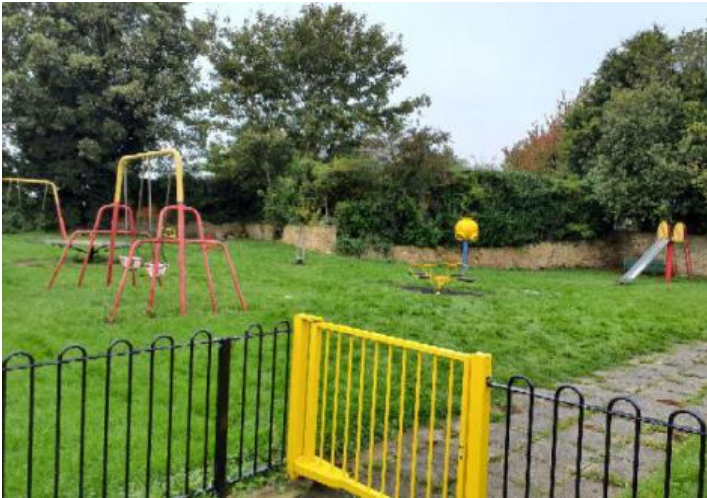
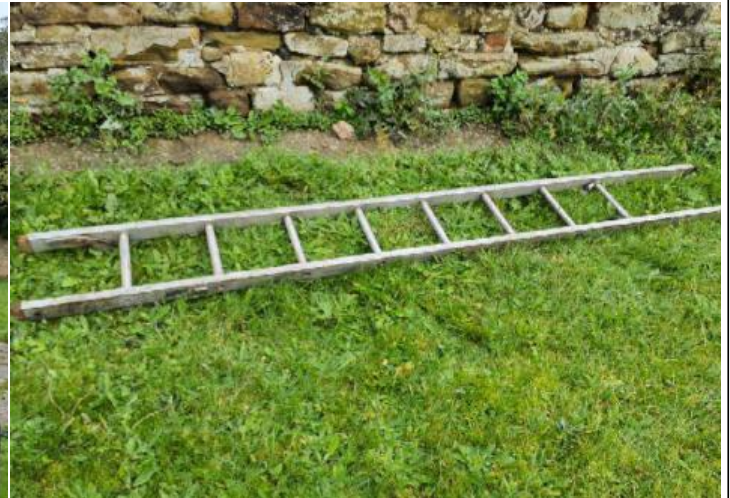
Item: Ancillary Items - Site General
Manufacturer: Owner/Operator

Finding: There is a ladder onsite

Action: Remove

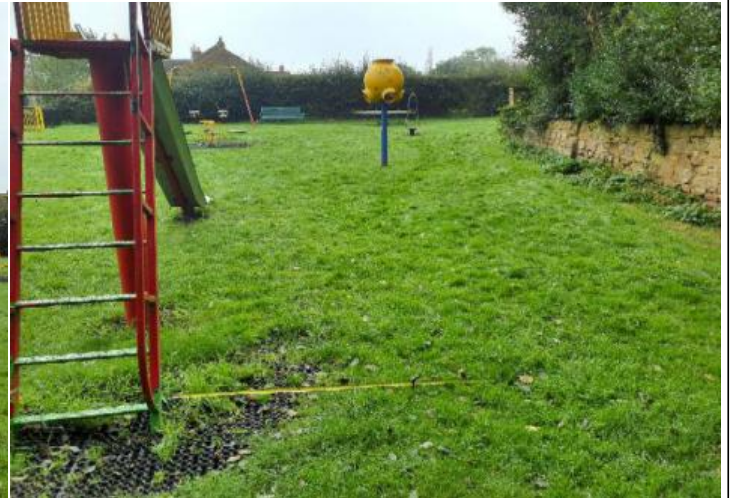
Item: Other - Free Standing Slide
Manufacturer: Not Identified

Finding: The surfacing dimensions are short and do not meet with the requirements of the current applicable standard (1.76m required / approximately 1.2m provided)

Action: Extend surface area to comply

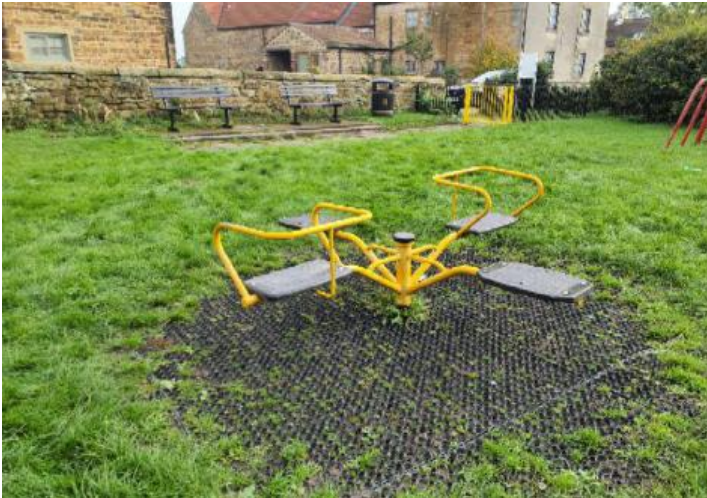
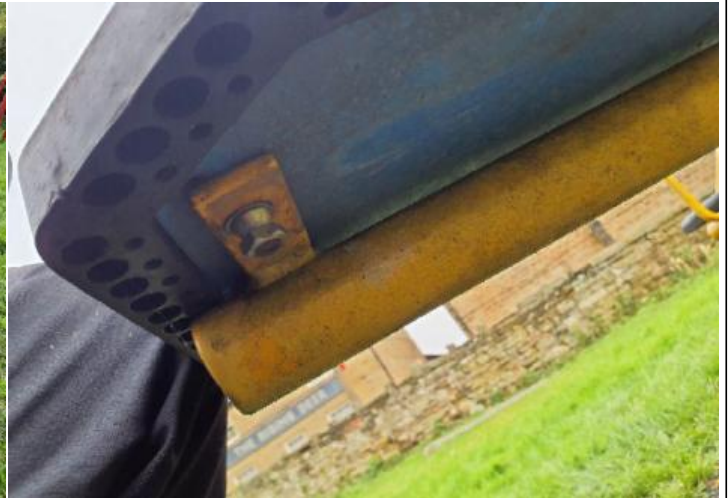
Item: Rotor Play - Rotating Chairs
Manufacturer: Wicksteed Playgrounds

Finding: Shear nuts have not been fully tightened and are still present on fixings

Action: Tighten heads on nuts to shear off and secure

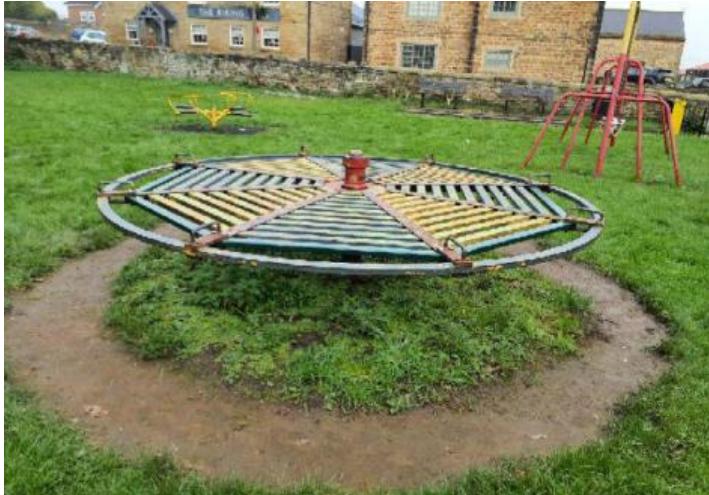
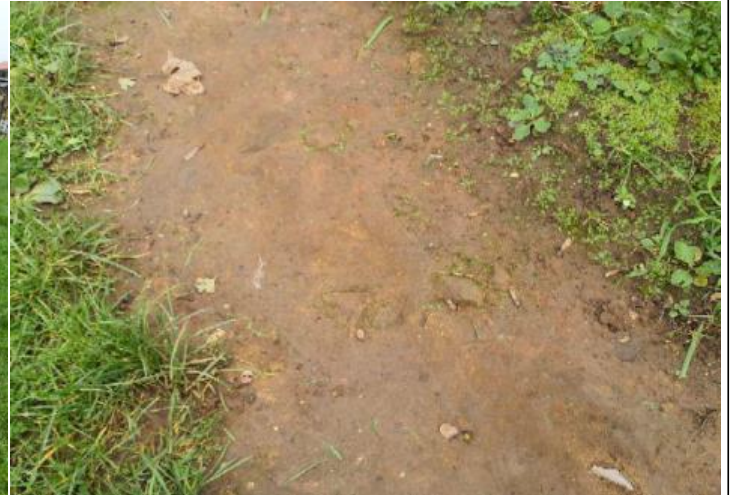
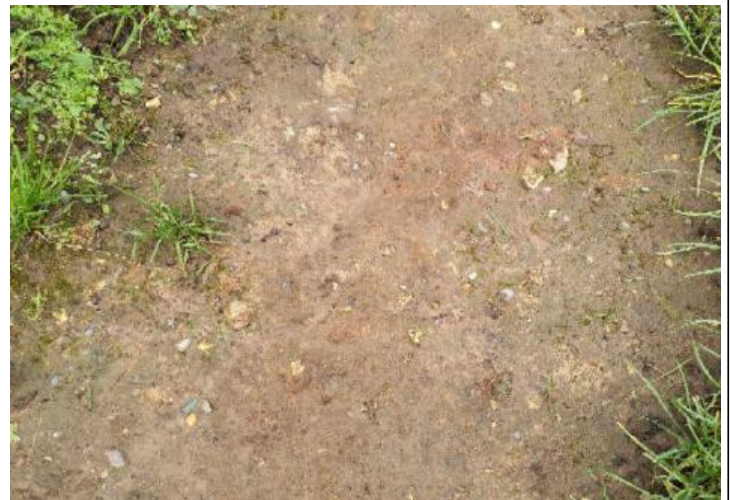
Item: Rotor Play - Roundabout
Manufacturer: Hirst & Sons Ltd

Finding: The grass has eroded within the impact area of the equipment exposing rocks and rubble and may not provide the necessary impact attenuating properties for the equipment fall height; the surface may also be slippery in wet weather

Action: Reinstate the grass or provide an all weather surface

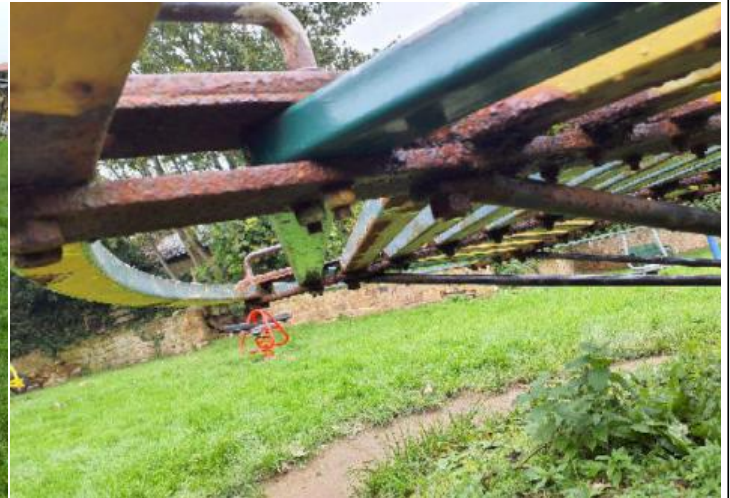
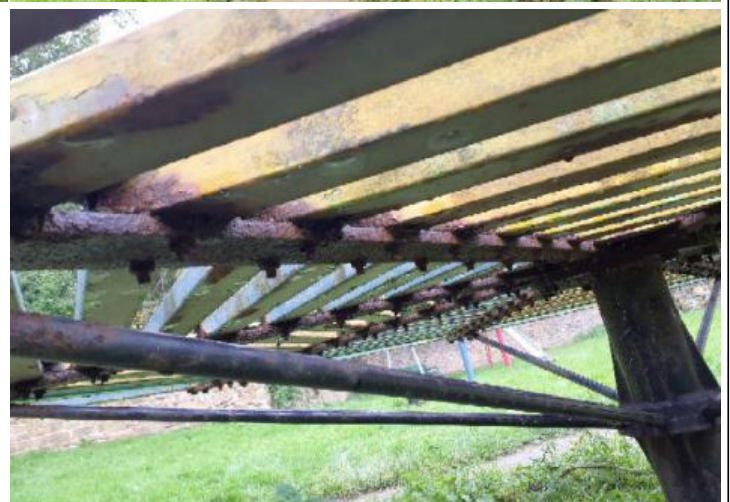
Item: Rotor Play - Roundabout
Manufacturer: Hirst & Sons Ltd

Finding: There are projecting bolt thread(s) present

Action: Remove excess thread length and deburr or provide cap

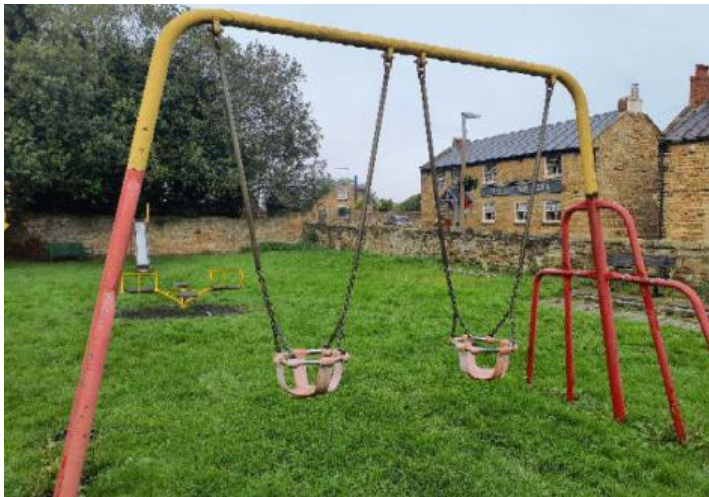
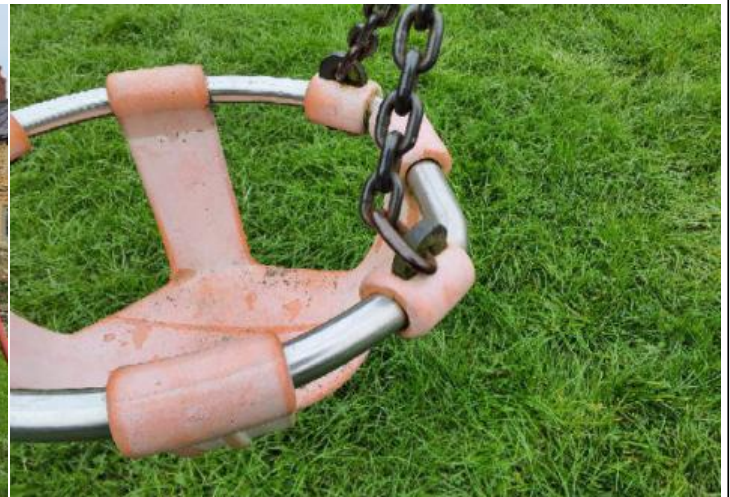
Item: Swings - 1 Bay 2 Seat (Cradle)
Manufacturer: Not Identified

Finding: The connecting links are not seated correctly

Action: Rectify the installation

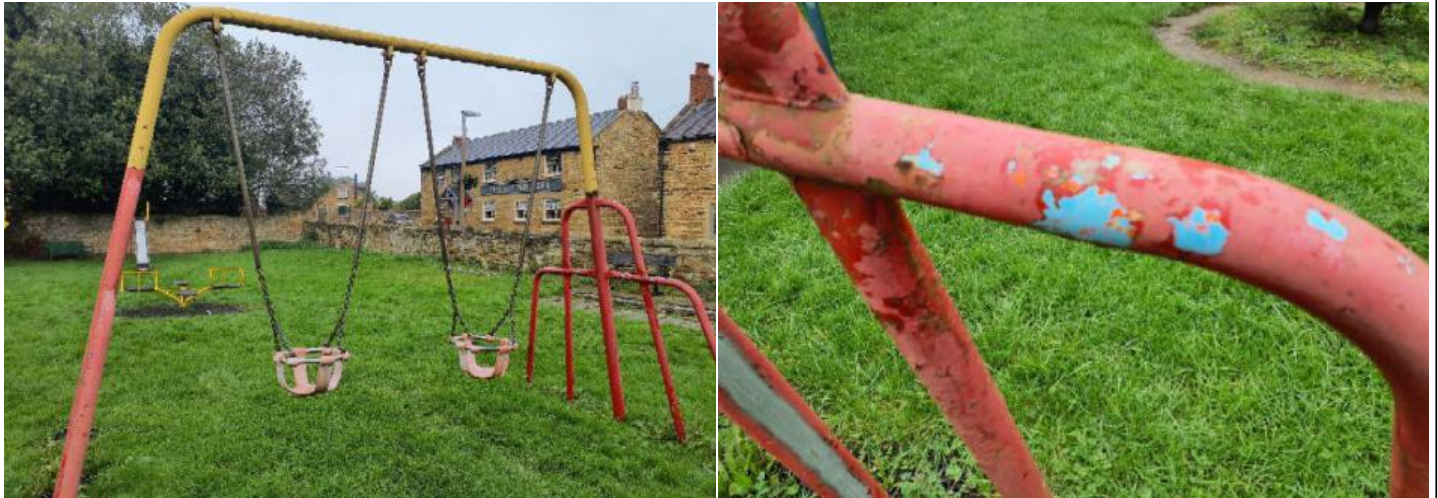
Item: Swings - 1 Bay 2 Seat (Cradle)
Manufacturer: Not Identified

Finding: The paint is flaking off the metalwork

Action: Rub down and re-paint
