## Gordon Bennett

Inspection Ref: 2174034

Operational Inspection - 18-September-2023 - 08:22 Inspector Terry Hill

Risk Assessment: 8 Low Risk

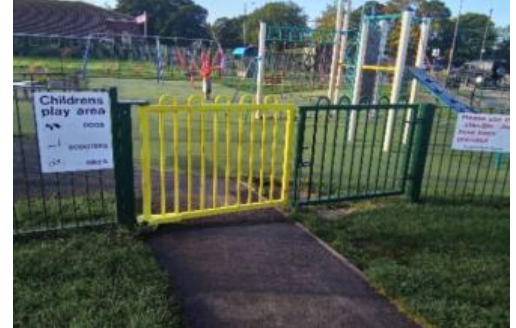
**Item:** Sign  
**Manufacturer:** Unknown  
**Surface Type:** Steel  
**Item Quantity:** 1  
**Equipment Compliance:** N/A  
**Surface Area Compliance:** N/A

This item is satisfactory - no work required -

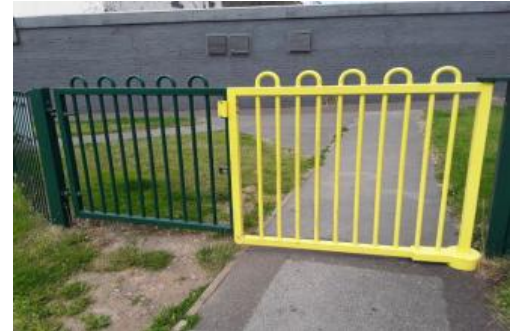
**Item:** Gate - Combination  
**Manufacturer:** Sutcliffe Play Limited  
**Surface Type:** Grass  
**Item Quantity:** 1  
**Equipment Compliance:** N/A  
**Surface Area Compliance:** N/A

This item is satisfactory - no work required -

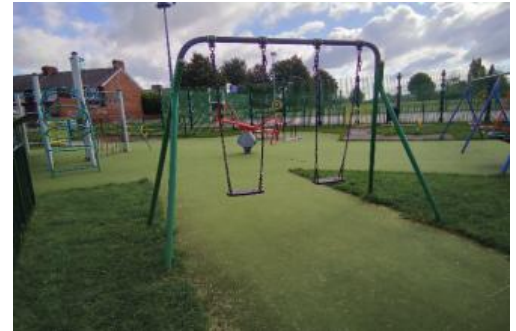
**Item:** 1 Bay 2 Seat (Flat)  
**Manufacturer:** Sutcliffe Play Limited  
**Surface Type:** Carpet System  
**Item Quantity:** 1  
**Equipment Compliance:** No  
**Surface Area Compliance:** Yes

This item is satisfactory - no work required -

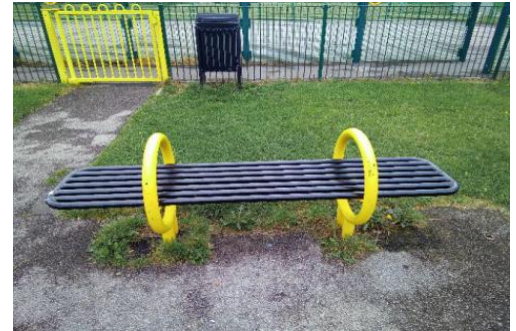
**Item:** Bench  
**Manufacturer:** Unknown  
**Surface Type:** Tarmac  
**Item Quantity:** 1  
**Equipment Compliance:** N/A  
**Surface Area Compliance:** N/A

Item satisfactory - Item satisfactory

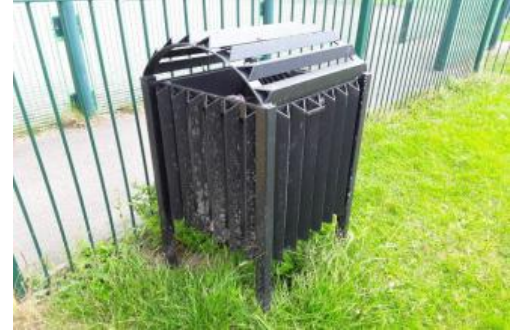
**Item:** Litter Bin  
**Manufacturer:** Streetmaster  
**Surface Type:** Grass  
**Item Part Number:** Cardiff  
**Item Quantity:** 1  
**Equipment Compliance:** N/A  
**Surface Area Compliance:** N/A  
**Total Findings:** 1

This item is satisfactory - no work required -

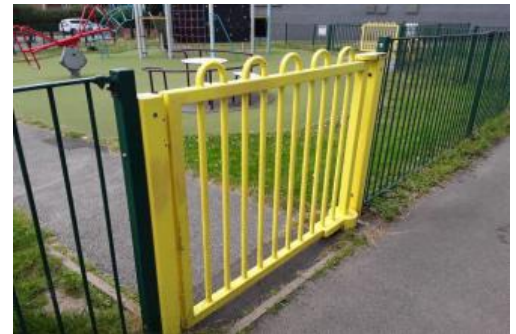
**Item:** Gate - Self Closing  
**Manufacturer:** Sutcliffe Play Limited  
**Surface Type:** Tarmac  
**Item Quantity:** 2  
**Equipment Compliance:** N/A  
**Surface Area Compliance:** N/A  
**Total Findings:** 1

This item is satisfactory - no work required -

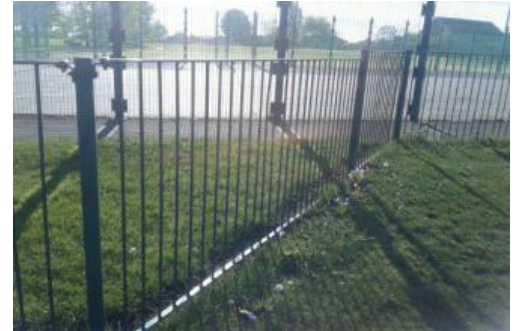
**Item:** Fencing - Flat Top  
**Manufacturer:** Unknown  
**Surface Type:** Grass  
**Item Quantity:** 1  
**Equipment Compliance:** N/A  
**Surface Area Compliance:** N/A

This item is satisfactory - no work required -

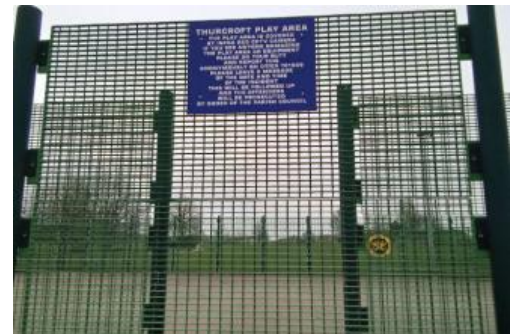
**Item:** Notice Board  
**Manufacturer:** Unknown  
**Surface Type:**  
**Item Quantity:** 1  
**Equipment Compliance:** N/A  
**Surface Area Compliance:** N/A

This item is satisfactory - no work required -

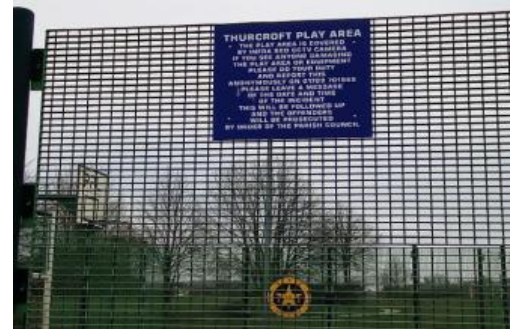
**Item:** Notice Board  
**Manufacturer:** Unknown  
**Surface Type:**  
**Item Quantity:** 1  
**Equipment Compliance:** N/A  
**Surface Area Compliance:** N/A

This item is satisfactory - no work required -

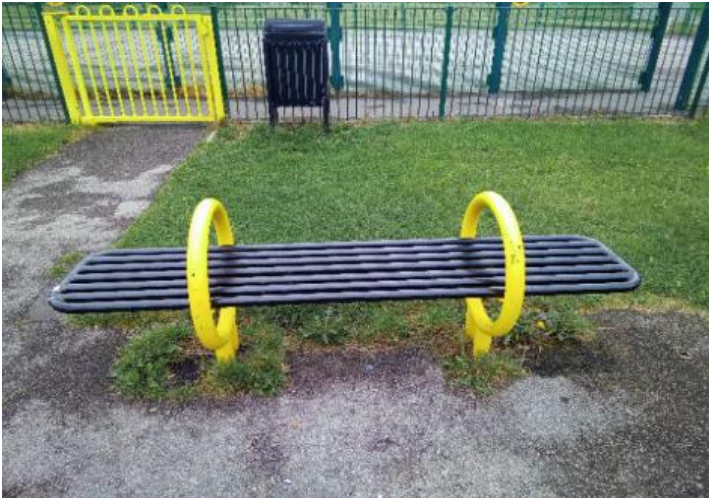
**Item:** Ancillary Items - Bench  
**Manufacturer:** Unknown  
**Risk Level:** N - Risk Assessment not Undertaken  
**Surface:** Tarmac

**Finding:** Item satisfactory

**Action:** Item satisfactory
