the **play** inspection company

Annual Inspection

Rotherham Metropolitan Borough Council

Green Arbour Road, Thurcroft, Rotherham, S66 9DD

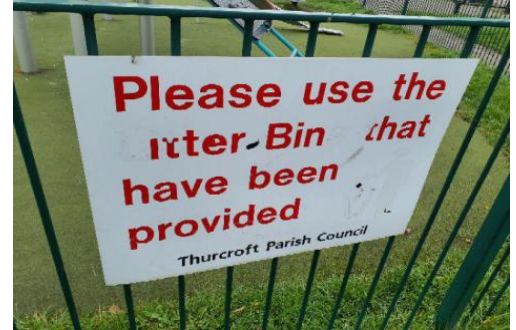
Item: Sign
Manufacturer: Unknown
Surface Type: Steel
Item Quantity: 1
Equipment Compliance: N/A
Surface Area Compliance: N/A

It is recommended that signage, with information including the site address, contact information for maintenance issues and emergency contact details are provided for the facility - Provide in accordance with the recommendations

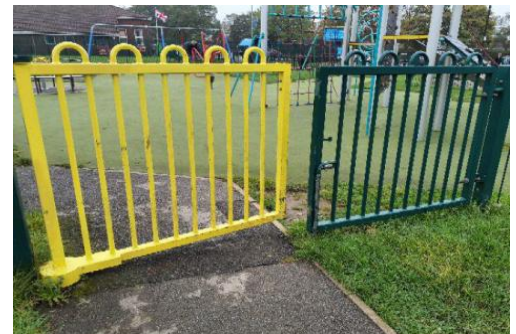
Item: Gate - Combination
Manufacturer: Sutcliffe Play Limited
Surface Type: Grass
Item Quantity: 1
Equipment Compliance: N/A
Surface Area Compliance: N/A

The gate is not operating correctly - Take effective action to ensure the gate closes between 4 and 8 seconds

There are trip hazards present - Reinststate surrounding surfaces to level to remove the trip points

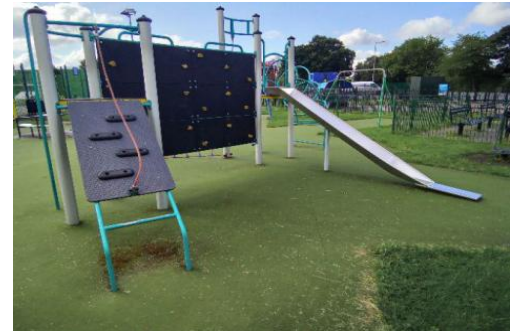
Item: Multi Play (Senior)
Manufacturer: Sutcliffe Play Limited
Surface Type: Carpet System
Item Quantity: 1
Equipment Compliance: No
Surface Area Compliance: Yes

There is/are bolt cap covers missing or damaged on the item - Replace missing or damaged bolt cap covers

There is algae, silt or moss growth on the surface resulting in slippery conditions - Clean and treat appropriately

The ropes/nets are worn/damaged in places - Monitor for any further deterioration and repair or replace as required

The item fails to meet the requirements of BS EN 1176 Part 1 4.2.7.2 for head and neck entrapment in the framework - Monitor - No remedial work recommended

There is/are finger entrapment/s in the framework and the item fails to meet the requirements of BS EN 1176 Part 1 4.2.7.6 Entrapment of fingers - Monitor - No remedial work recommended

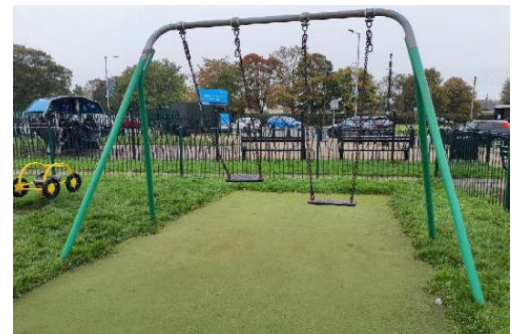
Item: 1 Bay 2 Seat (Flat)
Manufacturer: Sutcliffe Play Limited
Surface Type: Carpet System
Item Quantity: 1
Equipment Compliance: No
Surface Area Compliance: Yes

The chain openings are in excess of the 8.6mm as recommended by BS EN 1176 - Monitor - No remedial work recommended

There is some notable evidence of chain wear - Monitor for any further deterioration and replace when 40% worn

There is some wear to the shackles. - Monitor for any further deterioration and replace when 40% worn

The bushes are showing signs of wear - Monitor for any further deterioration and replace as required

The swing seat connectors are loose - Tighten to secure

The seat has minor damage or wear - Monitor for any further deterioration and replace as required

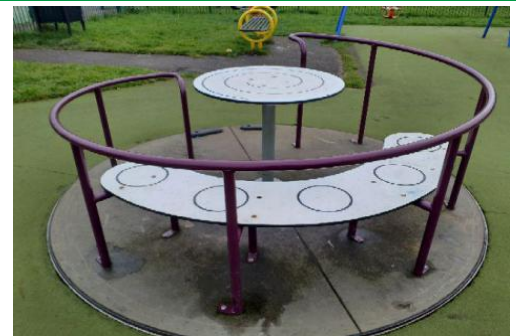
Item: Inclusive Roundabout
Manufacturer: Sutcliffe Play Limited
Surface Type: Carpet System
Item Quantity: 1
Equipment Compliance: No
Surface Area Compliance: No

The item has been damaged - Monitor for any further deterioration and replace as required

The surfacing dimensions are short and do not meet with the requirements of the current applicable standard - Monitor - no remedial action recommended

There is some minor damage to the surface - Monitor for any further deterioration and repair as required

There is a vertical displacement between the top surface of the platform and the ground in excess of 20mm and fails the requirements of BS EN 1176 Part 5 - Monitor - No remedial work recommended

The bearing is worn / damaged and the item is not operating correctly - Repair / replace

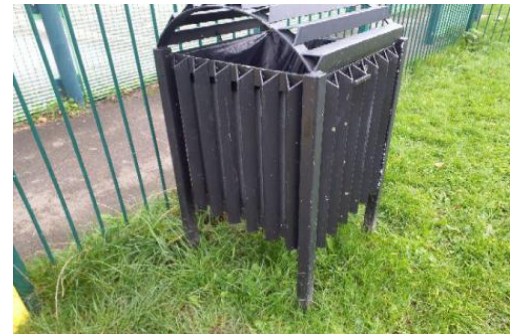
Item: Litter Bin
Manufacturer: Streetmaster
Surface Type: Grass
Item Part Number: Cardiff
Item Quantity: 1
Equipment Compliance: N/A
Surface Area Compliance: N/A
Total Findings: 1

There are trip hazards present - Reinstate surrounding surfaces to level to remove the trip points

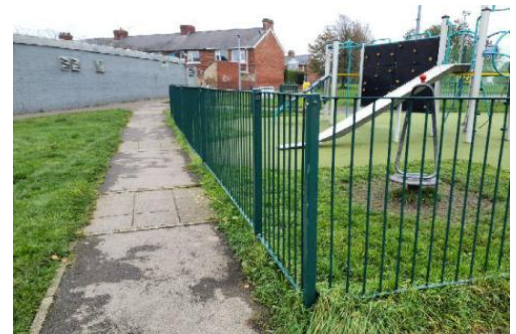
Item: Fencing - Flat Top
Manufacturer: Unknown
Surface Type: Grass
Item Quantity: 1
Equipment Compliance: N/A
Surface Area Compliance: N/A

A number of fixings have worked loose around the fencing - Secure all loose fixings

There is some damage to the fence sections - Monitor for any further deterioration and repair as required

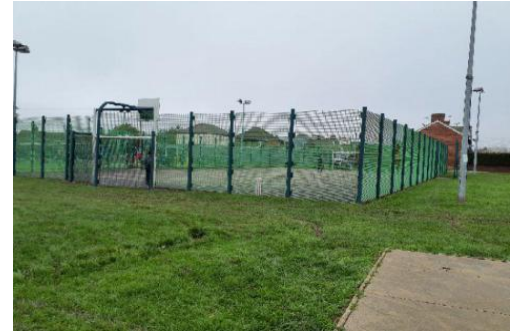
Item: Multi Use Games Area (MUGA)
Manufacturer: Parkdale Play & Leisure Ltd
Surface Type: Bitmac
Item Quantity: 1
Equipment Compliance: No
Surface Area Compliance: N/A

There are trip hazards present - Reinstate surrounding surfaces to level to remove the trip points

There is/are finger entrapments in the framework and the item fails to meet the requirements of BS EN 15312 Clause 4.4.2.2 Entrapment of fingers - Monitor - No remedial work recommended

A clearly visible facility sign should be provided in a prominent position with the wording as detailed BS EN 15312- the equipment is not intended for children less than 3 years old- the warning - Do not climb on the framework or nets- the warning - Do not hang on the ring (if provided)- the warning - Do not wear rings or other jewellery- name and telephone number of the administrator- number to call in case of accident - Provide signage to BS EN 15312

There is/are bolt cap covers missing or damaged on the item - Replace missing or damaged bolt cap covers

There is or are fixings missing on the item - Replace all missing fixings

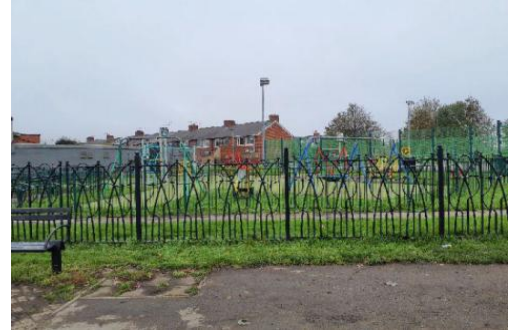
Item: Site General
Manufacturer: Owner/Operator
Surface Type: N/A
Item Quantity: 1
Equipment Compliance: N/A
Surface Area Compliance: N/A

Signage of the wheeled sports area should be provided as recommended in BS EN 14974; this will include, but not exclusively, the use of the area, a recommendation to wear protective equipment, emergency contact details etc. - Provide signage as recommended by BS EN 14974 for wheeled sports areas

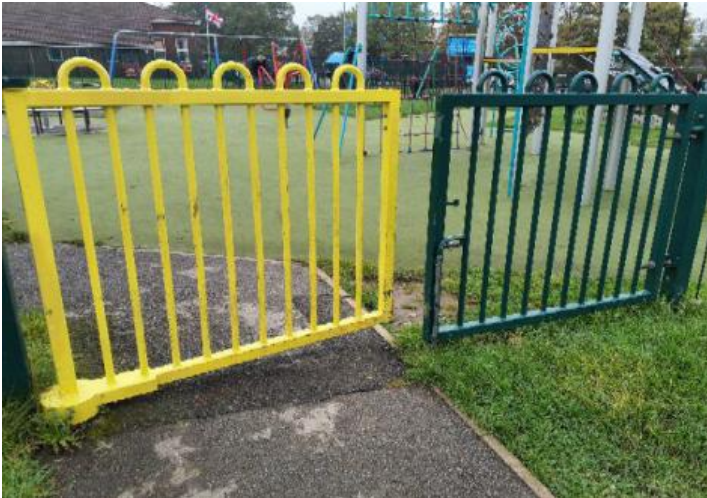
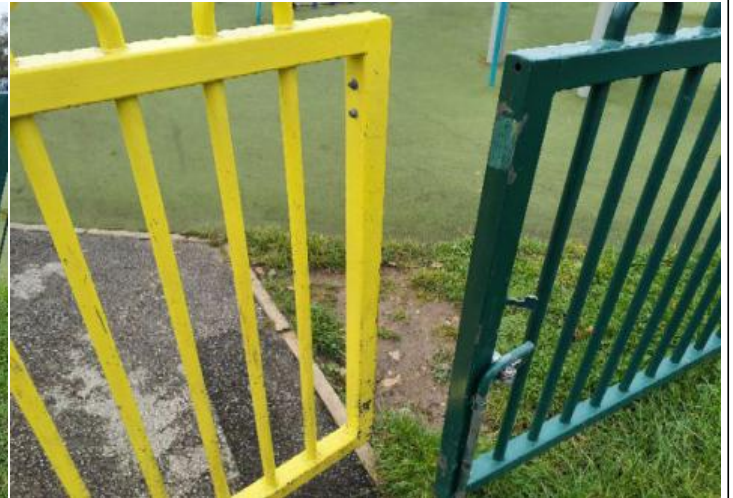
Item: Gates - Gate - Combination
Manufacturer: Sutcliffe Play Limited

Finding: The gate is not operating correctly

Action: Take effective action to ensure the gate closes between 4 and 8 seconds

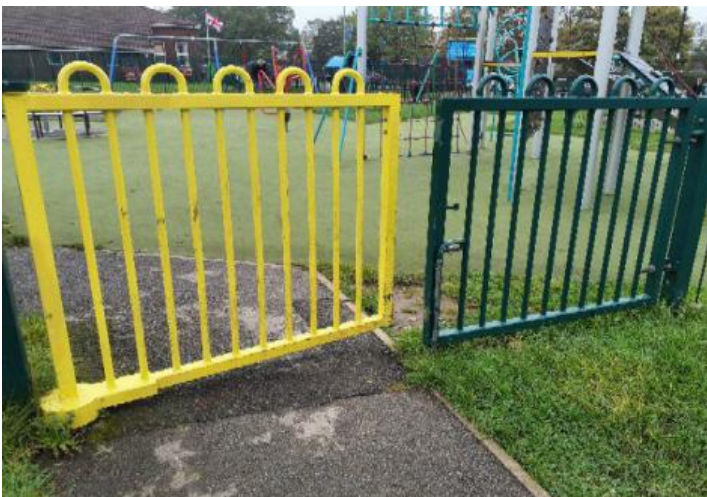
Item: Gates - Gate - Combination
Manufacturer: Sutcliffe Play Limited

Finding: There are trip hazards present

Action: Reinstate surrounding surfaces to level to remove the trip points

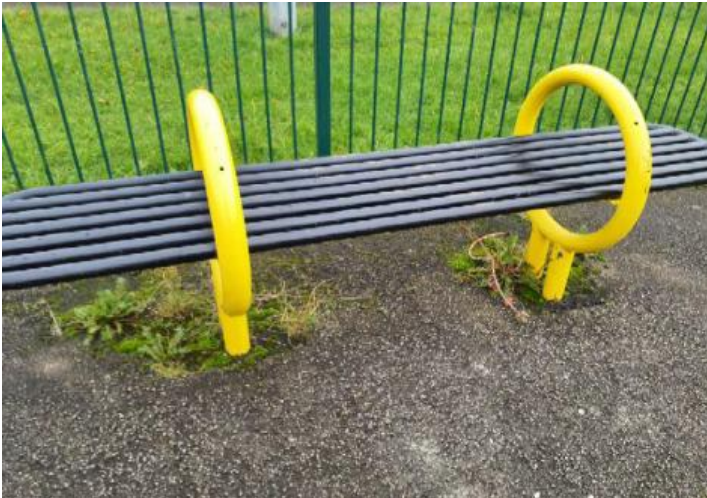
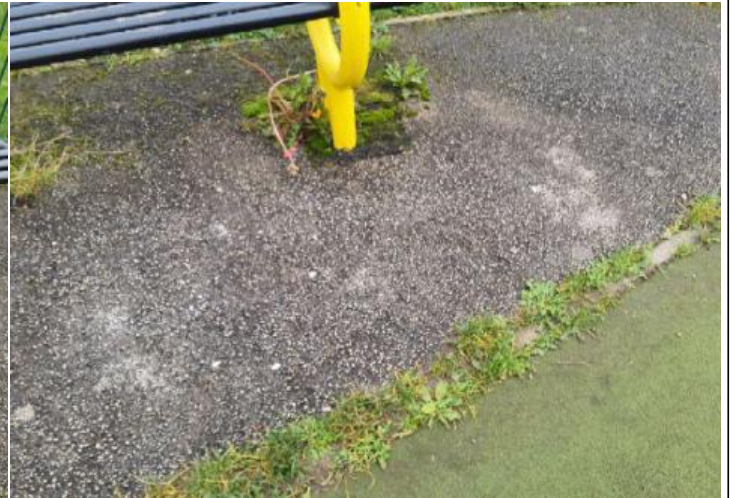
Item: Ancillary Items - Bench
Manufacturer: Sutcliffe Play Limited

Finding: There is weed / vegetation growth on, between, or around the edges of the surfacing
Action: Remove weed / vegetation growth

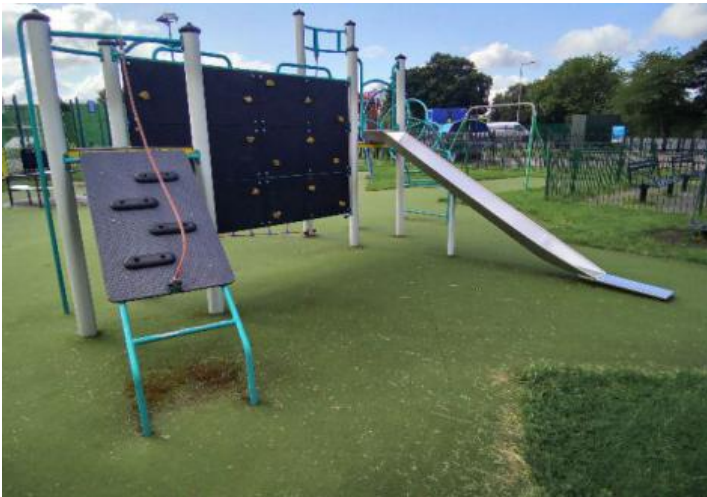
Item: Activity Equipment - Multi Play (Senior)
Manufacturer: Sutcliffe Play Limited

Finding: There is/are bolt cap covers missing or damaged on the item
Action: Replace missing or damaged bolt cap covers

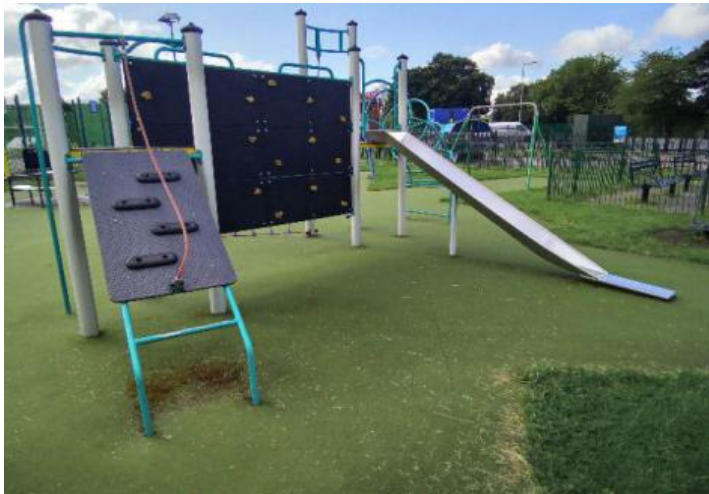
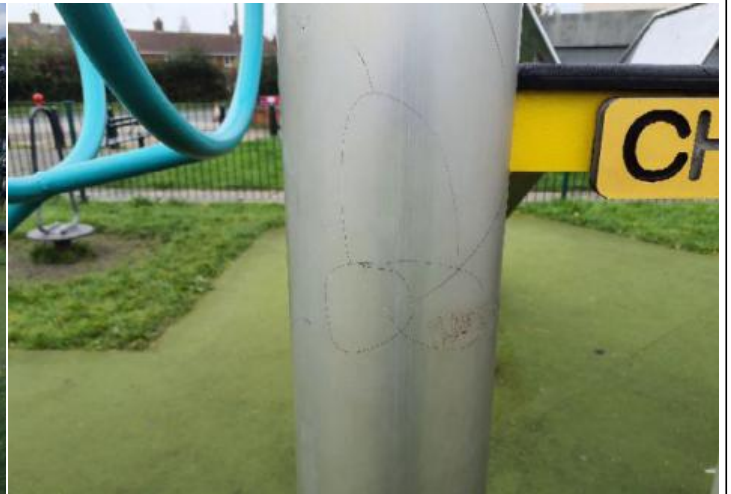
Item: Activity Equipment - Multi Play (Senior)
Manufacturer: Sutcliffe Play Limited

Finding: There is offensive graffiti present

Action: Remove as soon as practicable

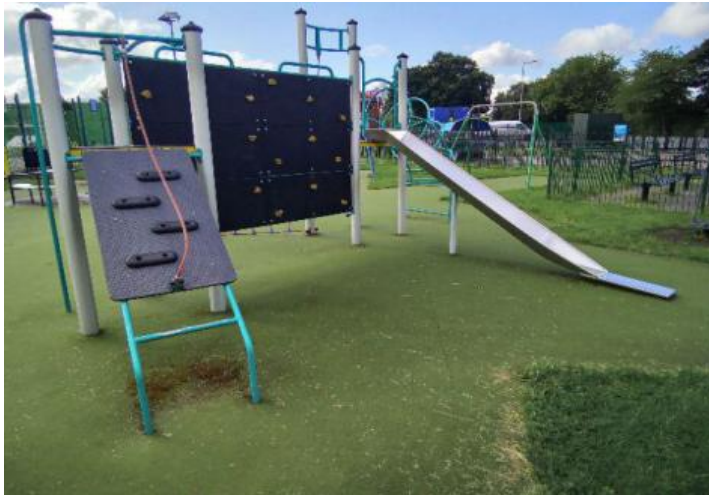
Item: Activity Equipment - Multi Play (Senior)
Manufacturer: Sutcliffe Play Limited

Finding: There is algae, silt or moss growth on the surface resulting in slippery conditions

Action: Clean and treat appropriately

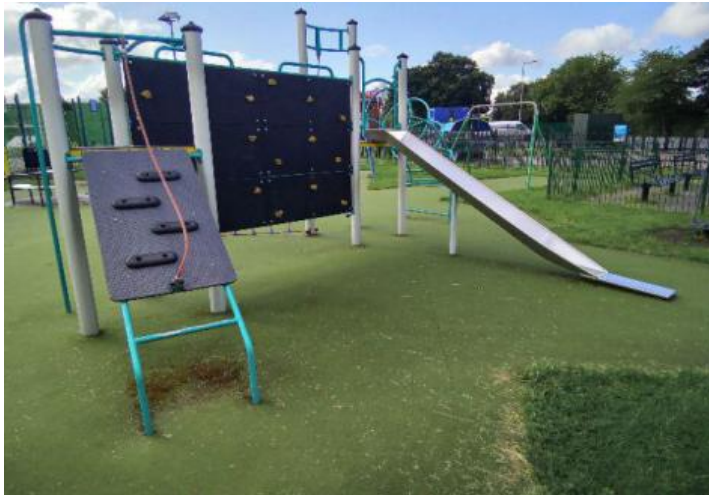
Item: Activity Equipment - Multi Play (Senior)
Manufacturer: Sutcliffe Play Limited

Finding: There is/are finger entrapment/s in the framework and the item fails to meet the requirements of BS EN 1176 Part 1 4.2.7.6 Entrapment of fingers

Action: Monitor - No remedial work recommended

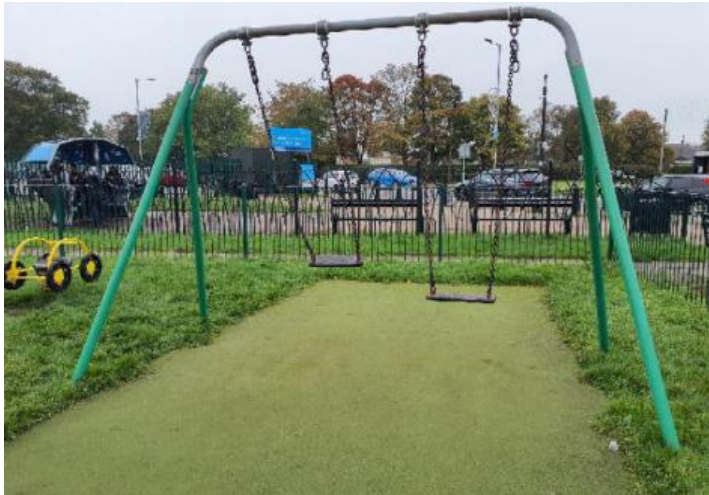
Item: Swings - 1 Bay 2 Seat (Flat)
Manufacturer: Sutcliffe Play Limited

Finding: There is some notable evidence of chain wear

Action: Monitor for any further deterioration and replace when 40% worn

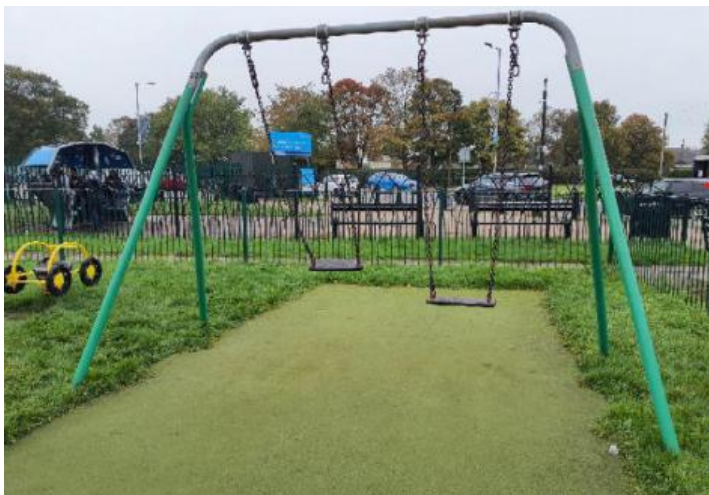
Item: Swings - 1 Bay 2 Seat (Flat)
Manufacturer: Sutcliffe Play Limited

Finding: There is some wear to the shackles.

Action: Monitor for any further deterioration and replace when 40% worn

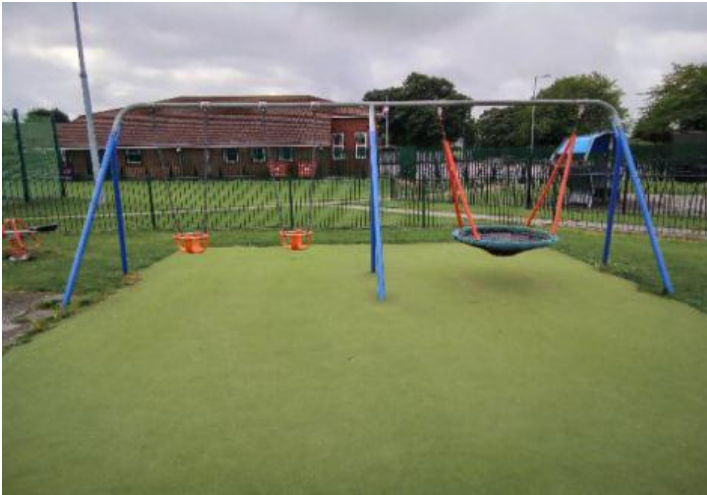
Item: Swings - 2 Bay 2 Cradle 1 Basket
Manufacturer: Sutcliffe Play Limited

Finding: The seat has minor damage or wear

Action: Monitor for any further deterioration and replace as required

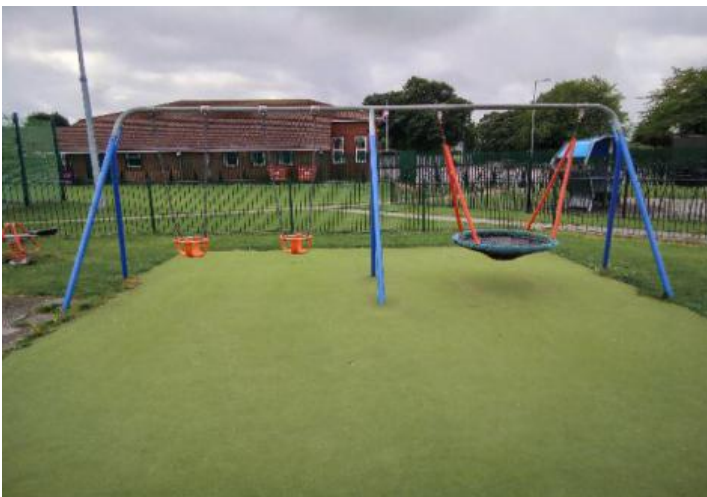
Item: Swings - 2 Bay 2 Cradle 1 Basket
Manufacturer: Sutcliffe Play Limited

Finding: The bushes are worn or missing

Action: Replace worn or missing bushes

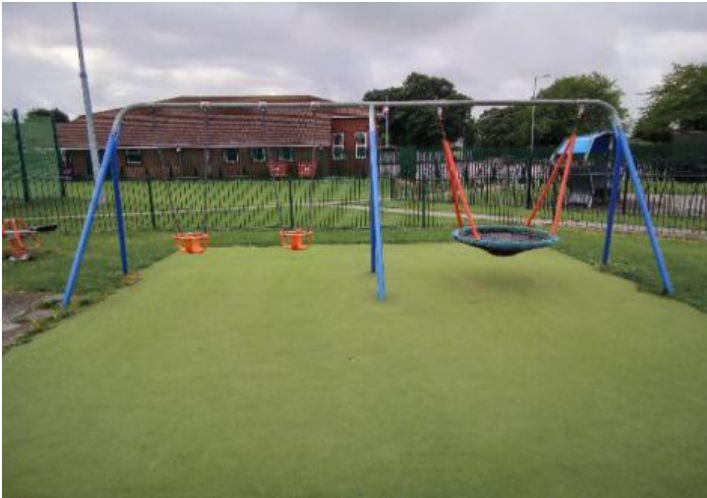
Item: Swings - 2 Bay 2 Cradle 1 Basket
Manufacturer: Sutcliffe Play Limited

Finding: There is some wear to the shackles.

Action: Monitor for any further deterioration and replace when 40% worn

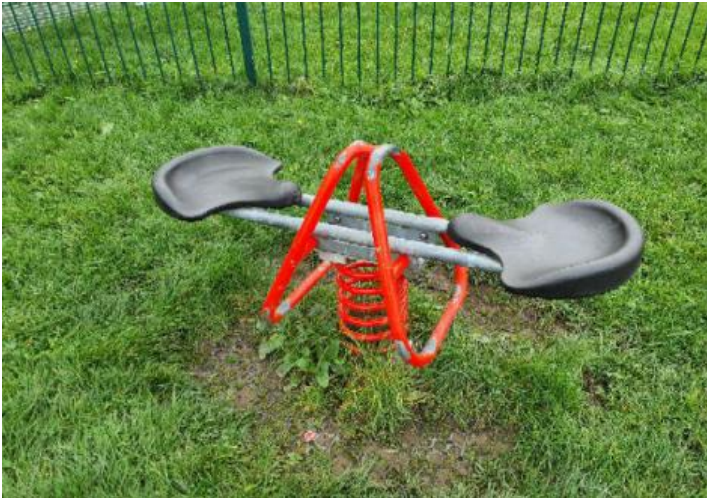
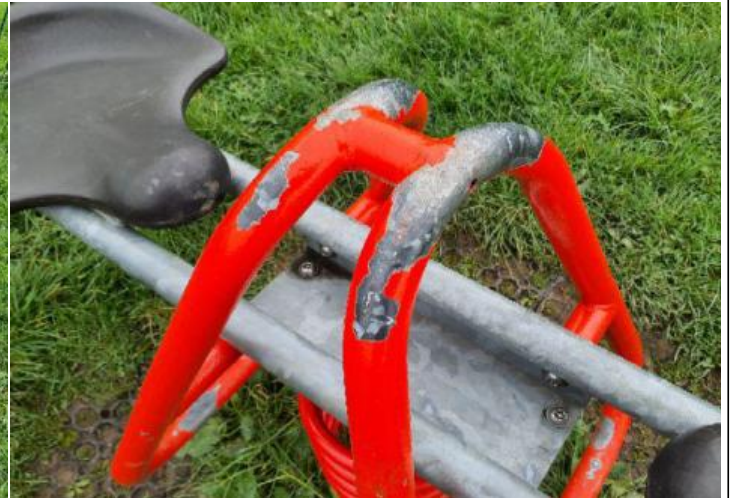
Item: Rocking Equipment - Spring See-Saw
Manufacturer: Sutcliffe Play Limited

Finding: The paint is flaking off the metalwork

Action: Rub down and re-paint

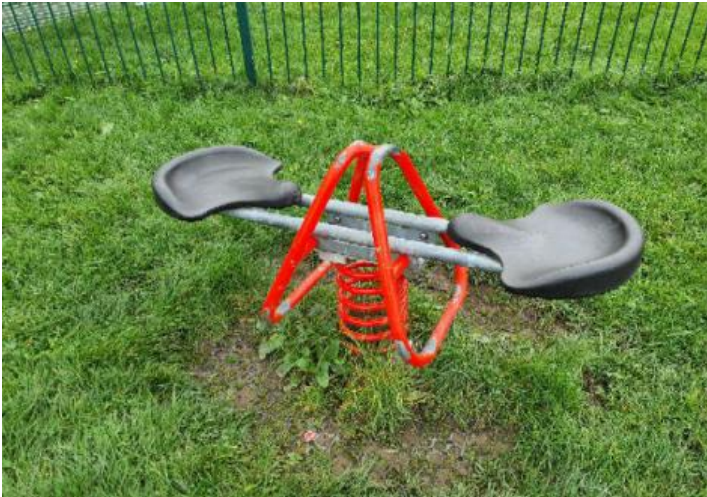
Item: Rocking Equipment - Spring See-Saw
Manufacturer: Sutcliffe Play Limited

Finding: The spring clamps are loose

Action: Tighten all loose fixings

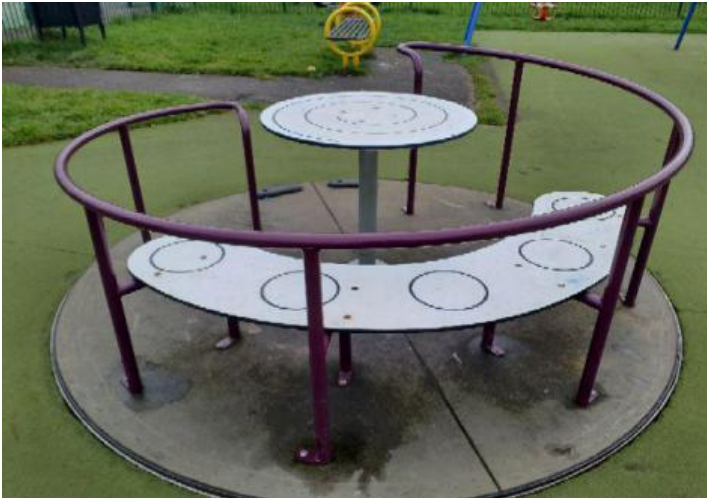
Item: Rotor Play - Inclusive Roundabout
Manufacturer: Sutcliffe Play Limited

Finding: The item has been damaged

Action: Monitor for any further deterioration and replace as required

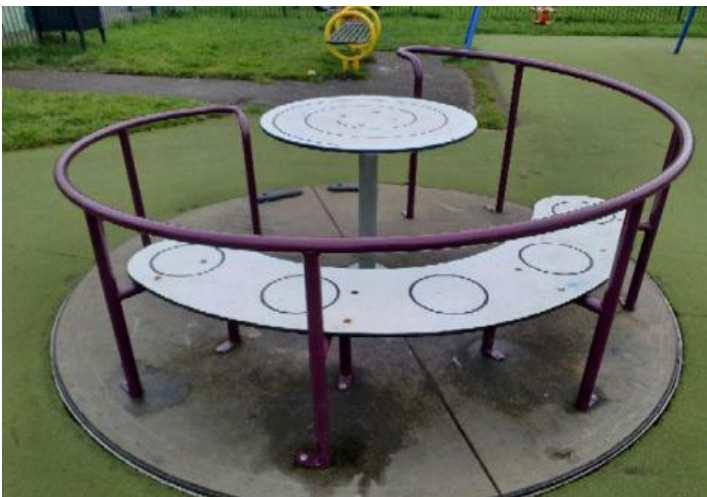
Item: Rotor Play - Inclusive Roundabout
Manufacturer: Sutcliffe Play Limited

Finding: The surfacing dimensions are short and do not meet with the requirements of the current applicable standard

Action: Monitor - no remedial action recommended

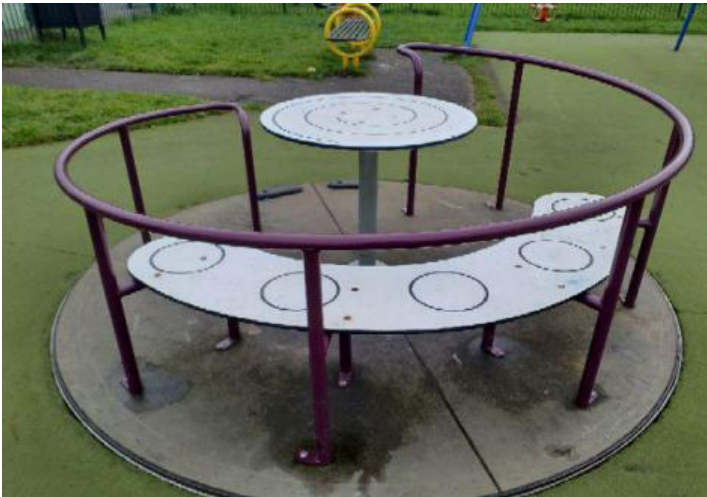
Item: Rotor Play - Inclusive Roundabout
Manufacturer: Sutcliffe Play Limited
Risk Level: L - Low Risk
Surface: Carpet System

Finding: There is a vertical displacement between the top surface of the platform and the ground in excess of 20mm and fails the requirements of BS EN 1176 Part 5
Action: Monitor - No remedial work recommended

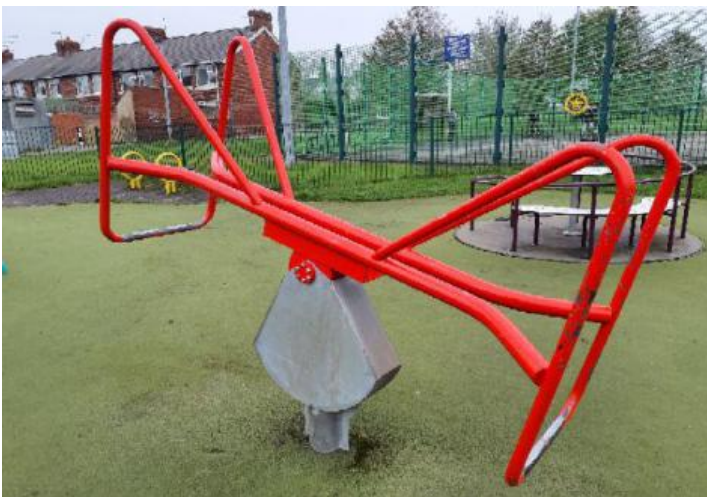
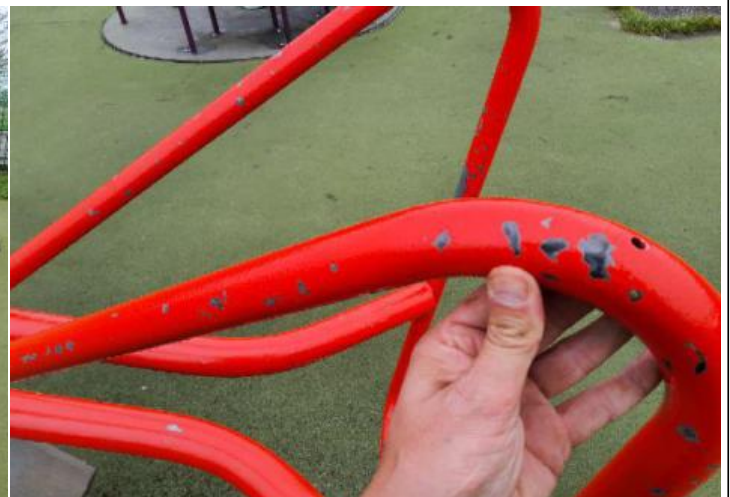
Item: Rocking Equipment - Stand up SeeSaw
Manufacturer: Sutcliffe Play Limited

Finding: The paint is flaking off the metalwork
Action: Rub down and re-paint

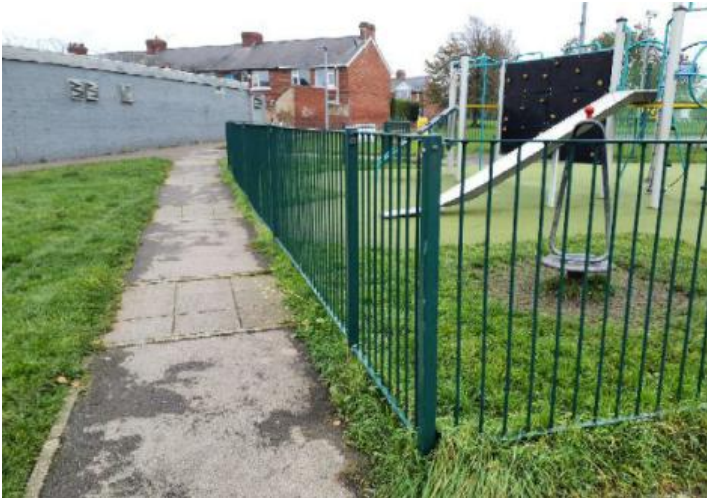
Item: Fences - Fencing - Flat Top
Manufacturer: Unknown

Finding: A number of fixings have worked loose around the fencing
Action: Secure all loose fixings

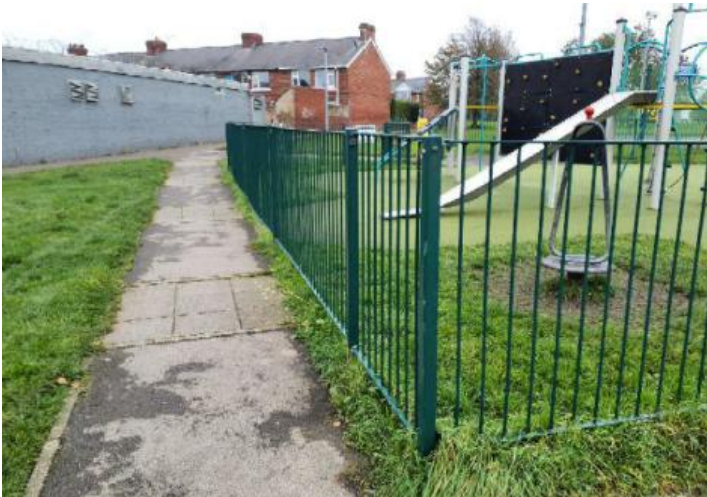
Item: Fences - Fencing - Flat Top
Manufacturer: Unknown

Finding: There is some damage to the fence sections
Action: Monitor for any further deterioration and repair as required

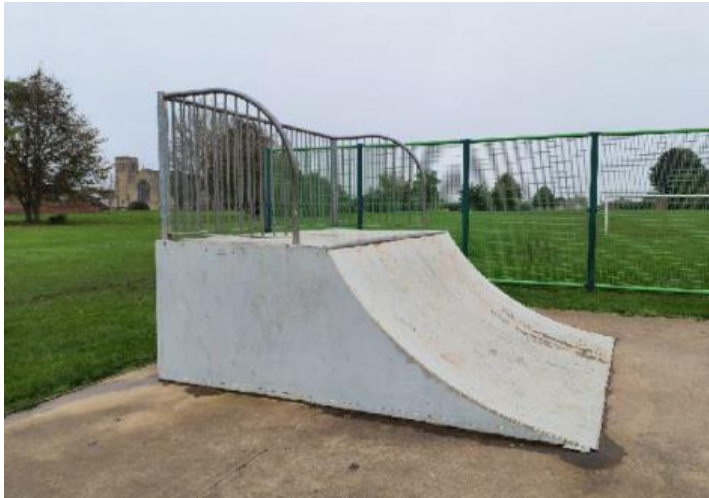
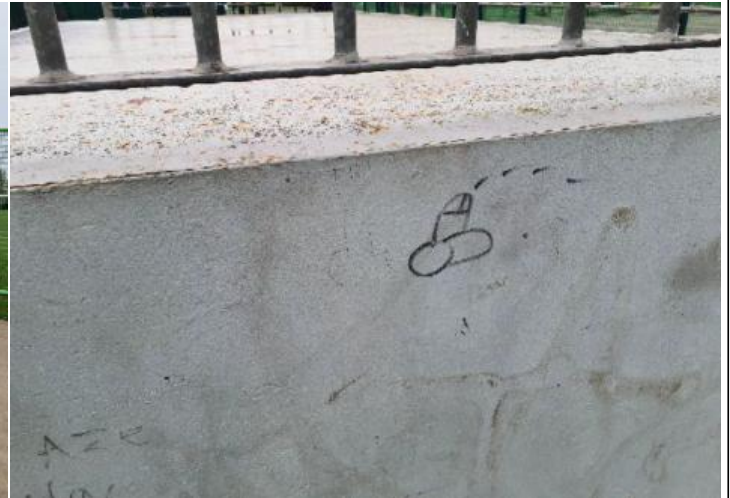
Item: Wheeled Sports - Quarter Pipe
Manufacturer: Not Identified

Finding: There is offensive graffiti present

Action: Remove as soon as practicable

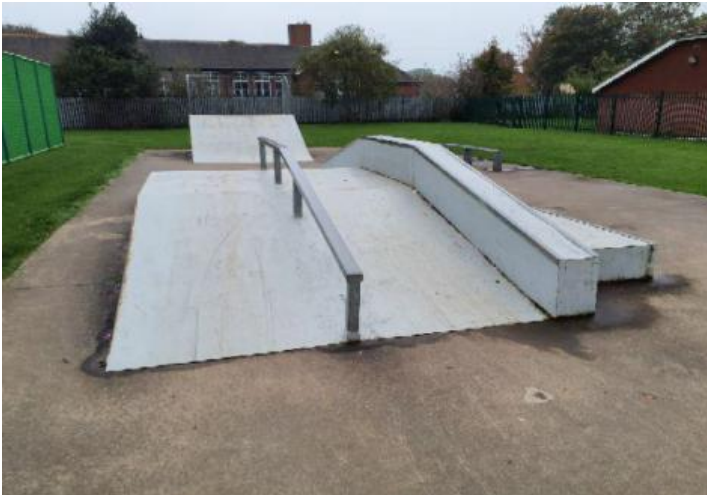
Item: Wheeled Sports - Fun Box
Manufacturer: Not Identified

Finding: The paintwork on this item has been damaged or worn exposing the metal underneath which is rusting / corroding

Action: Treat affected areas and repaint

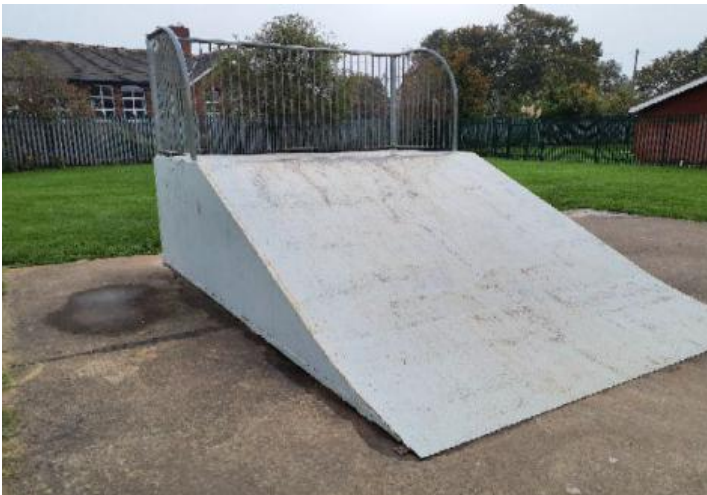
Item: Wheeled Sports - Flat Ramp
Manufacturer: Not Identified

Finding: There is some damage to the barrier sections

Action: Monitor for any further deterioration and repair as required

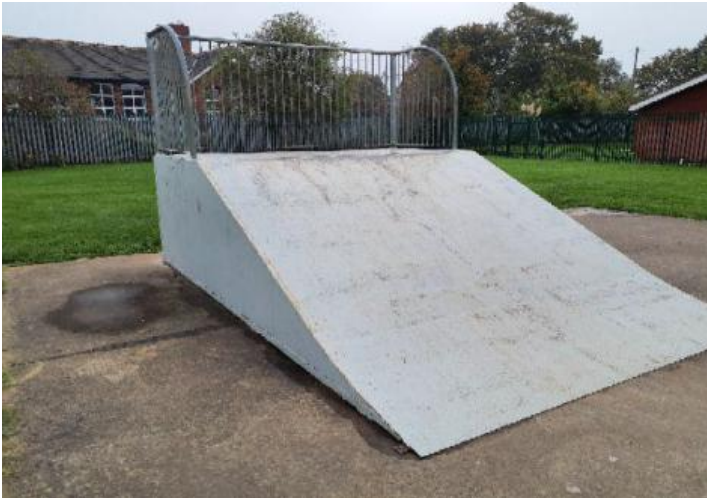
Item: Wheeled Sports - Flat Ramp
Manufacturer: Not Identified

Finding: The paintwork on this item has been damaged or worn exposing the metal underneath which is rusting / corroding

Action: Treat affected areas and repaint

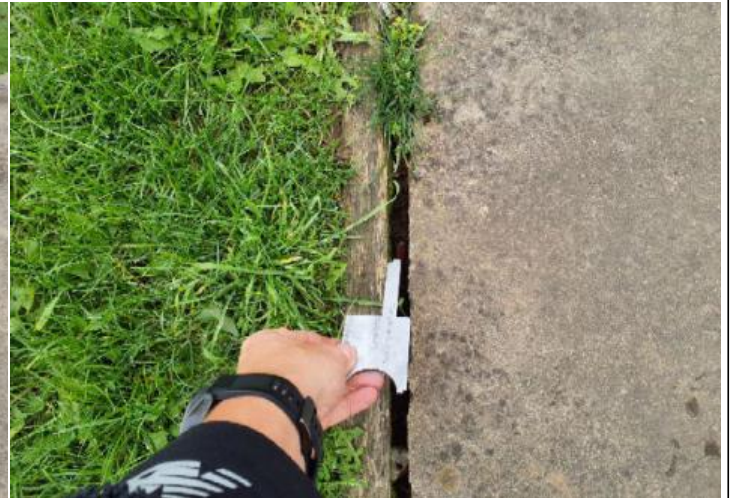
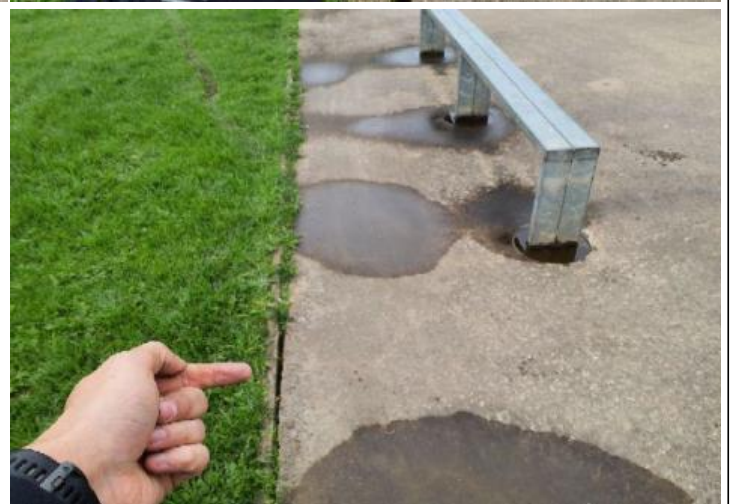
Item: Wheeled Sports - Grind Rail
Manufacturer: Not Identified

Finding: Joints between the riding surfaces should not be greater than 5mm to meet the requirements of BS EN 14974 **Action:** Take corrective action to ensure that the gaps between the joints do not exceed 5mm

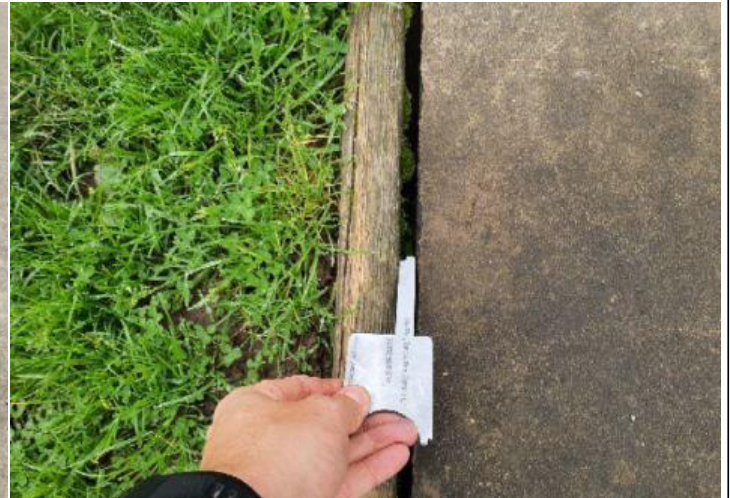
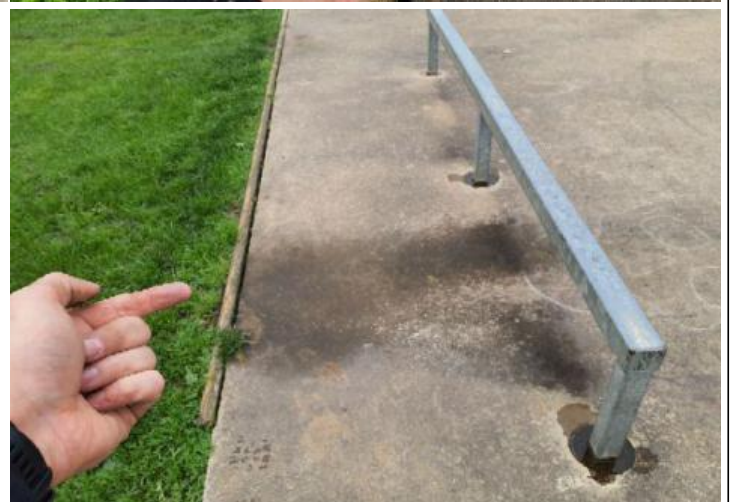
Item: Wheeled Sports - Grind Rail
Manufacturer: Not Identified

Finding: Joints between the riding surfaces should not be greater than 5mm to meet the requirements of BS EN 14974
Action: Take corrective action to ensure that the gaps between the joints do not exceed 5mm

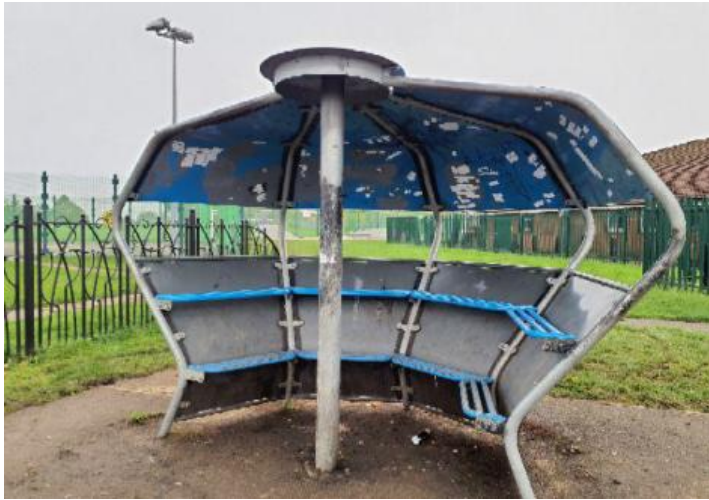
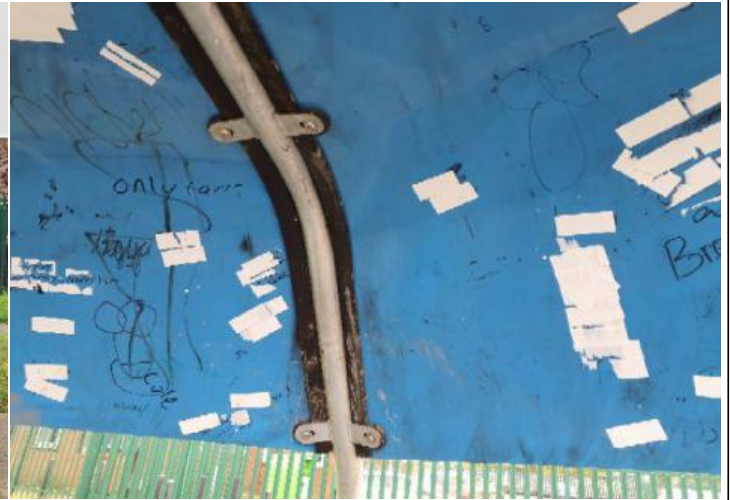
Item: Ancillary Items - Shelter
Manufacturer: Owner/Operator

Finding: There is offensive graffiti present

Action: Remove as soon as practicable

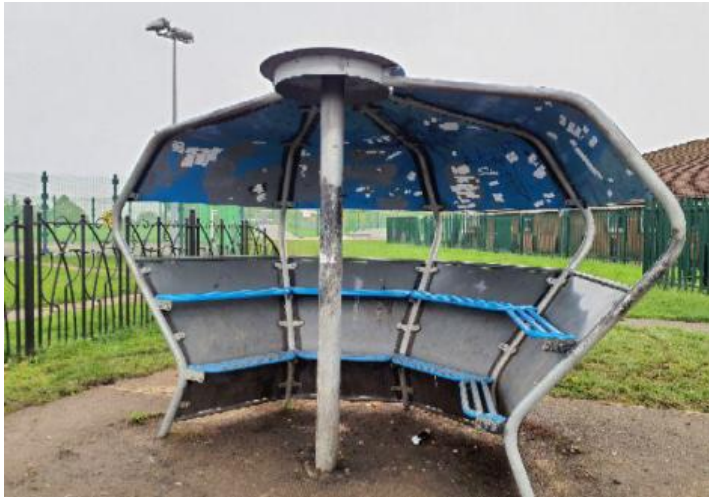
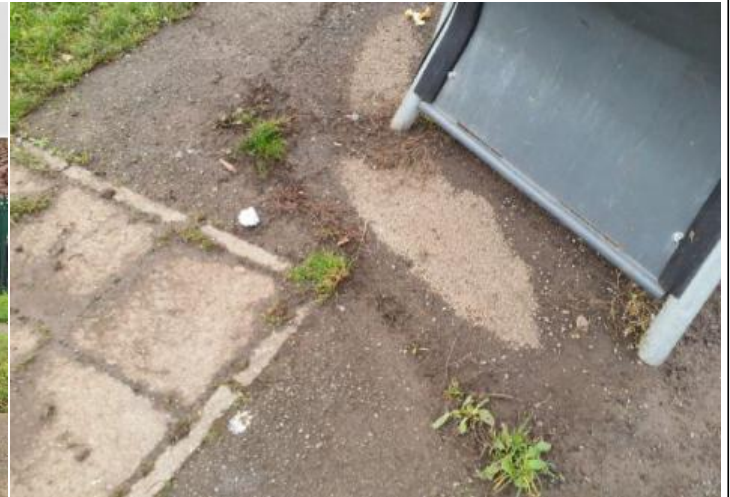
Item: Ancillary Items - Shelter
Manufacturer: Owner/Operator

Finding: There is weed / vegetation growth on, between, or around the edges of the surfacing

Action: Remove weed / vegetation growth
